# INTERSTATE-McBEE

## FAILURE ANALYSIS GUIDE

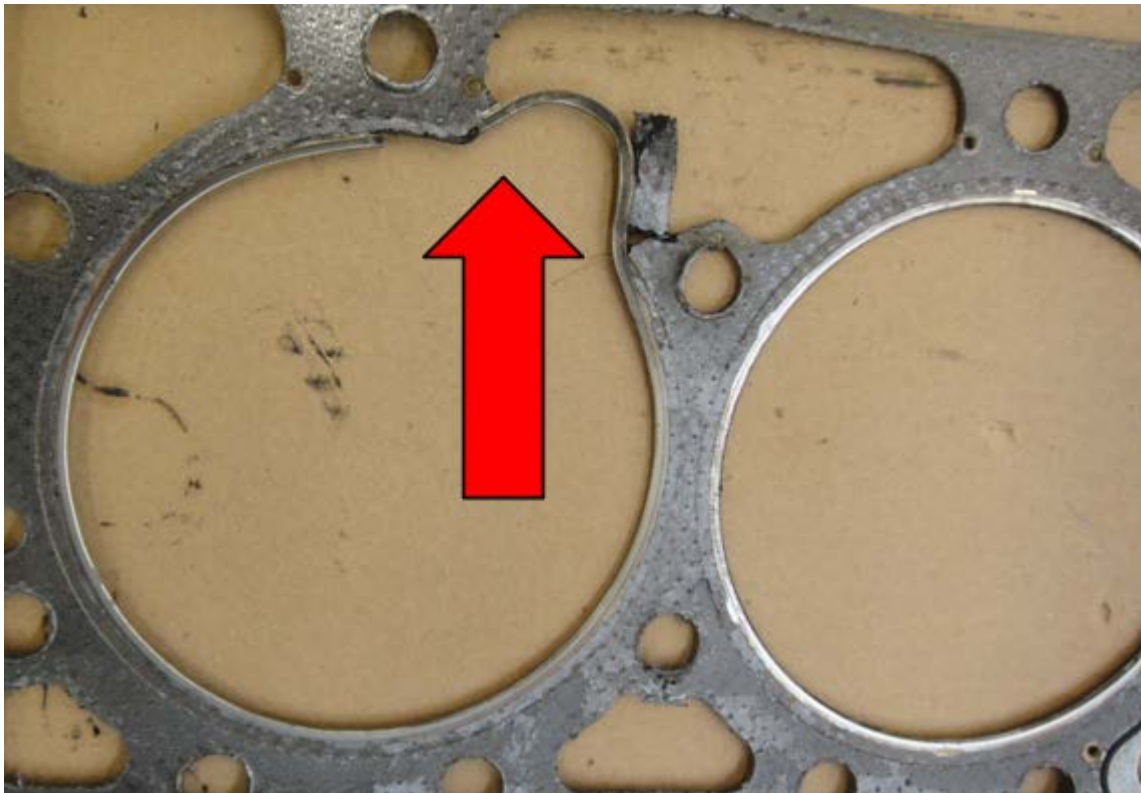
The first picture shows the damage to the fire ring on #4 cylinder of the returned head gasket. Note: the condition of the fire ring in the adjoining cylinder which did not fail. The head gasket failed from detonation causing thermo push fracturing the fire ring.

The following picture shows the result of thermo push caused by detonation.

Conclusion: Inspection revealed the head gasket failed due to detonation resulting in thermal push. Detonation is uncontrollable combustion creating combustion temperatures and pressures exceeding cylinder components design capabilities.

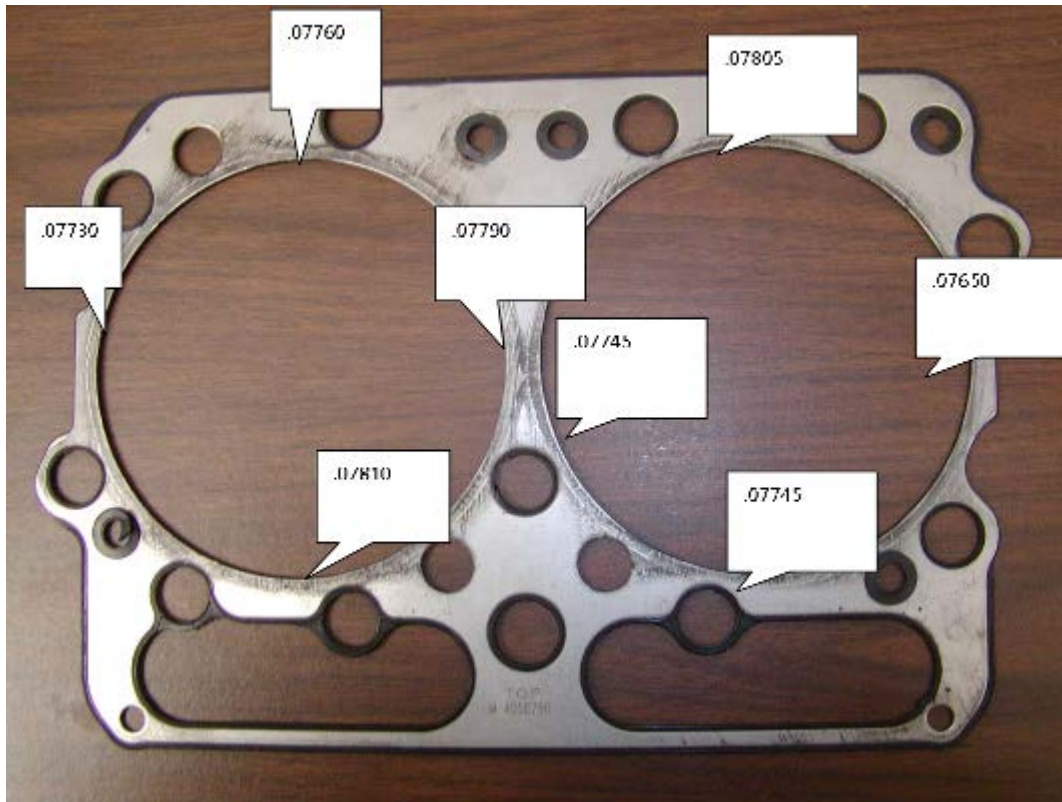
The first picture shows top view and measurements of head thickness variations. Note lines on gasket indicate head surface may be too rough.

Conclusion: Minor variations in the gasket thickness indicate surface flatness, liner perpendicularity and even head bolt clamping force. Failure of seals was caused by too rough a surface on the cylinder head. This allowed multiple combustion leak paths resulting in damage to the head seals.

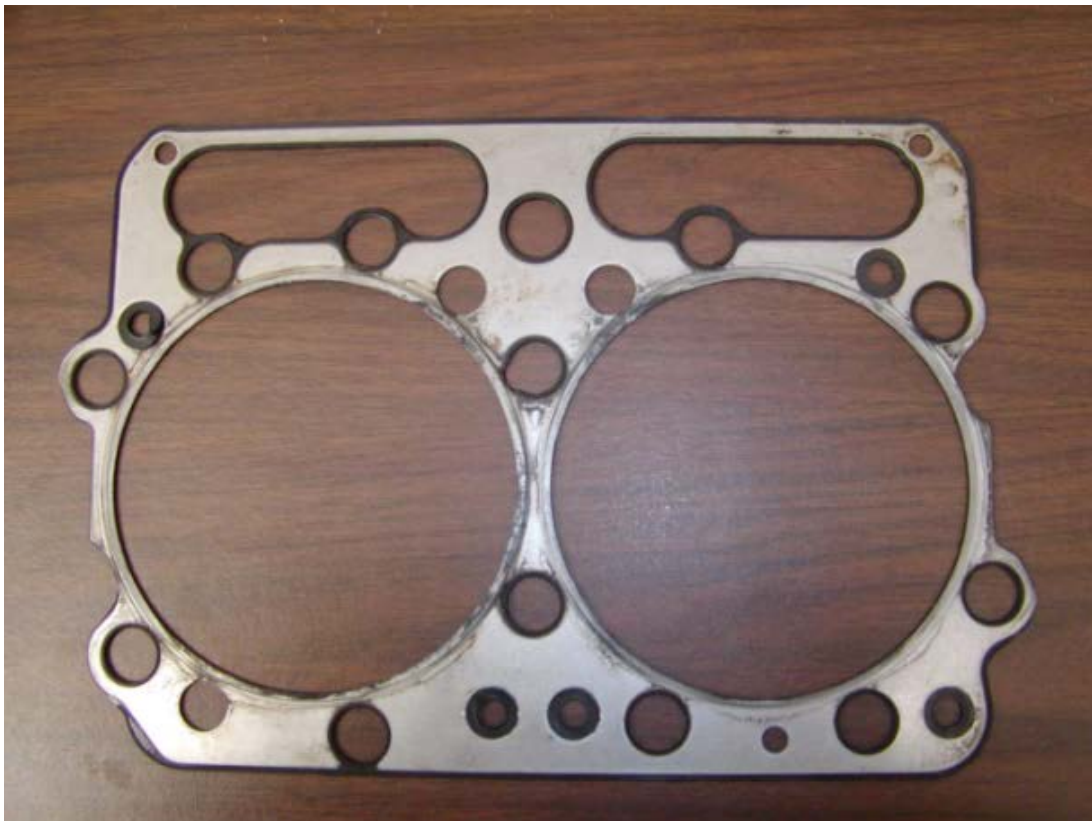
This picture shows bottom side of head gasket; note no coarse resurface lines showing.

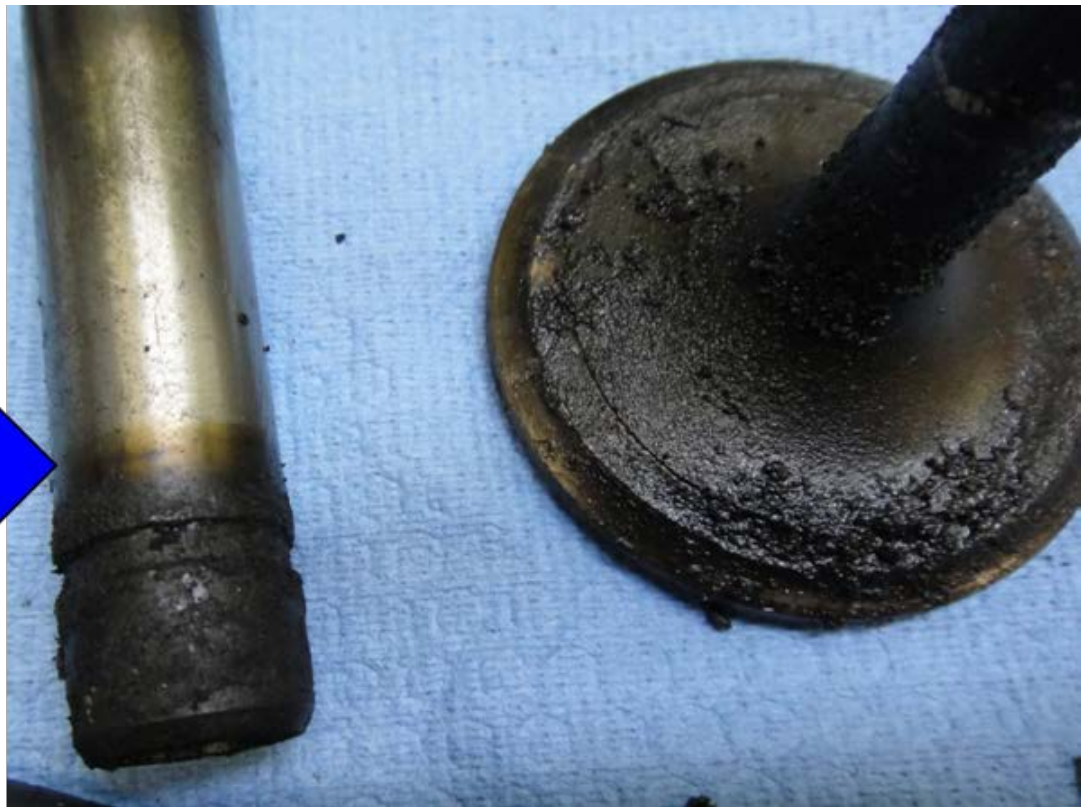
The next several pictures will show the heavy abrasive carbon build up on the valve, valve spring and rotator and the valve guide. Note the heat discoloration of the guide (blue arrow). These parts failed due to carbon build up due to external conditions and not defects in the product.

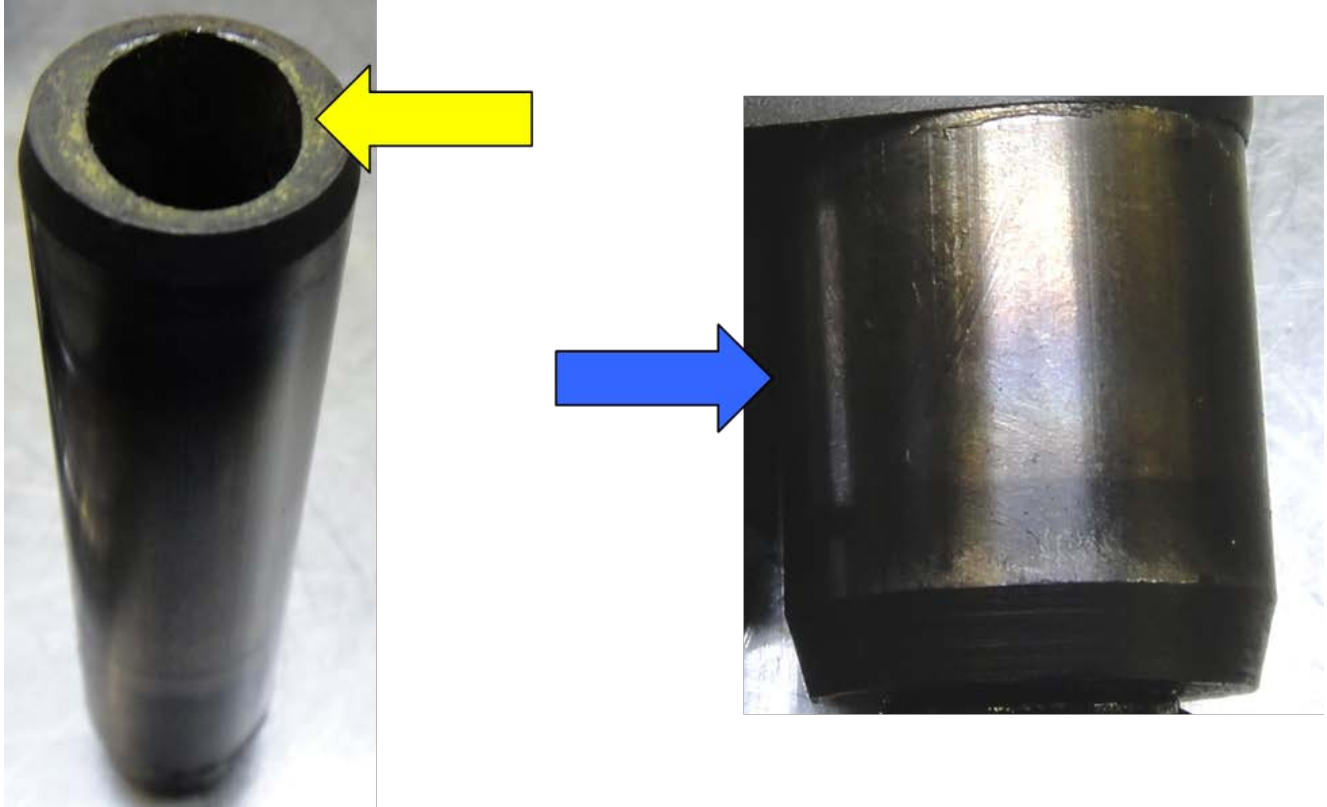
The first two pictures show the wear in the lower part of the valve guide closest to the valve head. The second picture shows the heat discoloration on the lower part of the guide was caused from excessive heat. Excessive guide wear most likely occurred from improperly set valve bridges and maintenance issues.

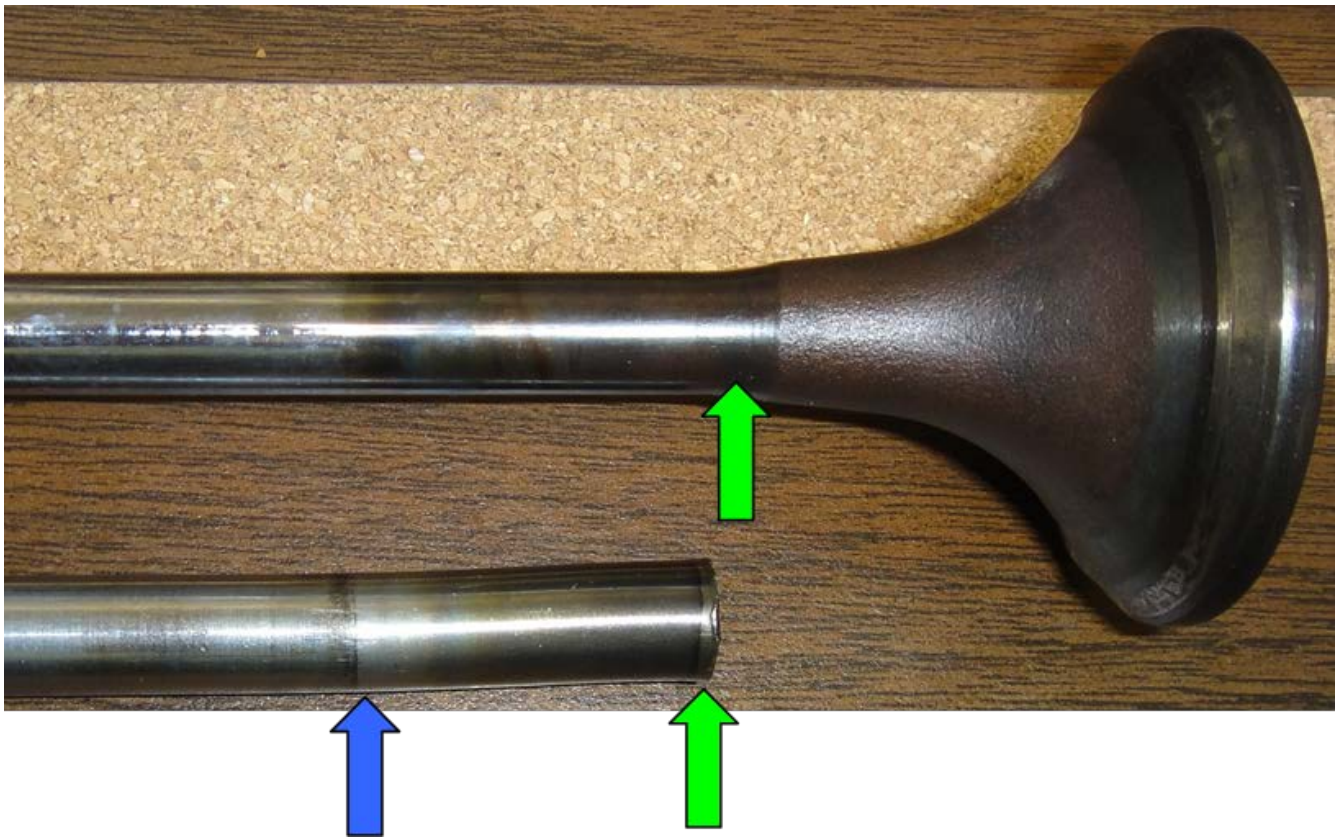
The following picture shows a complete valve and the stem of the failed valve. The green arrows will point out where the failed valve broke in relationship to the complete valve. The blue arrow will point out where the valve head is welded to the valve stem.

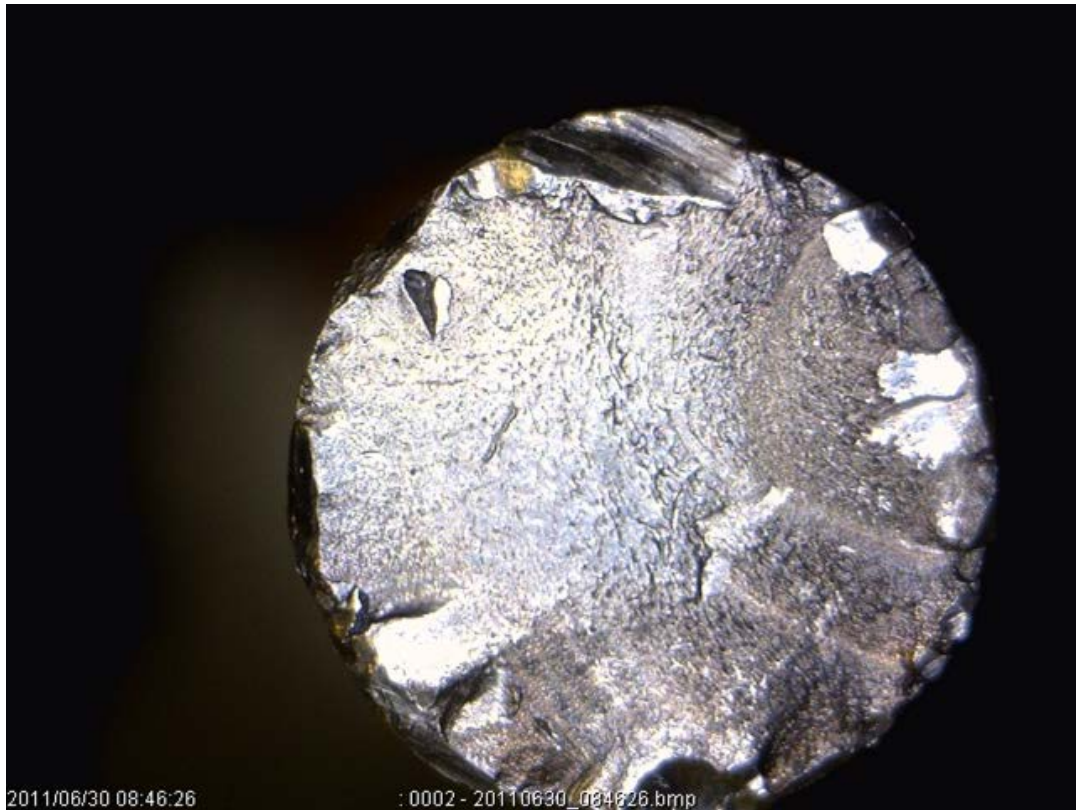
The next picture is a view of the valve stem break that is a bending fatigue failure.

The failed valve had no inclusions or flaws in the break area. The valve did not break at the weld attaching the valve head to the shaft as claimed. The most likely cause for the failure is bending fatigue caused by misalignment.

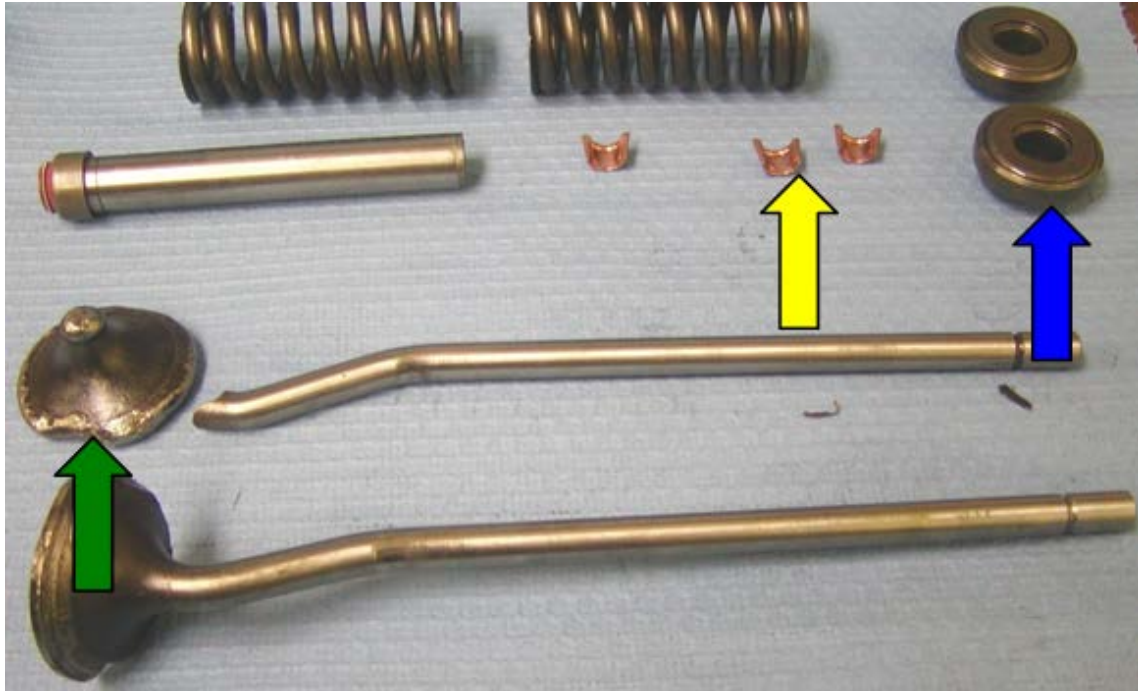
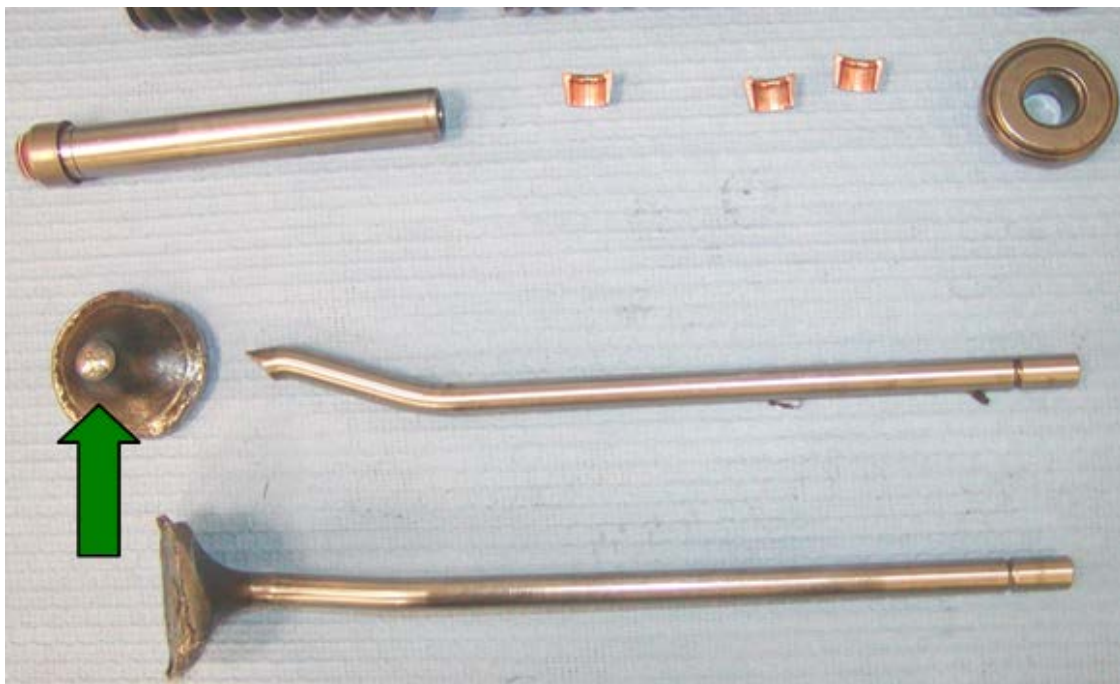
- The yellow arrow pointing at the valve retainers show they are undamaged.
- The rotators indicated by the blue arrow were inspected and function properly showing no damage.
- The two valves in the foreground show no galling in the stem indicating they did not seize in the valve guide.
- The Green arrow points to the broken valve, note location of break.

In the above picture the green arrow points to the valve head and the area the valve broke. This is in the weld area of the valve, the strongest part of a valve. This type of failure only occurs from impact. The second valve is bent in the same location but did not break. All the possible causes such as valve sticking in guide, broken valve retainers show no signs of failure as seen in the first picture.

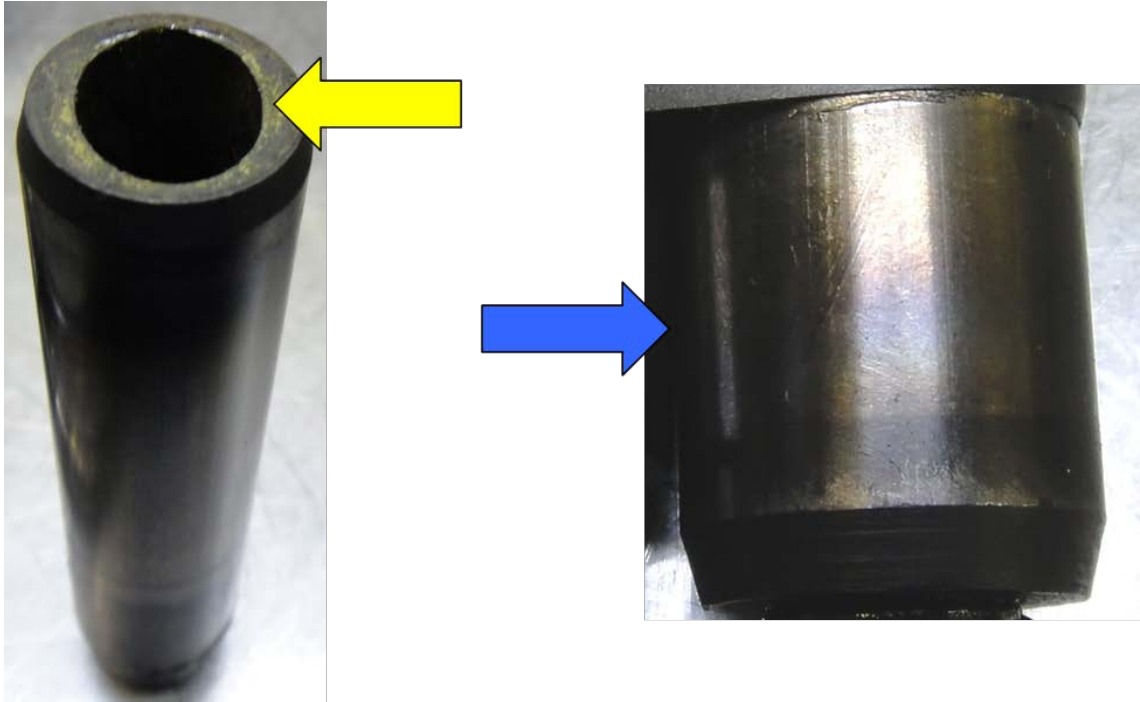
The first two pictures show the wear in the lower part of the valve guide closest to the valve head. The second picture shows the heat discoloration on the lower part of the guide was caused from excessive heat. Excessive guide wear most likely occurred from improperly set valve bridges and maintenance issues.

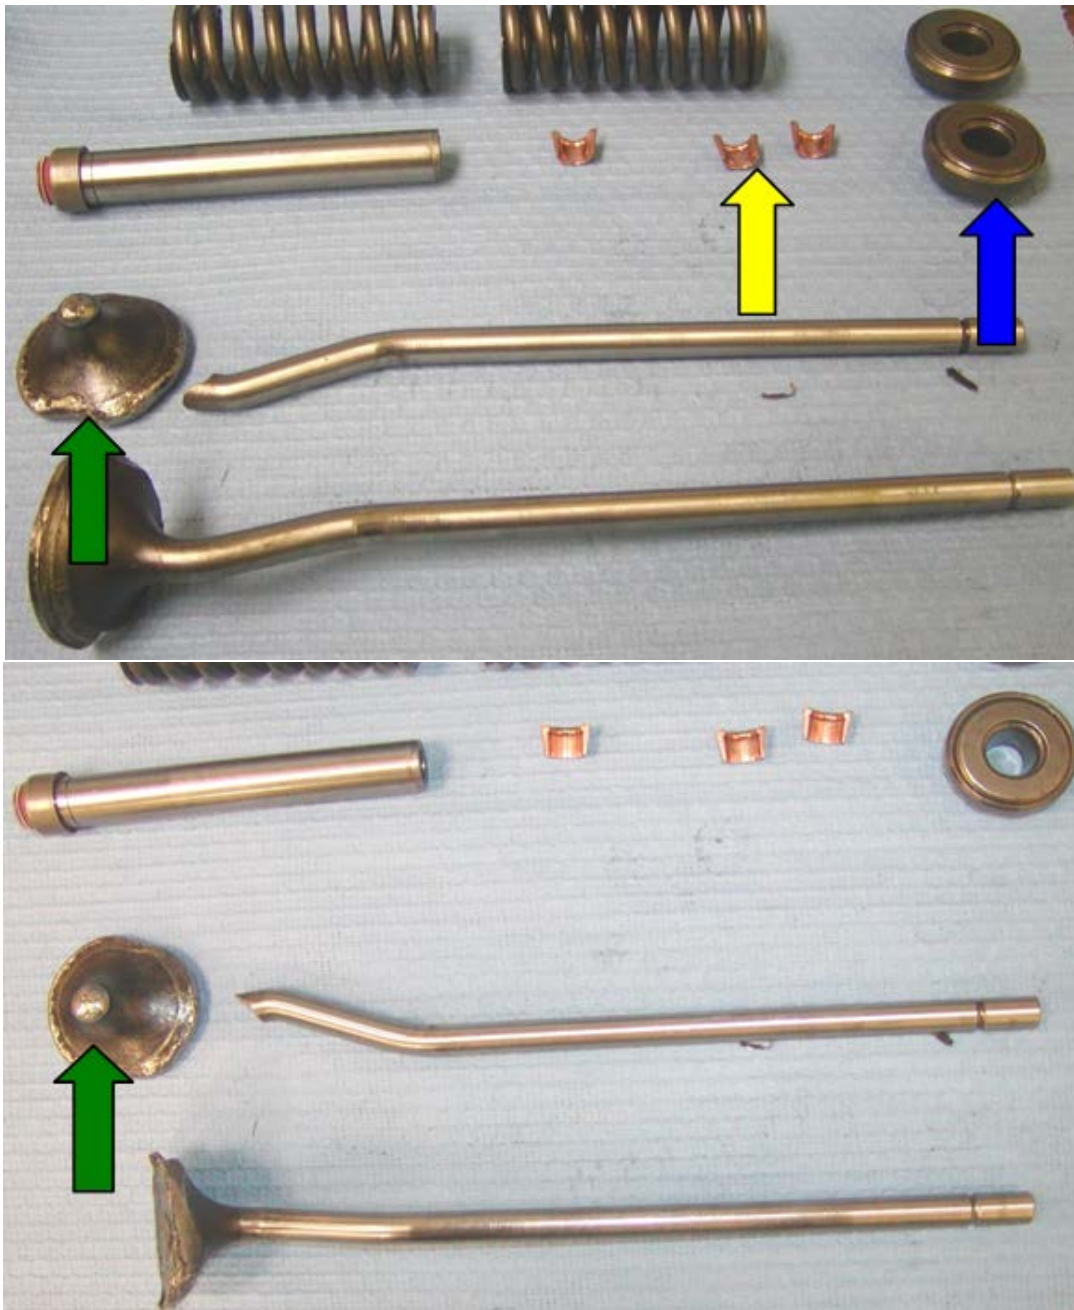
The following pictures shows material returned. The yellow arrow pointing at the valve retainers show they are undamaged. The rotators indicated by the blue arrow were inspected and function properly showing no damage. The two valves in the foreground show no galling in the stem indicating they did not seize in the valve guide. The Green arrow points to the broken valve, note location of break.

In the above picture the green arrow points to the valve head and the area the valve broke. This is the strongest part of a valve. This type of failure only occurs from impact. The second valve is bent in the same location but did not break. All the possible causes such as valve sticking in guide, broken valve retainers show no signs of failure as seen in the first picture.

Conclusion: Since both valves are bent in a similar manner, the piston hit the valves and not some random piece of foreign material. The root cause of failure is impact loading.

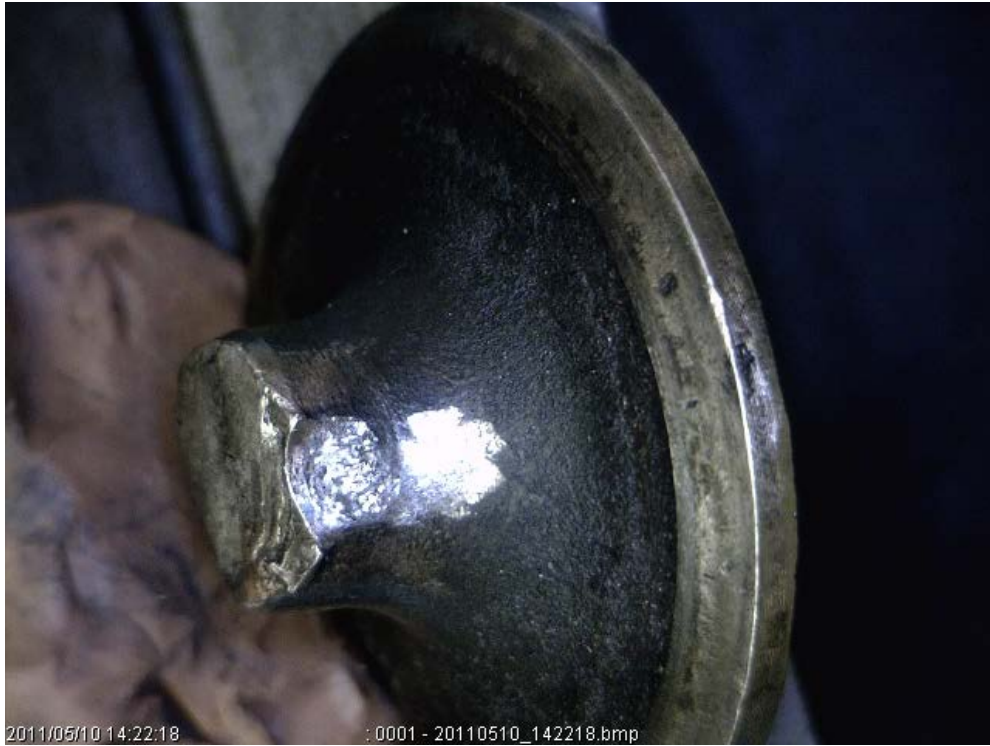
The first picture shows the valve head. The valve broke in the strongest part of the valve and not at the parting line between the valve head and stem. Breaks in this part of the valve occur when the valve is hit and the failure is caused by impact loading.

Conclusion: The most likely cause for the valve failure was found to be impact loading caused when the valve was momentarily locked in the open position by the turned valve bridge allowing the piston to strike the valve breaking it off from the stem.

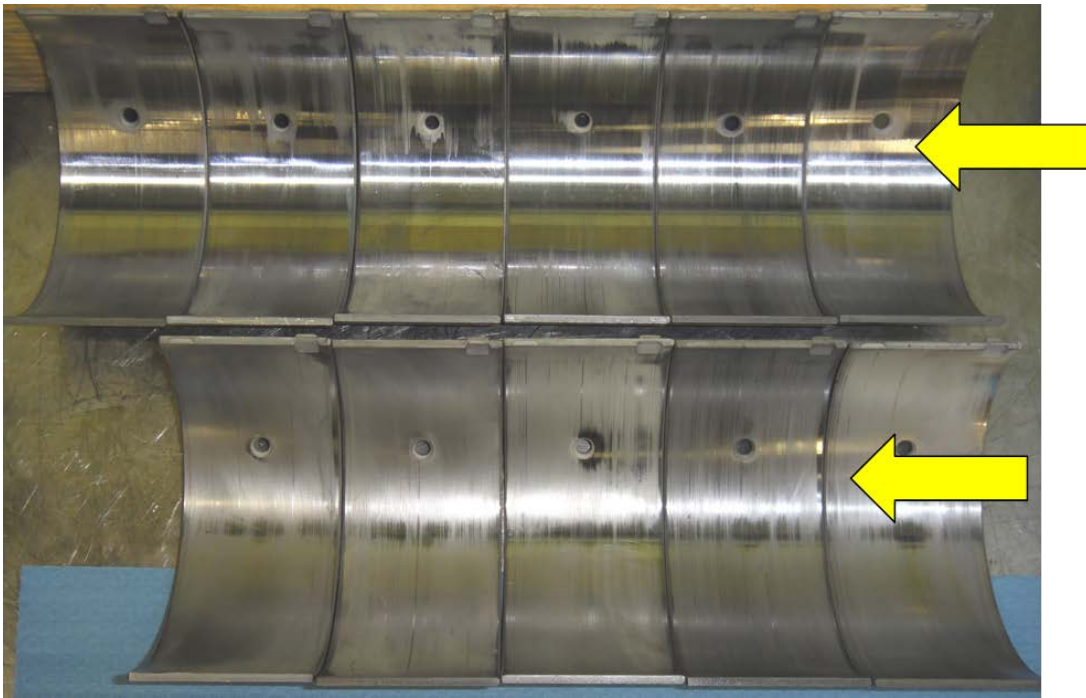
Notice the extremely polished condition of the bearings with the worst streaking toward the center of the bearing. This is an indicator of oil starvation, possibly from a dry start up or low oil.

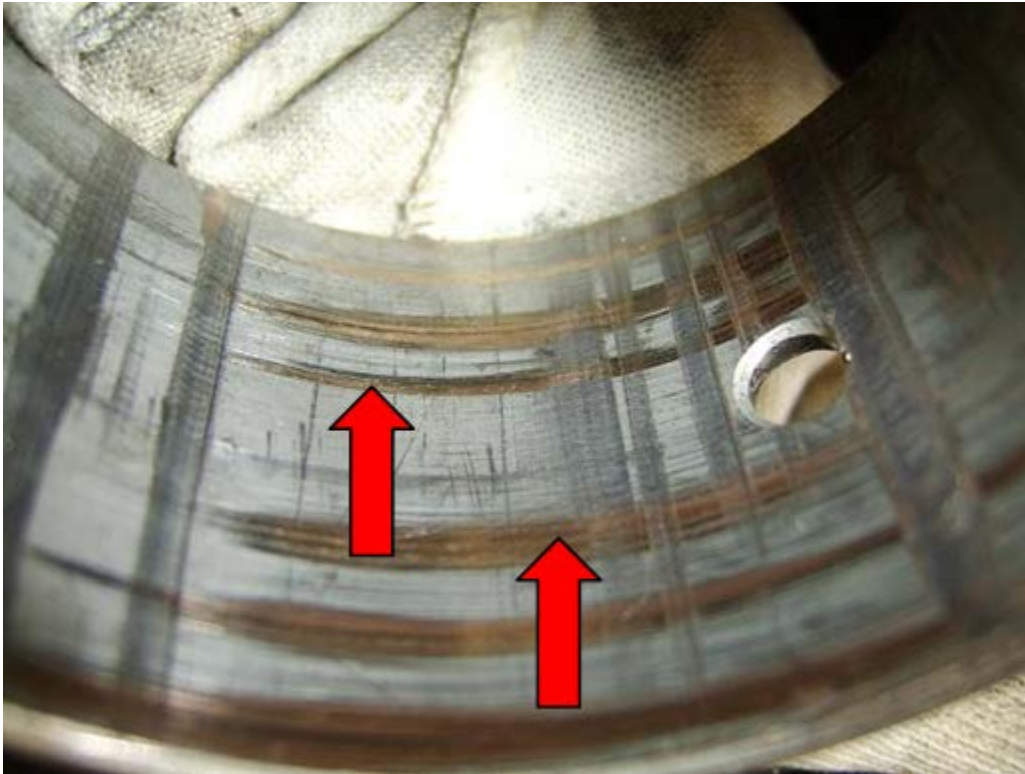
The picture shows a wear pattern caused by an uneven and rough cam bearing bore in block.

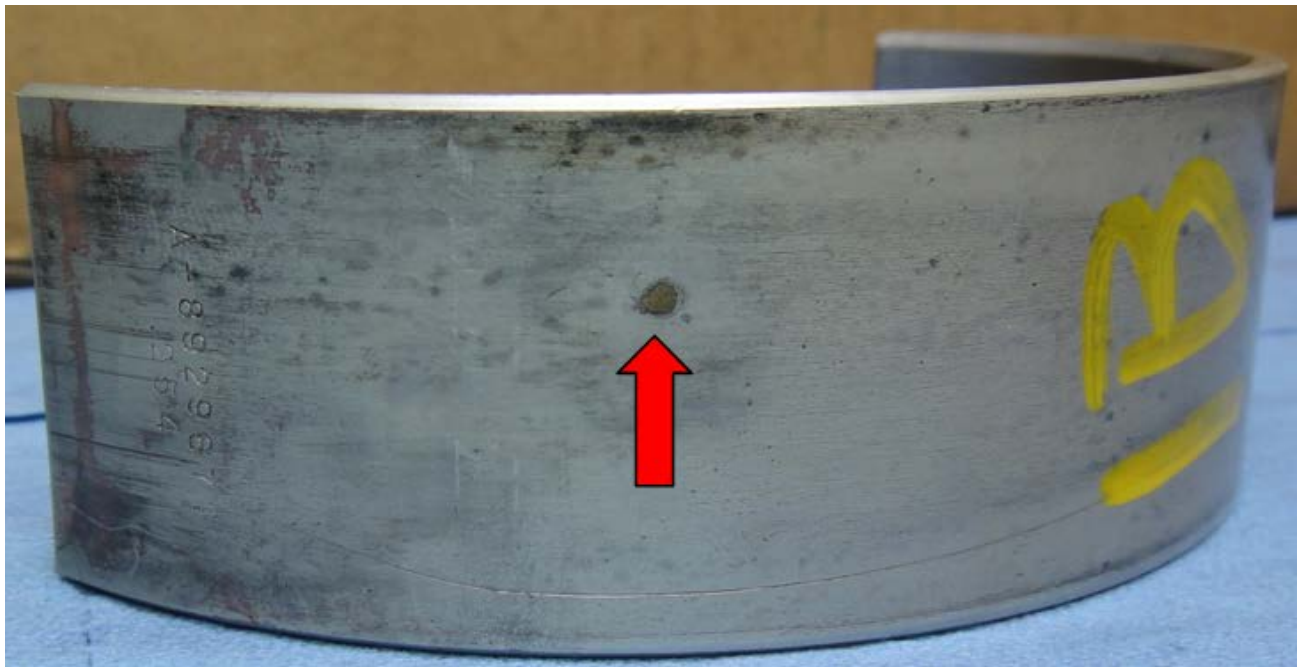
Foreign material trapped between main bearing and block.

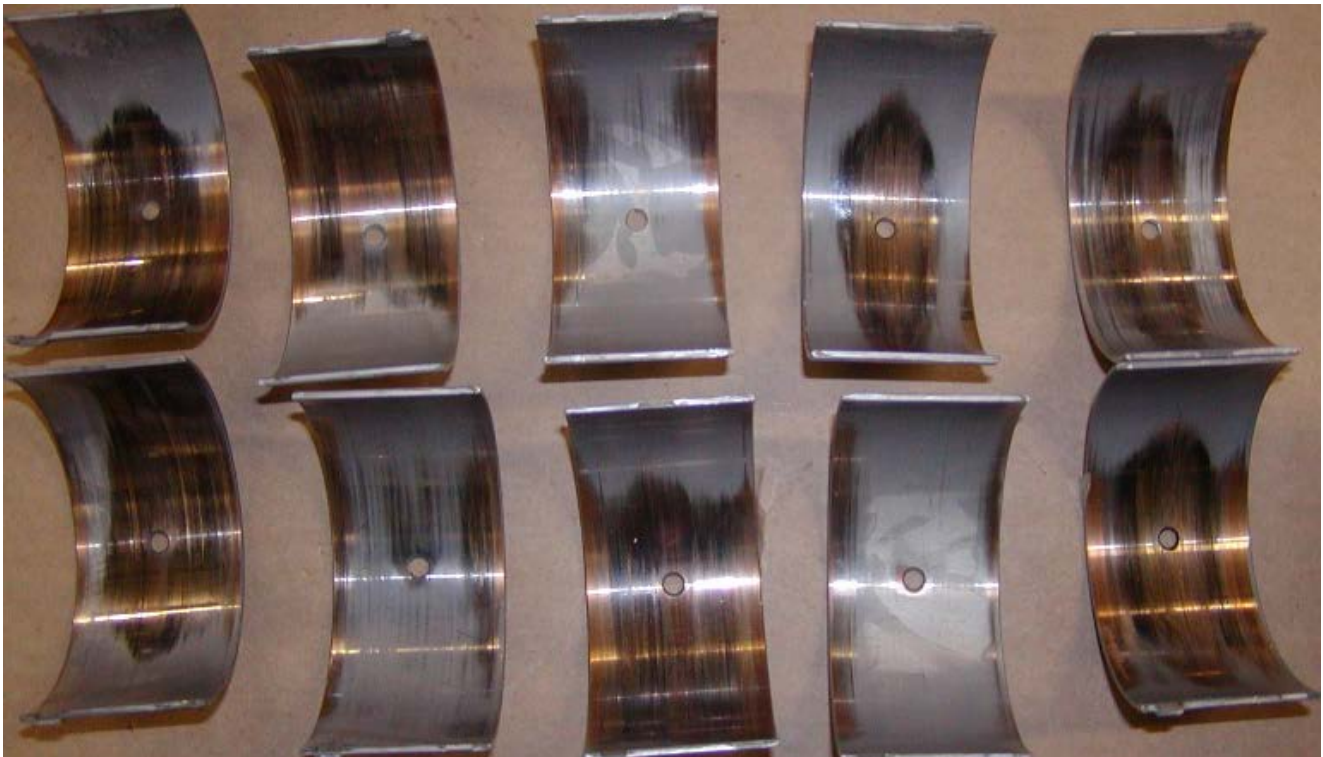
Example of uneven wear caused by severely worn crankshaft rod journals

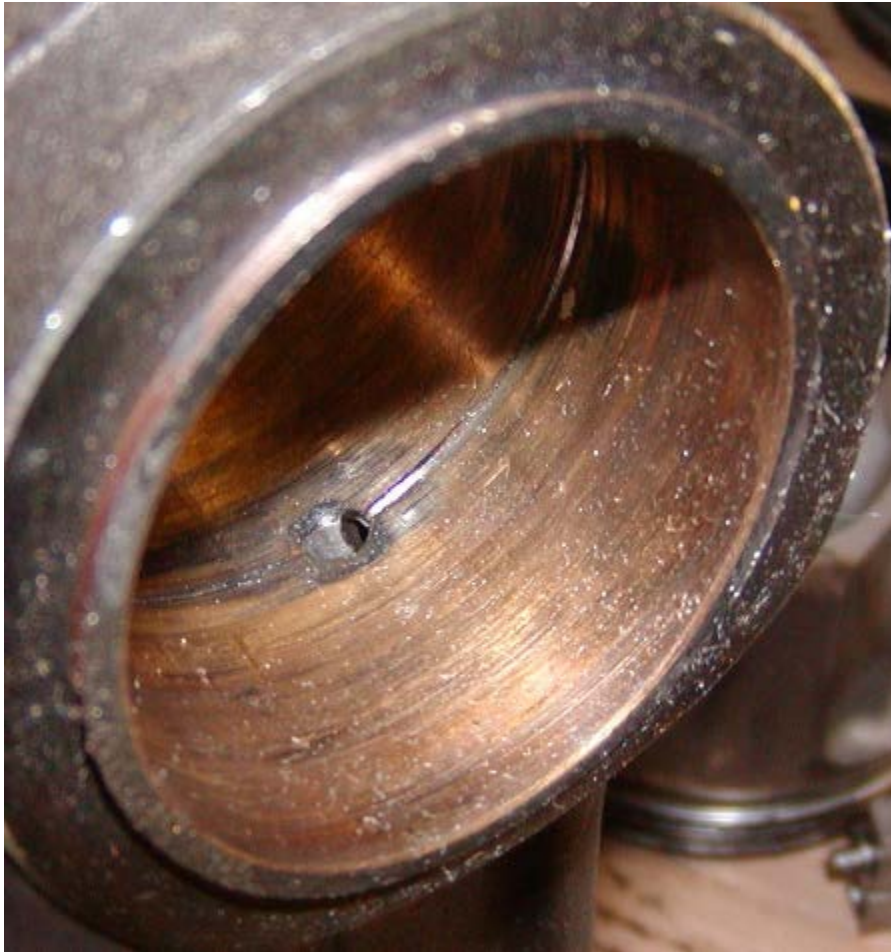
Example of a bearing failure caused by assembly error; the oil feed hole in the connecting rod was not lined up with the bear lubrication hole.

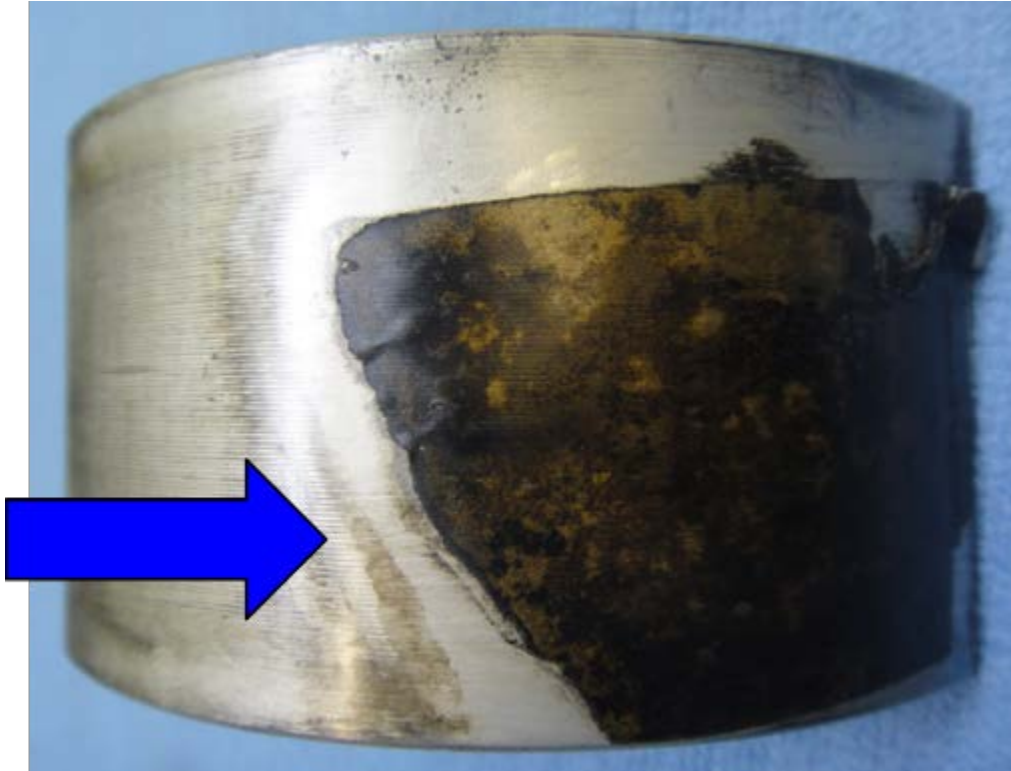
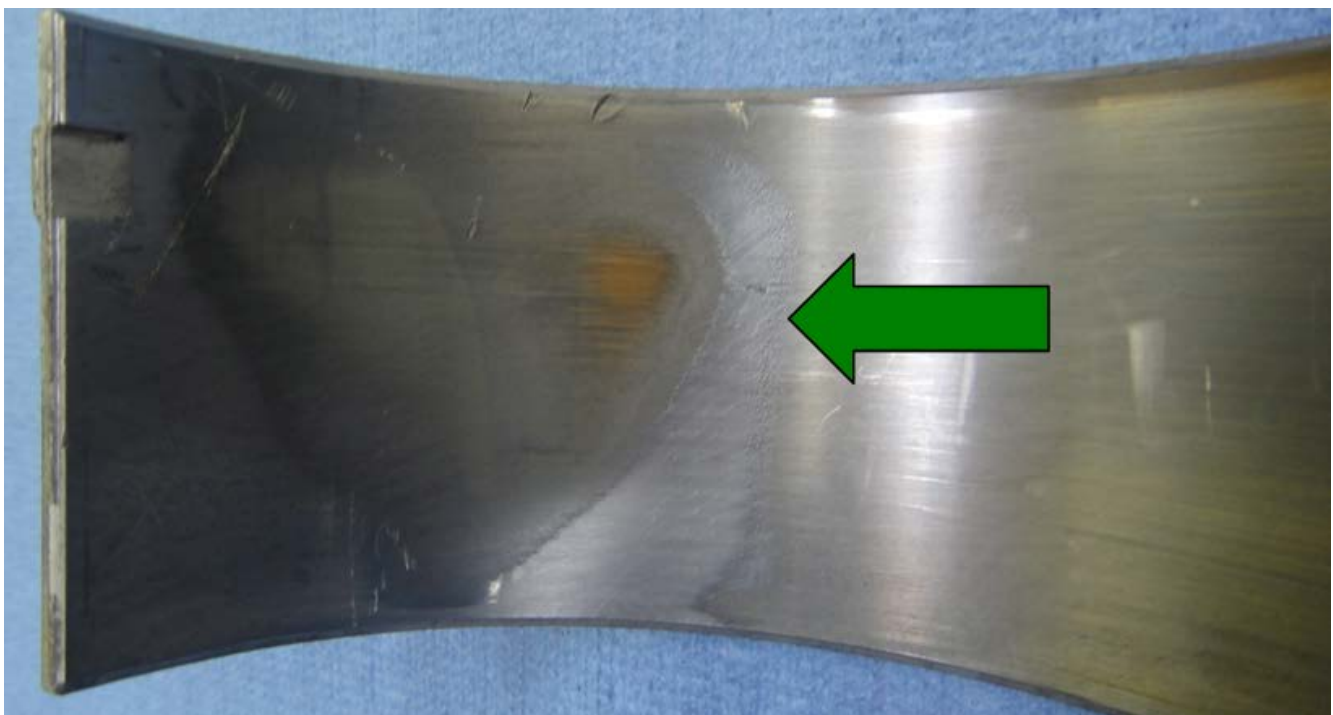
The next two pictures show a rod bearing with a piece of tape or paper on the back of the bearing where it seats in the connecting rod (blue arrow); the pattern of the tape is clearly visible on the front side of the bearing where it came in contact with the crankshaft connecting rod journal (green arrow).

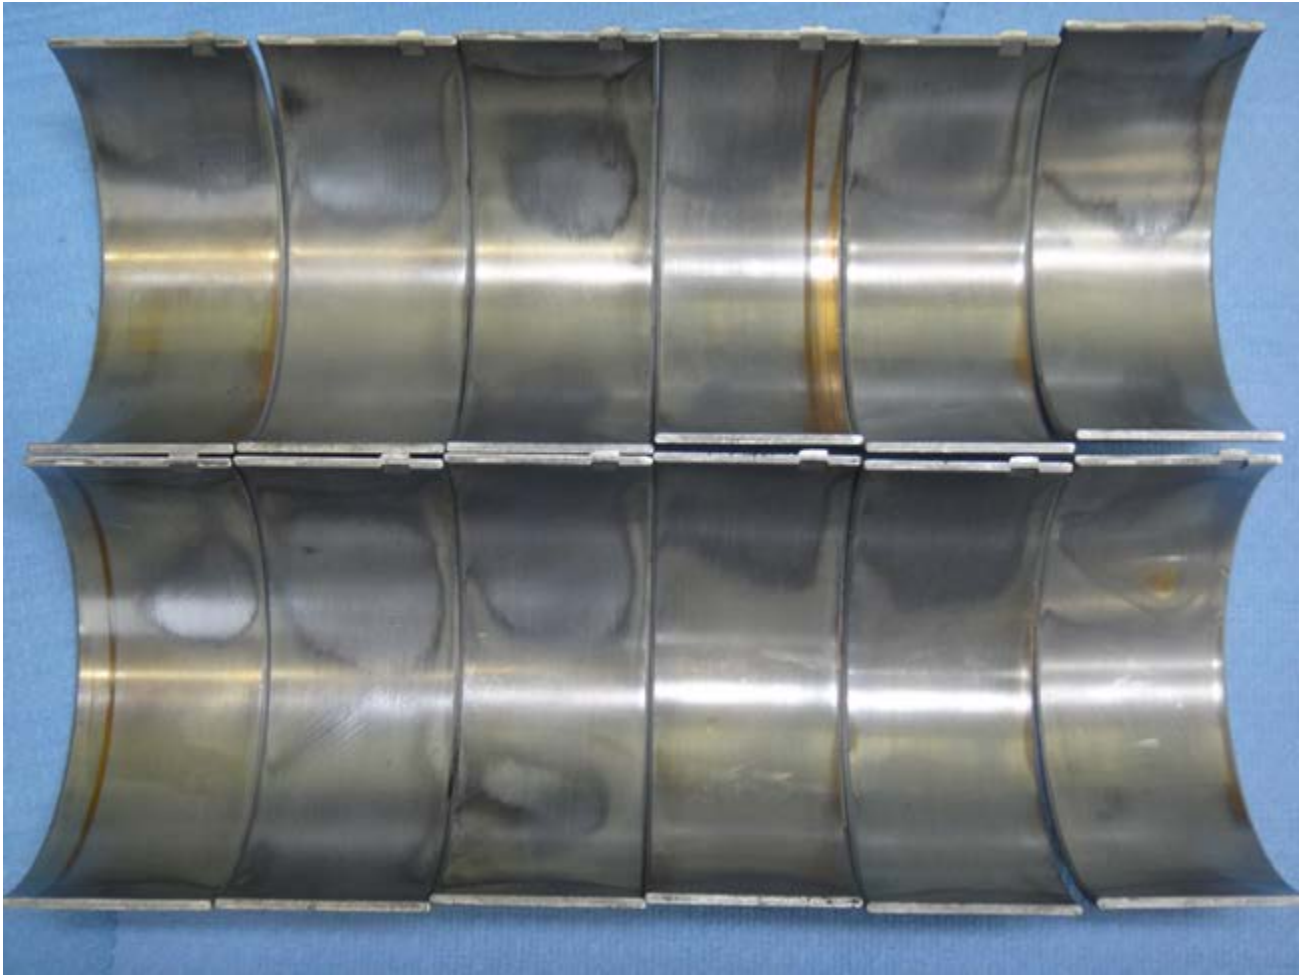
The final picture shows the uneven wear patterns on the rod bearings. Gouges in the bearings are caused from abrasive contamination not properly removed from the engine during overhaul.

Conclusion: The bearings have uneven wear spots most likely caused by either a worn crankshaft or out of round connecting rod bearing bores. One bearing had a piece of tape on it that was between the bearing and the rod bearing surface. The pattern of the tape was clearly visible on the reverse side of the bearing.

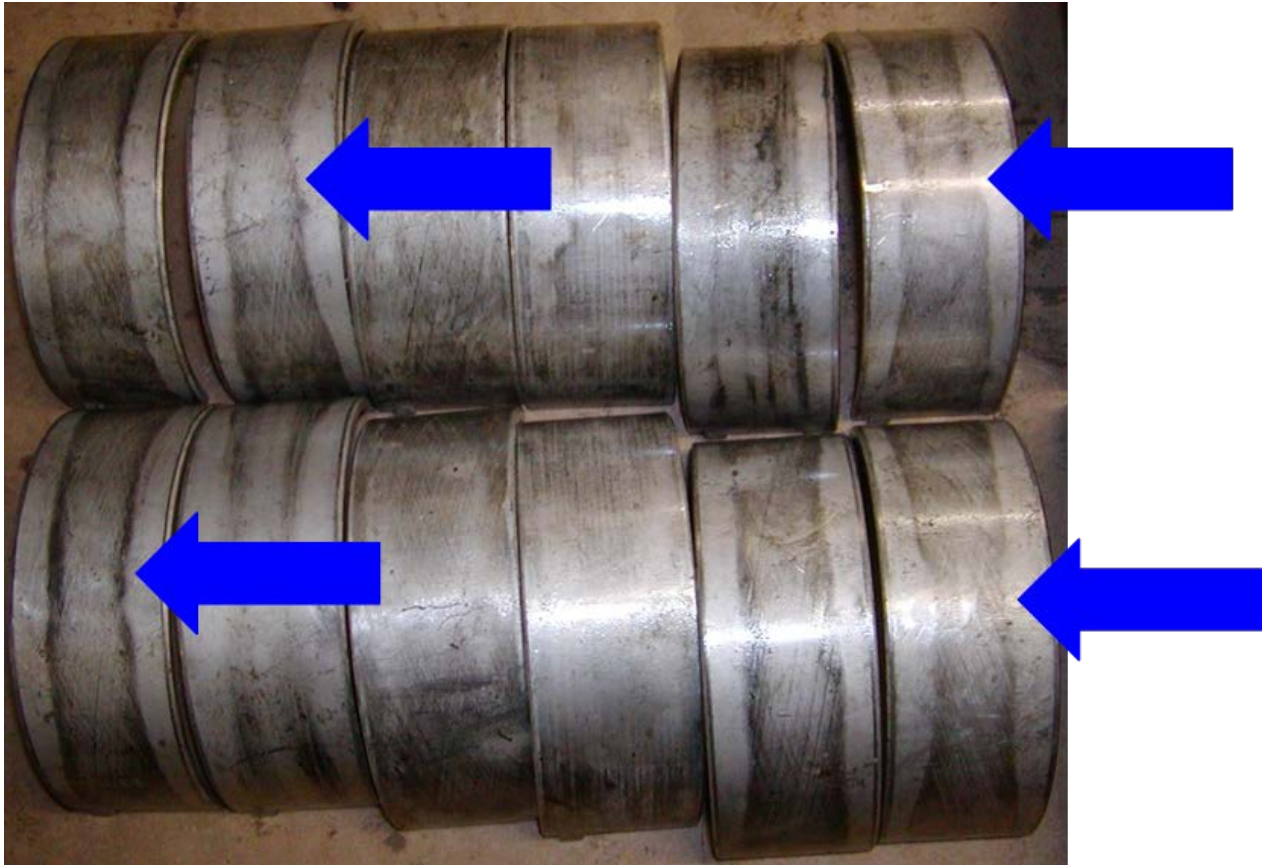
The pattern on the rod bearings indicate either a barrel shaped crankshaft or distorted and worn connecting rod bores.
