# INTERSTATE-McBEE

## FAILURE ANALYSIS GUIDE

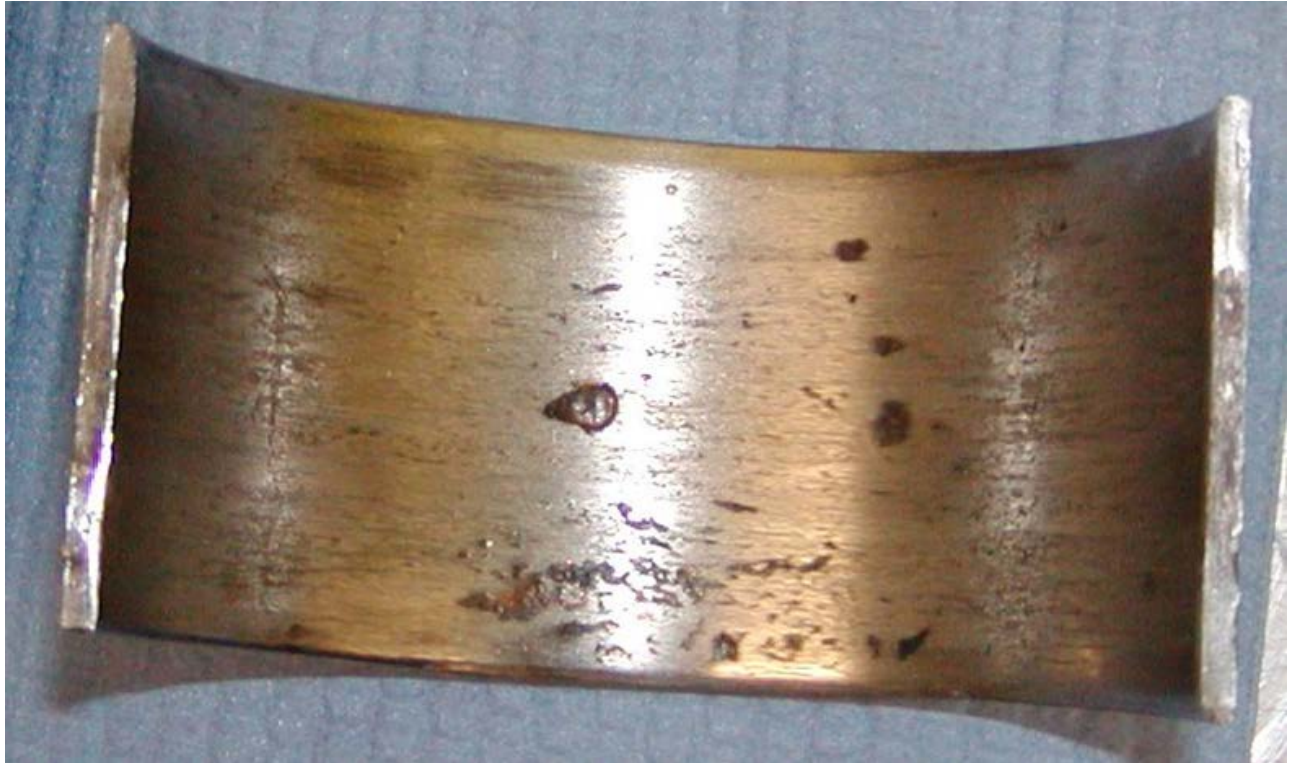
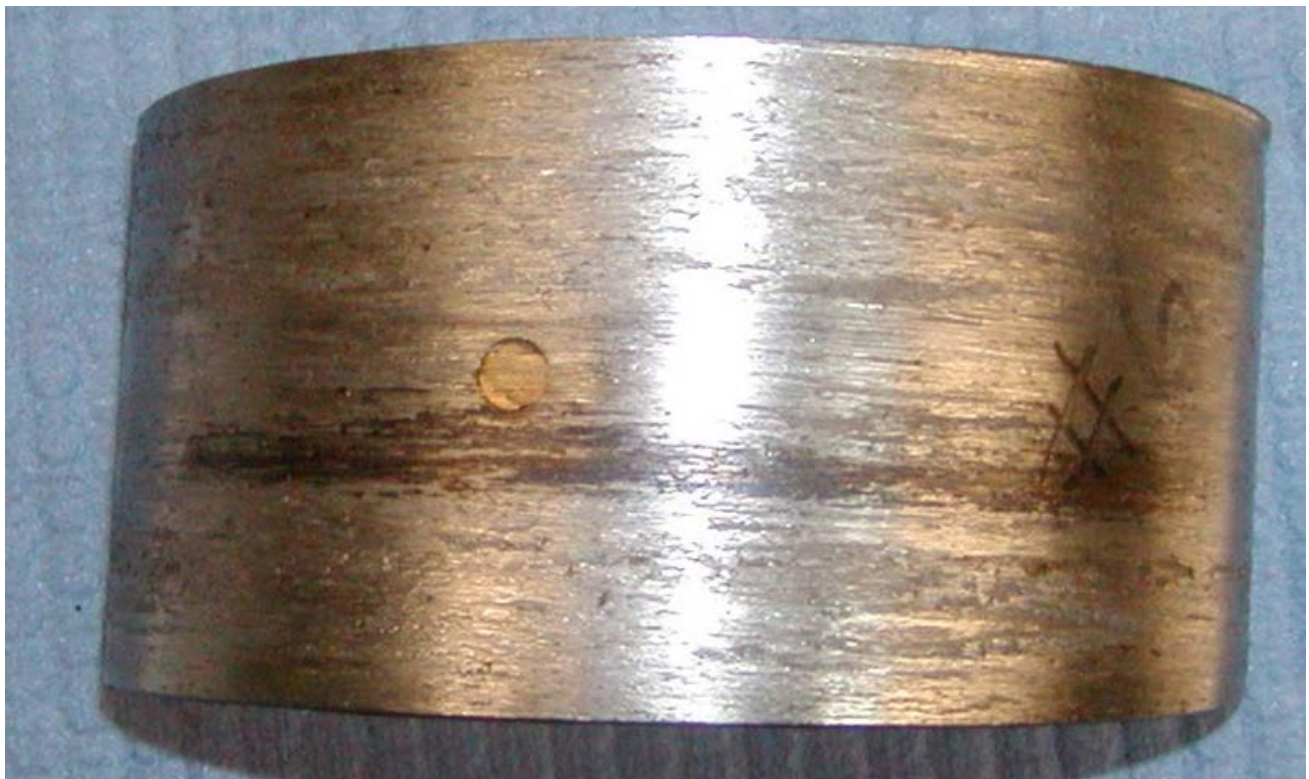
The first two pictures show the spun connecting rod bearings.

Conclusion: The above pictures show two areas of failure, the connecting rod bearing and the cylinder kit. Also shown is a damaged piston cooler. The piston cooler if bent can cause a piston to seize and cause the piston pin bearing to fail. The connecting rod was not up dated at time of overhaul to the recommended drilled rod. The rod bearing failure caused by lack of proper lubrication.

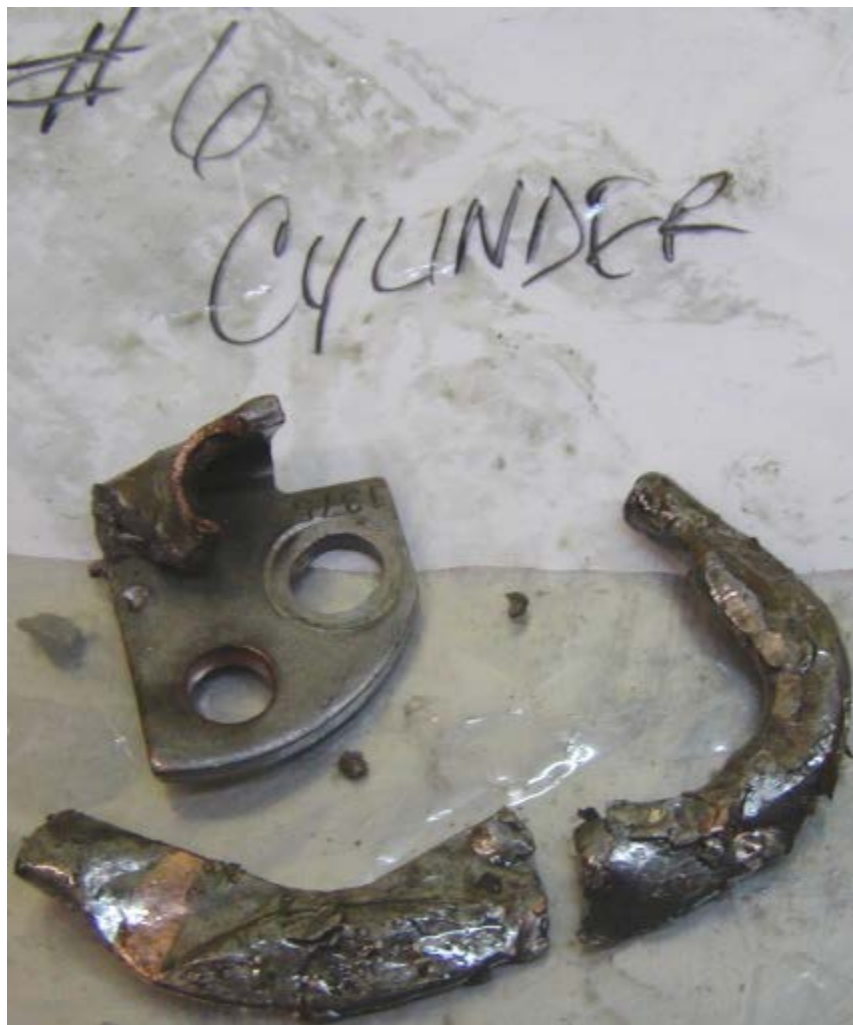
The final picture shows the remains of the piston cooler.

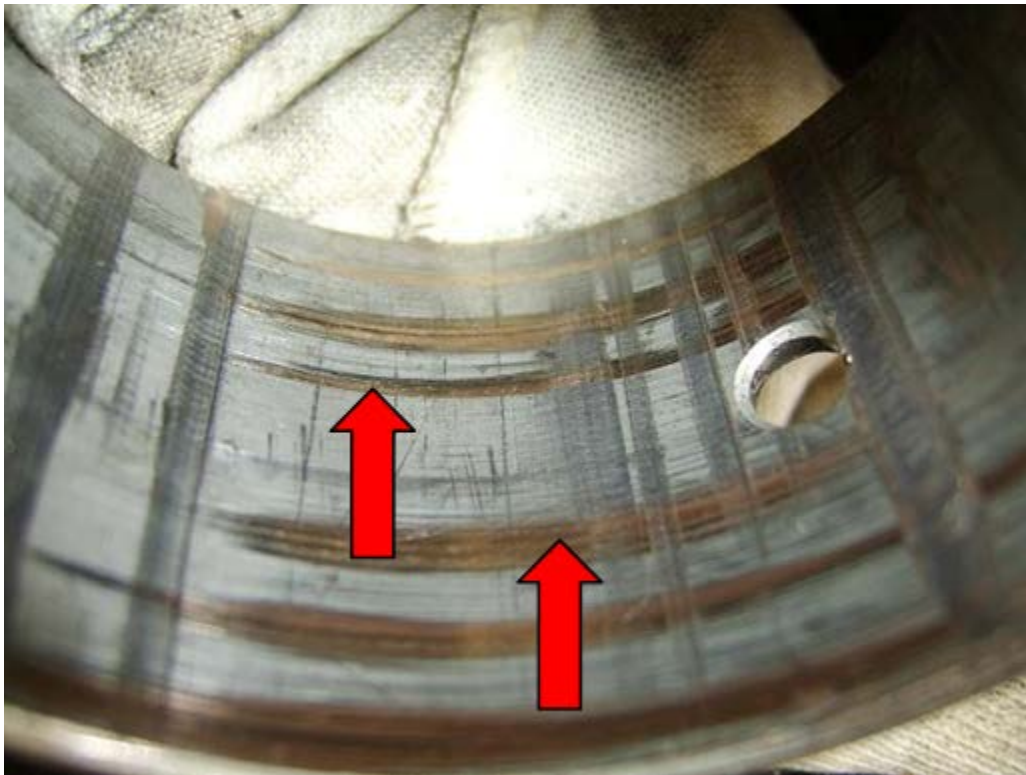
The picture shows a wear pattern caused by an uneven and rough cam bearing bore in block.  
Cause of failure uneven support.

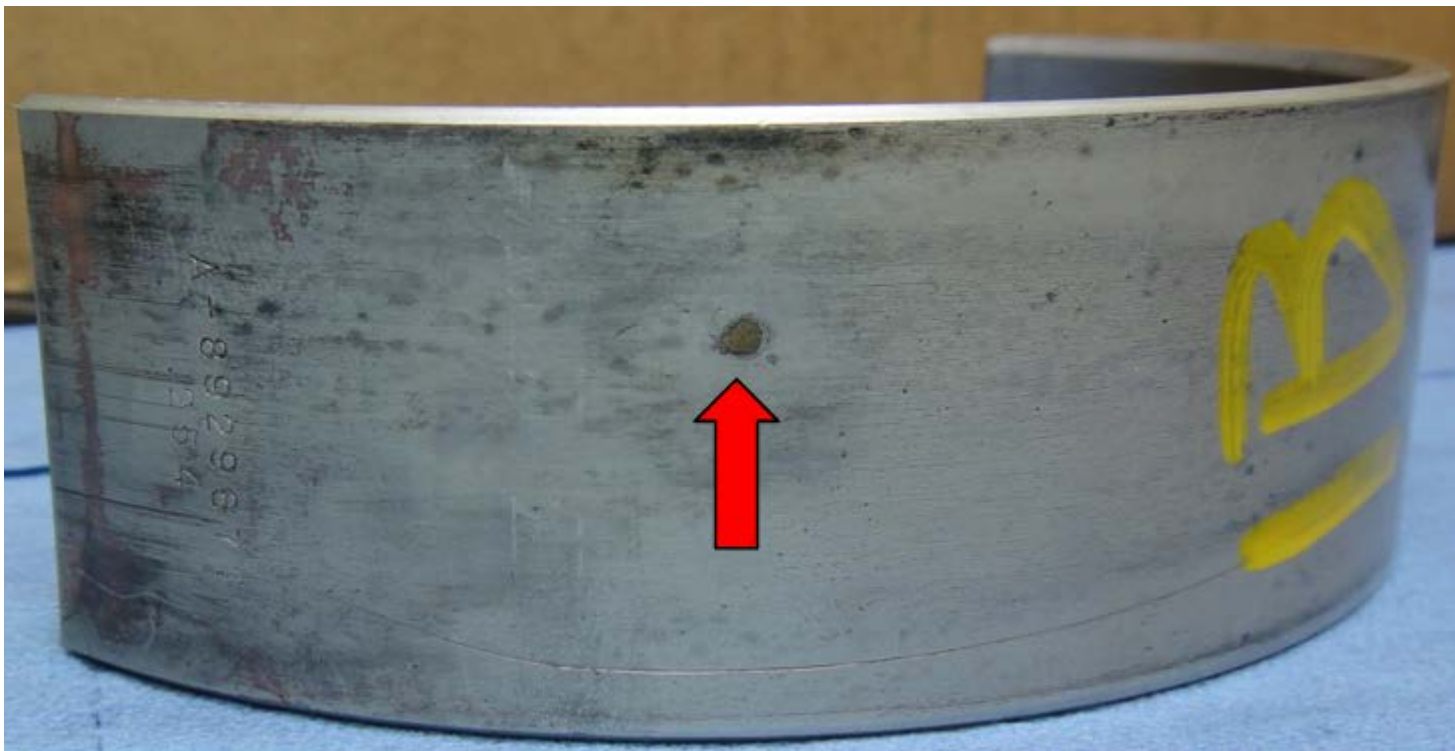
Foreign material trapped between main bearing and block

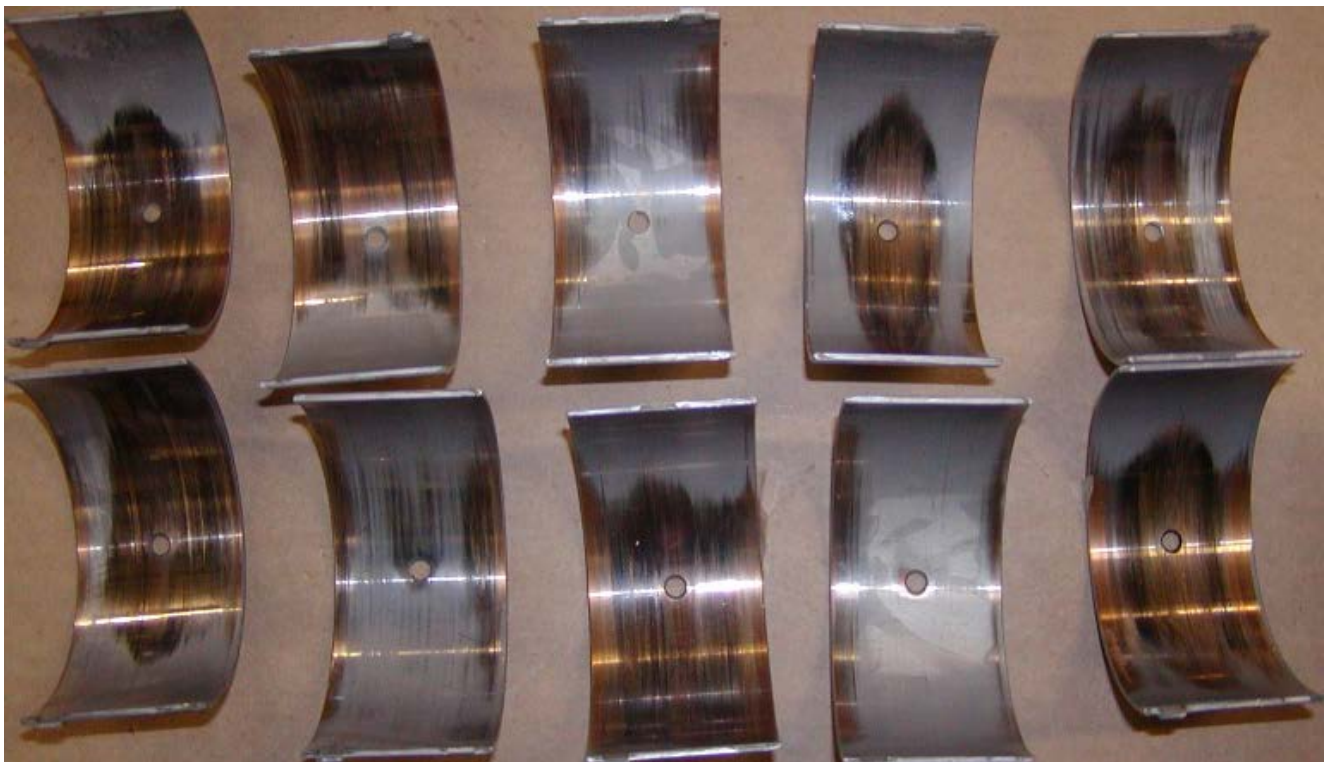
Example of uneven wear caused by severely worn crankshaft rod journals

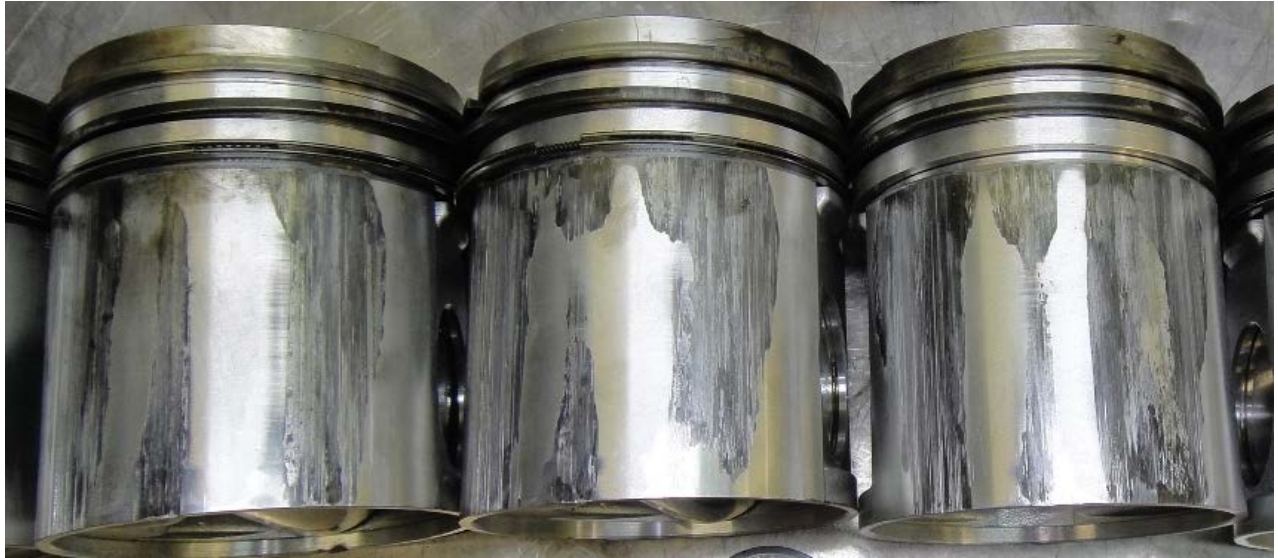
### A. Piston damaged by adding cold coolant to a hot engine

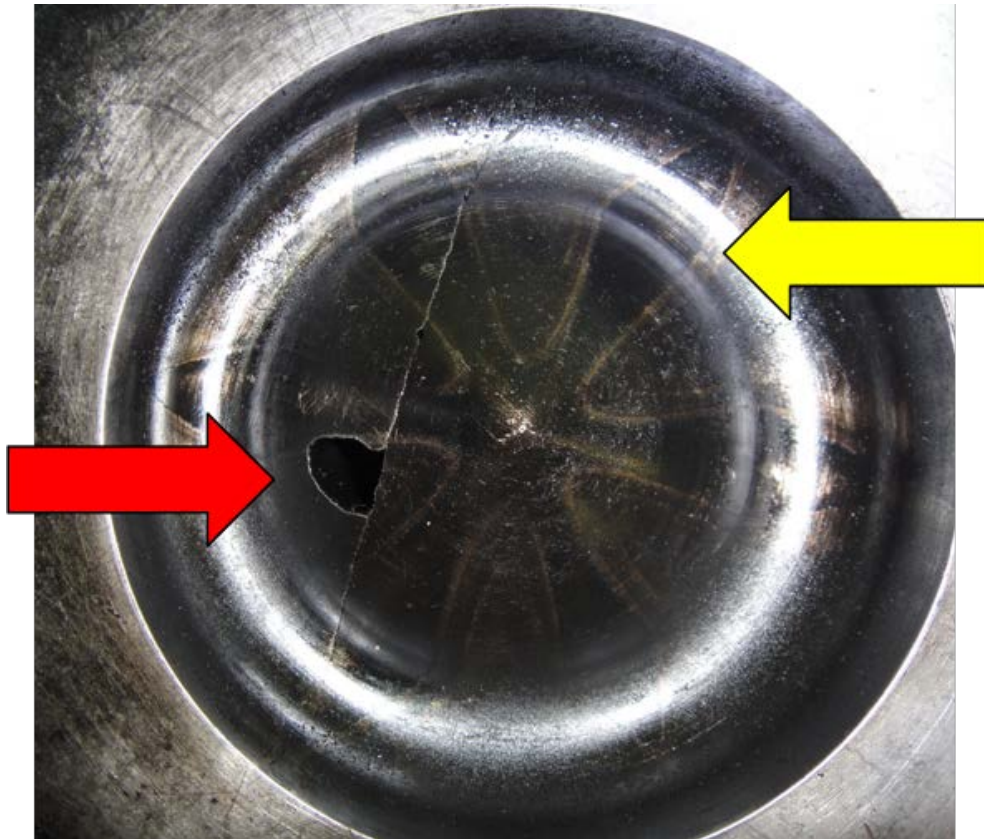
The final picture shows the piston crown. The red arrow points out the crack and hole in the crown and the yellow arrow points out the fuel pattern.

The piston and liner are severely scored from overhear. Top of piston is cracked and has a hole in it caused by detonation. The fuel spray pattern on the piston crown is too close to the center of the bowl indicating a timing issue or a damaged fuel injector. The most likely cause of failure would be incorrect timing.

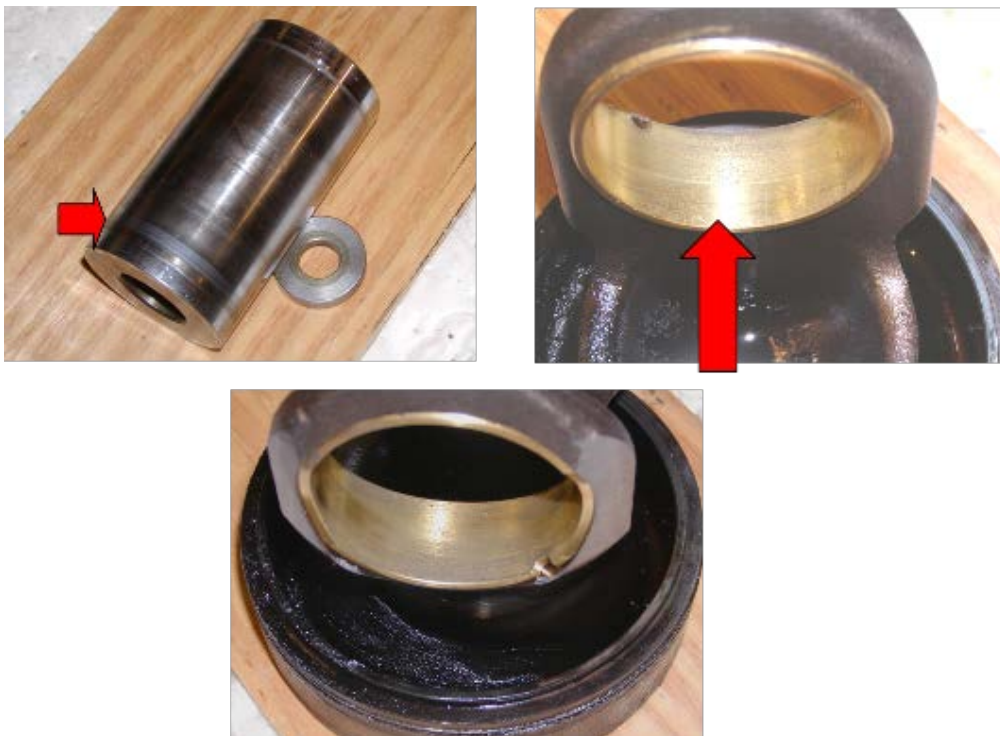
The following pictures show the start of discoloration of piston pin and fretting in piston pin bearings from lack of sufficient lubrication.

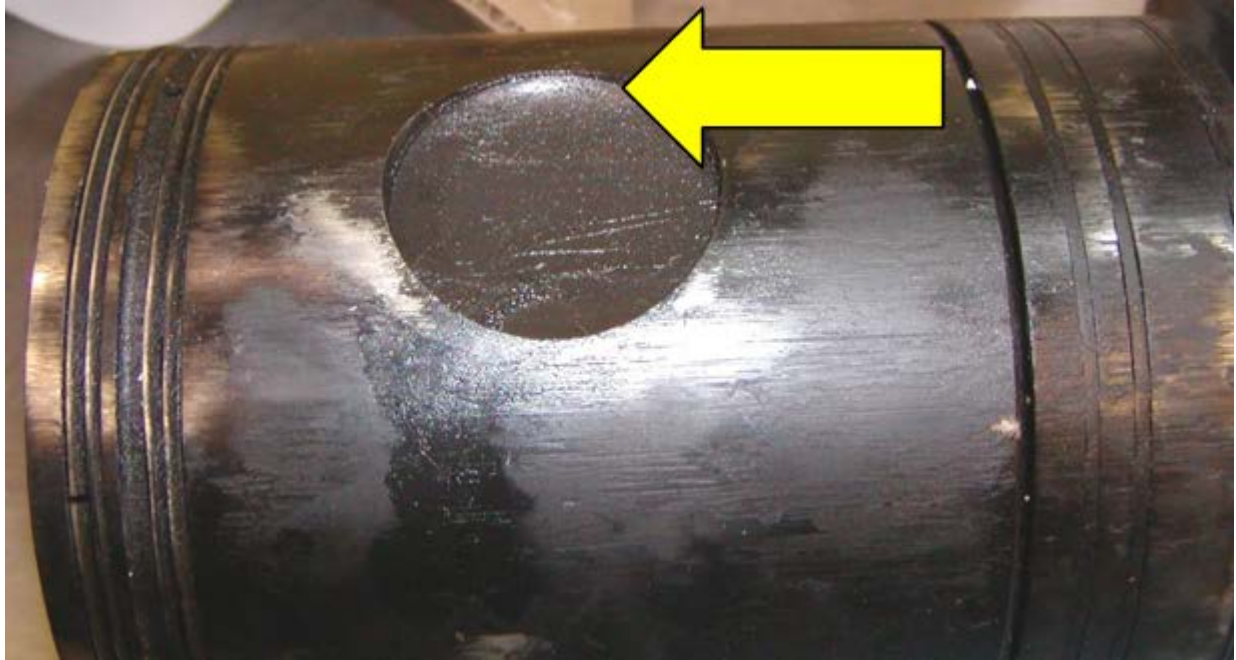
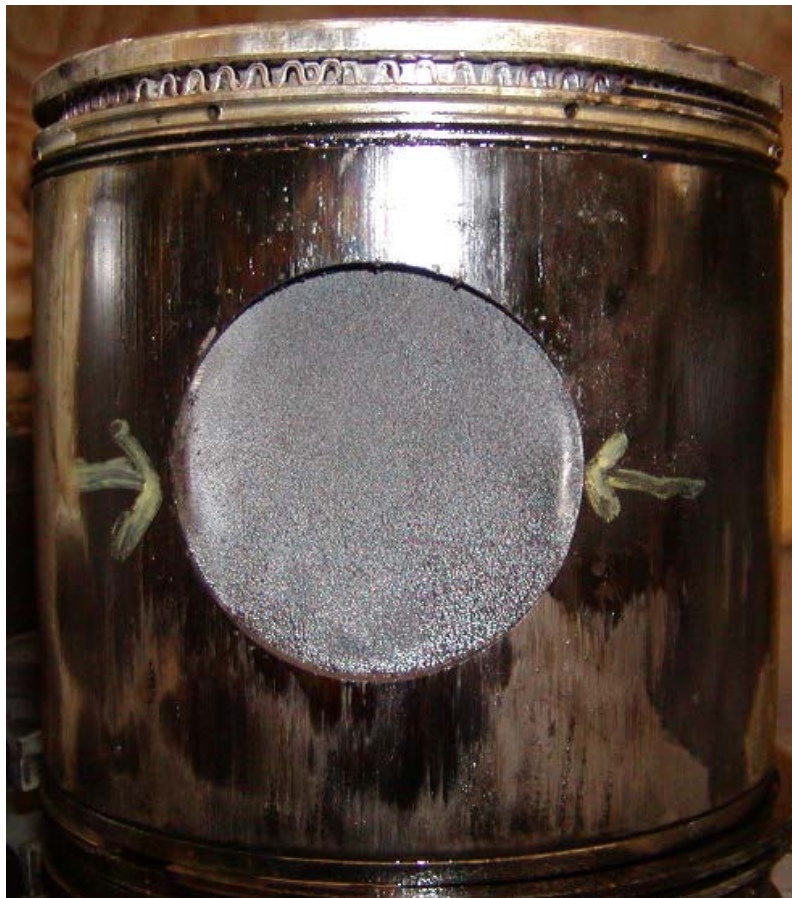
The pictures show the piston pin retainer bent on the edge and not fully seated in the recess. Cause of failure, leaking wrist pin retainers. Oil leaking from retainers overcame the piston rings and became an external fuel source. At the same time the oil loss reduced the flow of lubrication used in cooling the underside of the piston. The combination of both these conditions caused the extreme overheat and excessive thermal expansion of the piston, causing the piston and liner to make contact and seize.

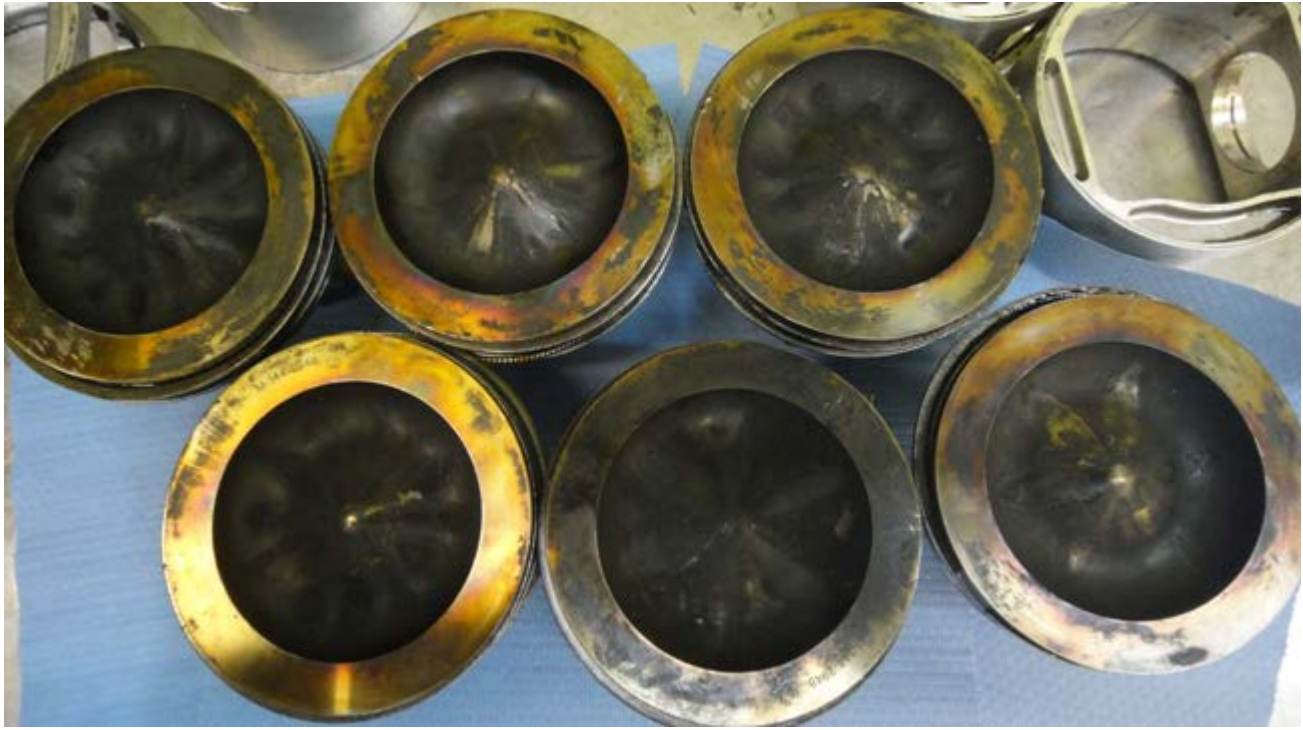
The first picture shows the top of the piston crowns discolored from excessive heat.

The tops of the piston crowns are discolored (blue) and the underside of the crowns are burnt. This is caused from severe overheating and lack of proper lubrication. The most likely cause of the failure is operating the engine with low oil pressure.

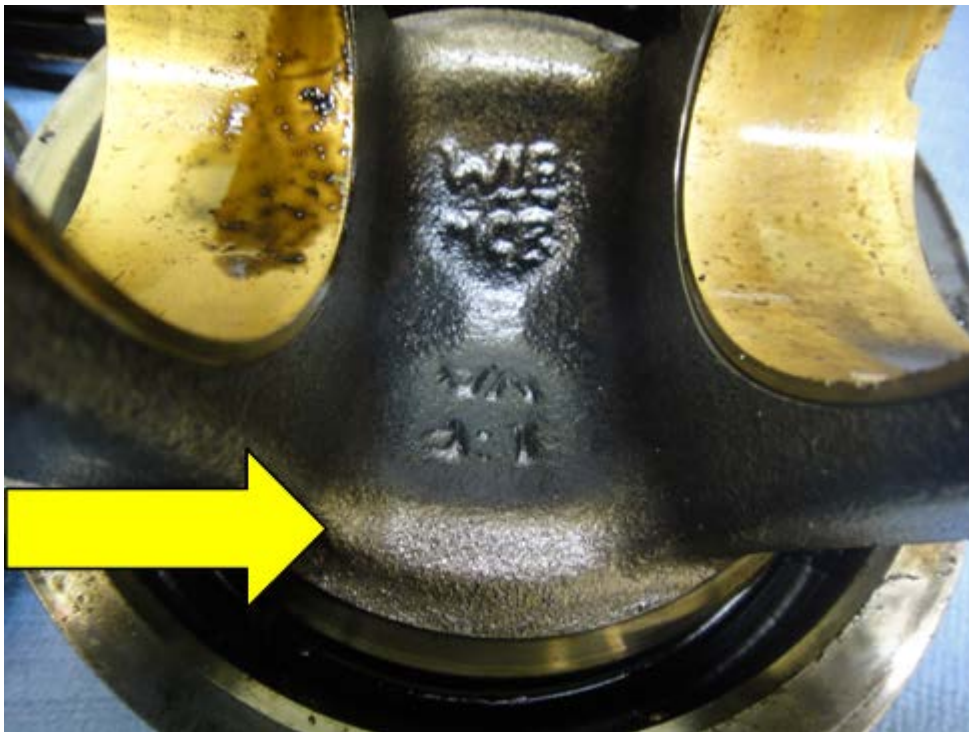
The next picture shows the underside of one of the piston crowns burnt from over heat.

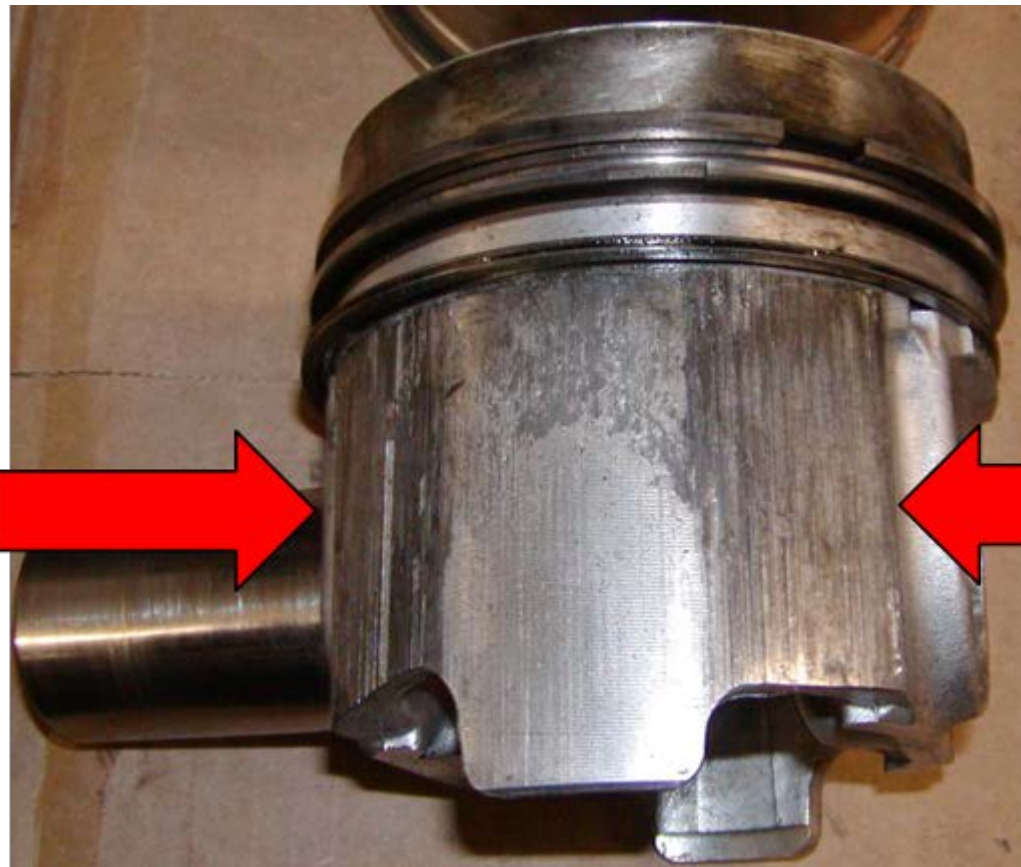
The following pictures show quarter point scuffing. Pattern of fuel injector on top of piston appeared normal. The underside of the piston was clean with no burnt oil indicating that lack of lubrication was not the root cause. The most likely cause of failure points to the cooling system and the possibility of air entrainment.

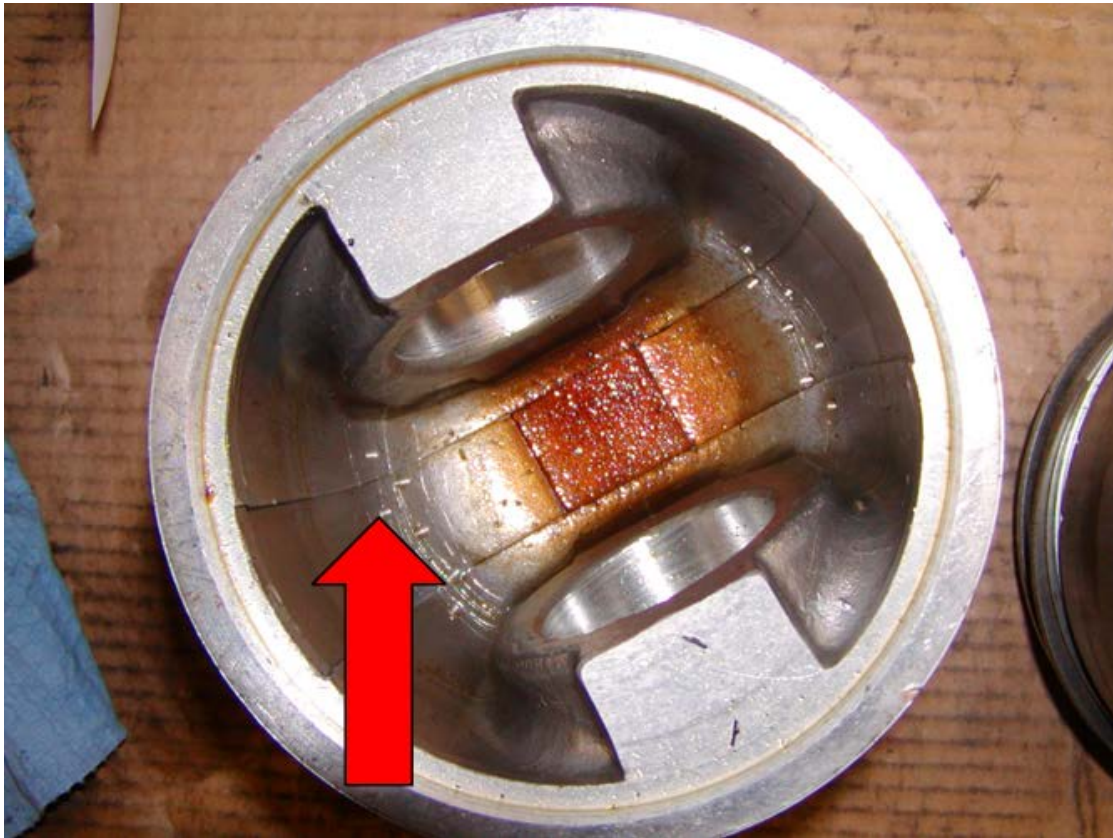
Natural gas application - The picture shows discoloration of piston crown caused by excessive combustion chamber temperatures. In a natural gas application, this type of failure is normally the result of improper engine timing or incorrect fuel mixture.

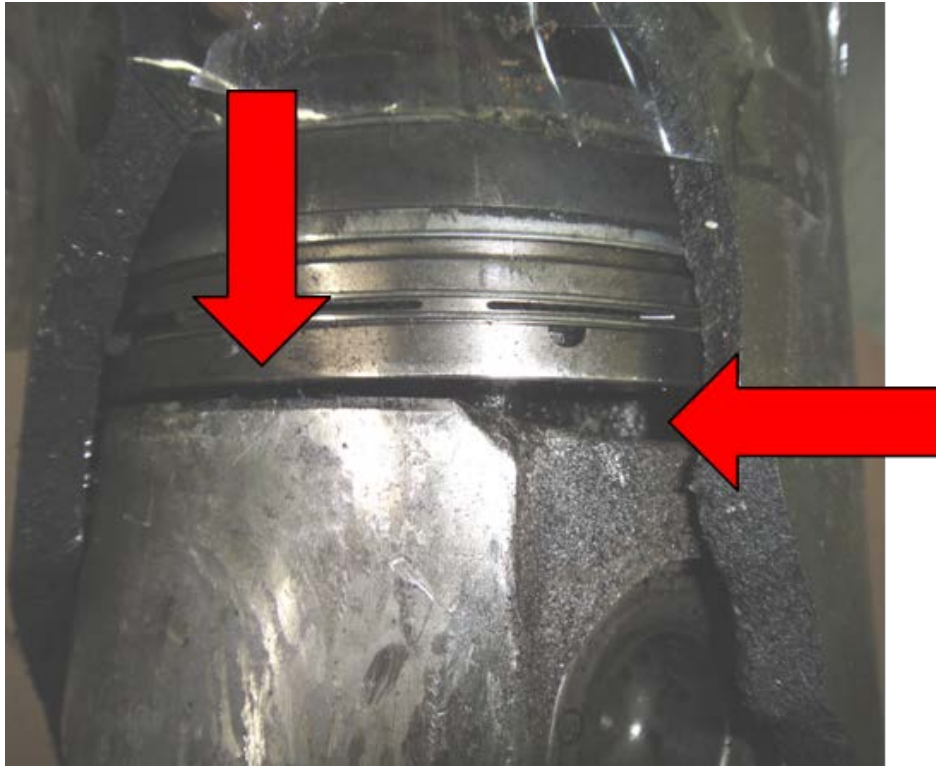
The following picture shows the piston skirt in the liner with the skirt on upside down. Red arrows point to bottom of skirt.

Conclusion: The cause of failure is assembly error. Piston skirts were installed upside down on the pistons. When installed in this manner the skirt can make contact with the crankshaft throws. This will place excessive loads on the connecting rod retaining bolts causing them to fracture.

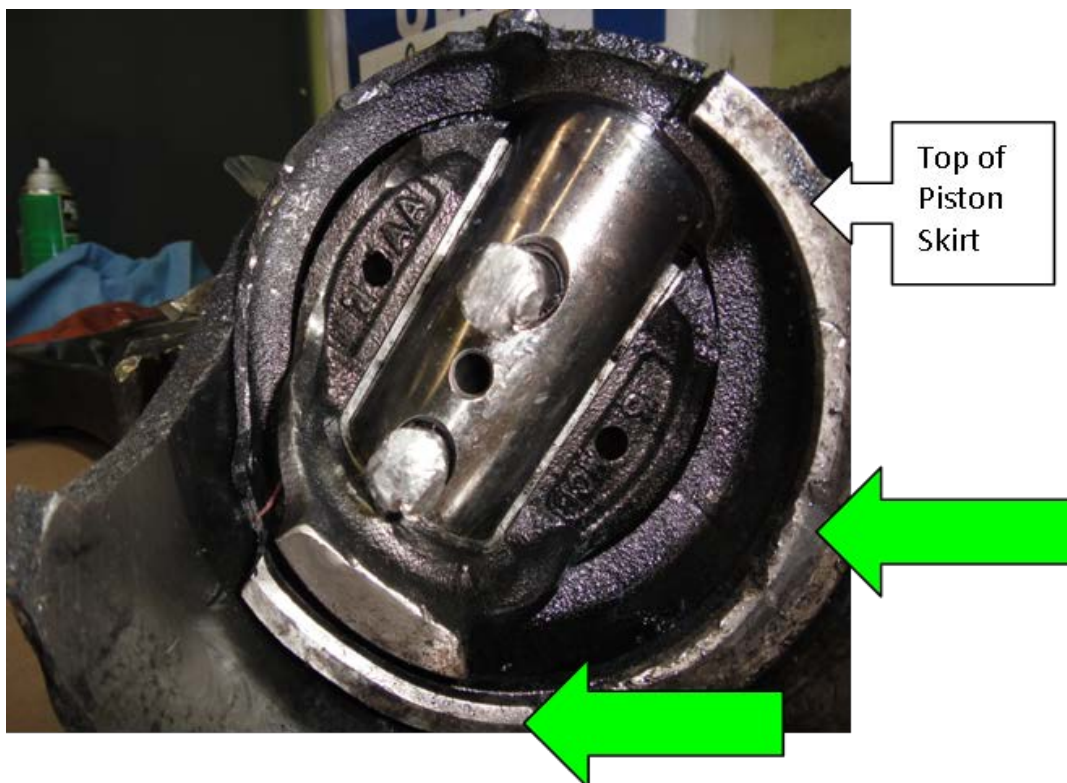
The next picture shows the bolts broken in the piston pin and the top of the piston skirt pointing down.

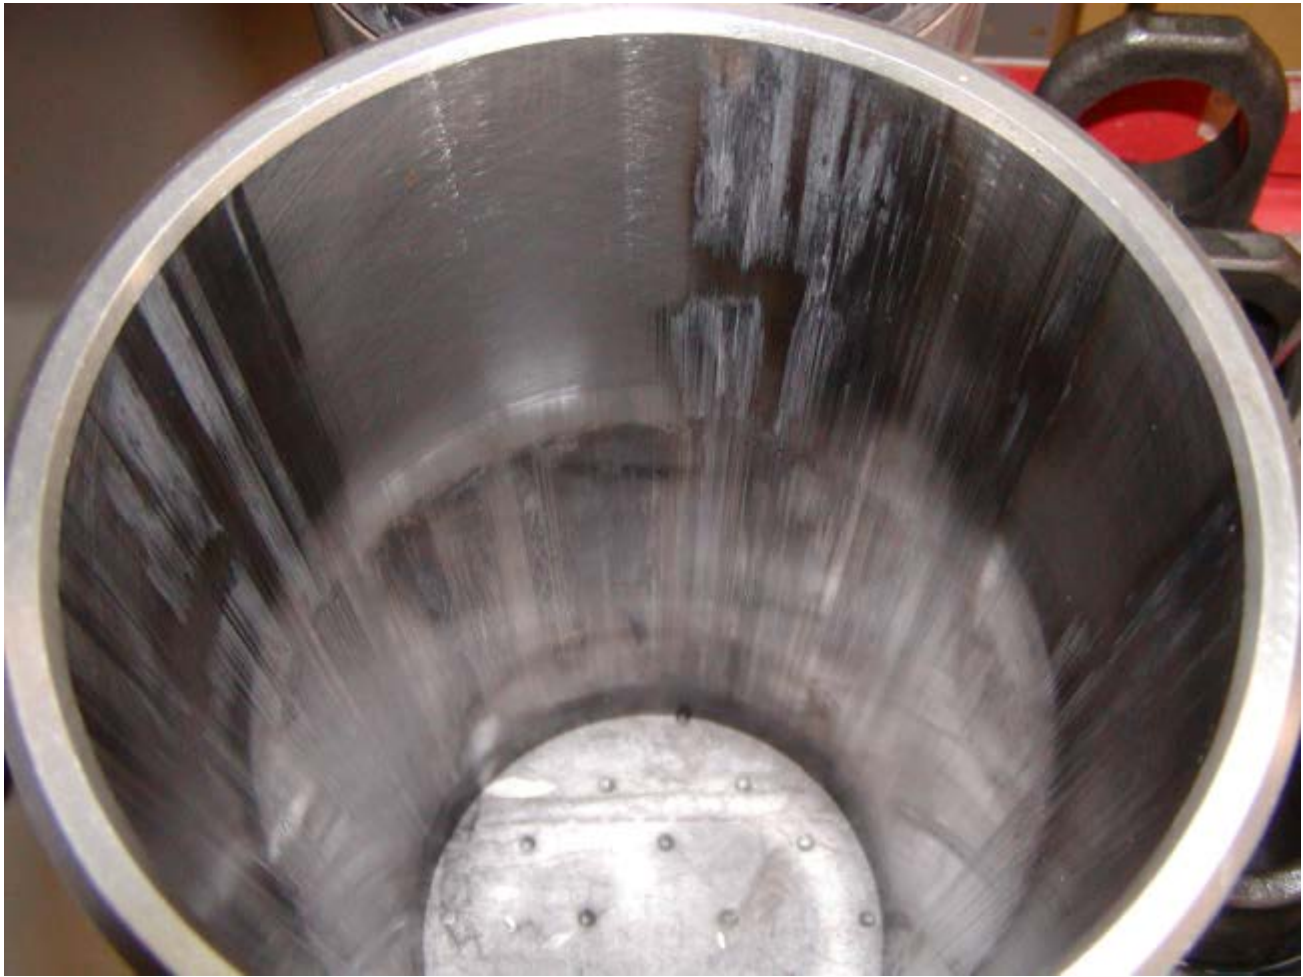
The final picture is the inside of the liner showing 360 degree scuffing on the upper half of the liner and the quarter point on the lower half. Liner is upside down in this picture.

Conclusion: Both failures are caused by overhear. The most likely cause of the scuffing is low coolant.

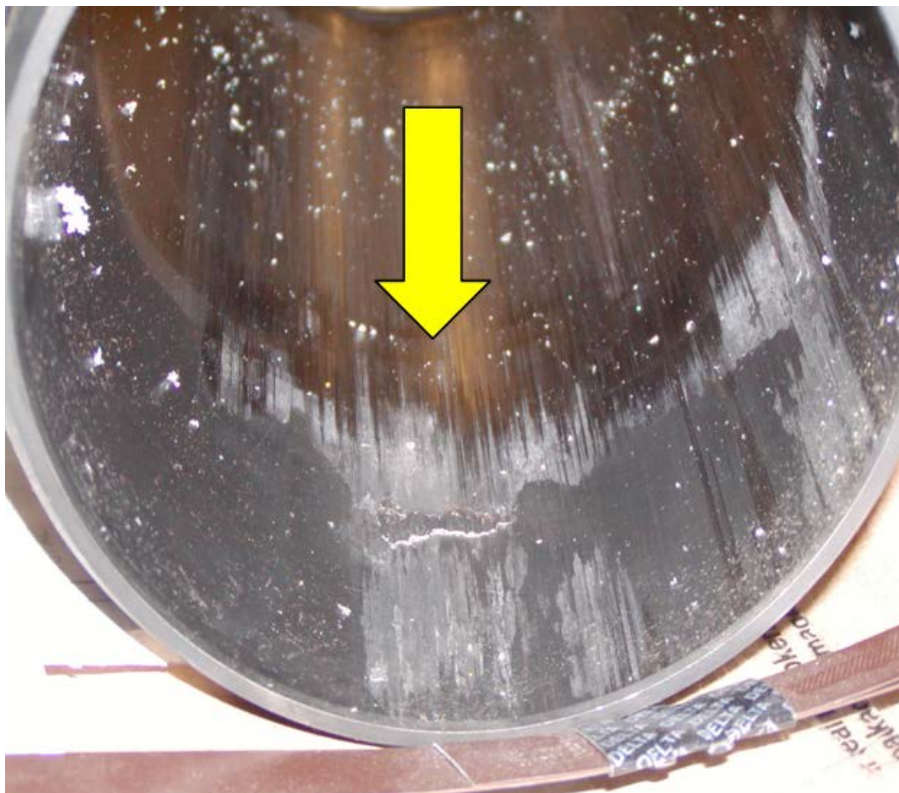
View of inside of above liner shows a buildup of transferred skirt material at bottom of liner caused by the o-ring forcing the liner inward.

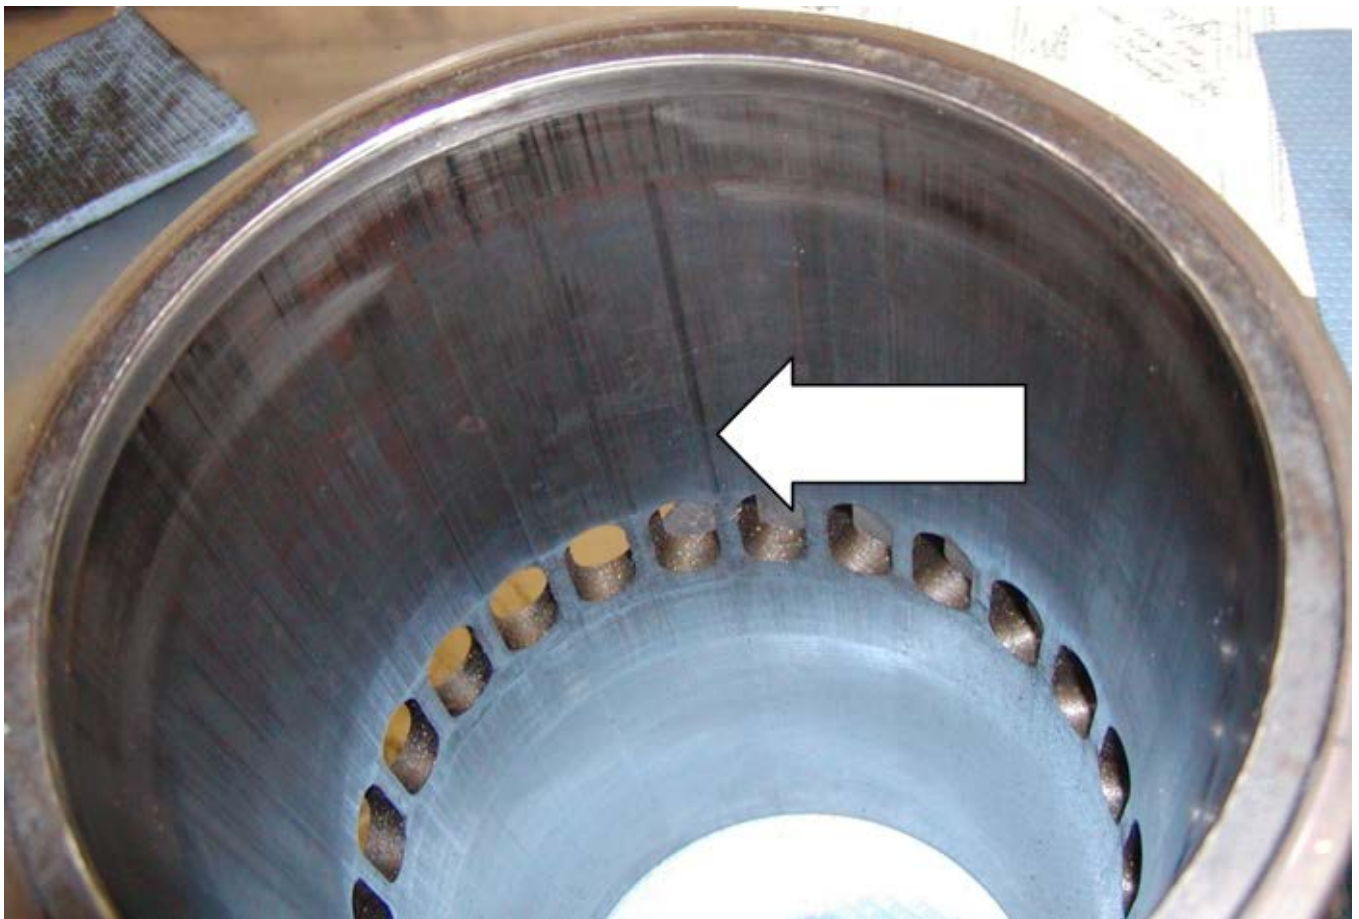
The next picture shows the score marks inside one of the liners (white arrow). Scratches and some scoring is present in most of the liners.

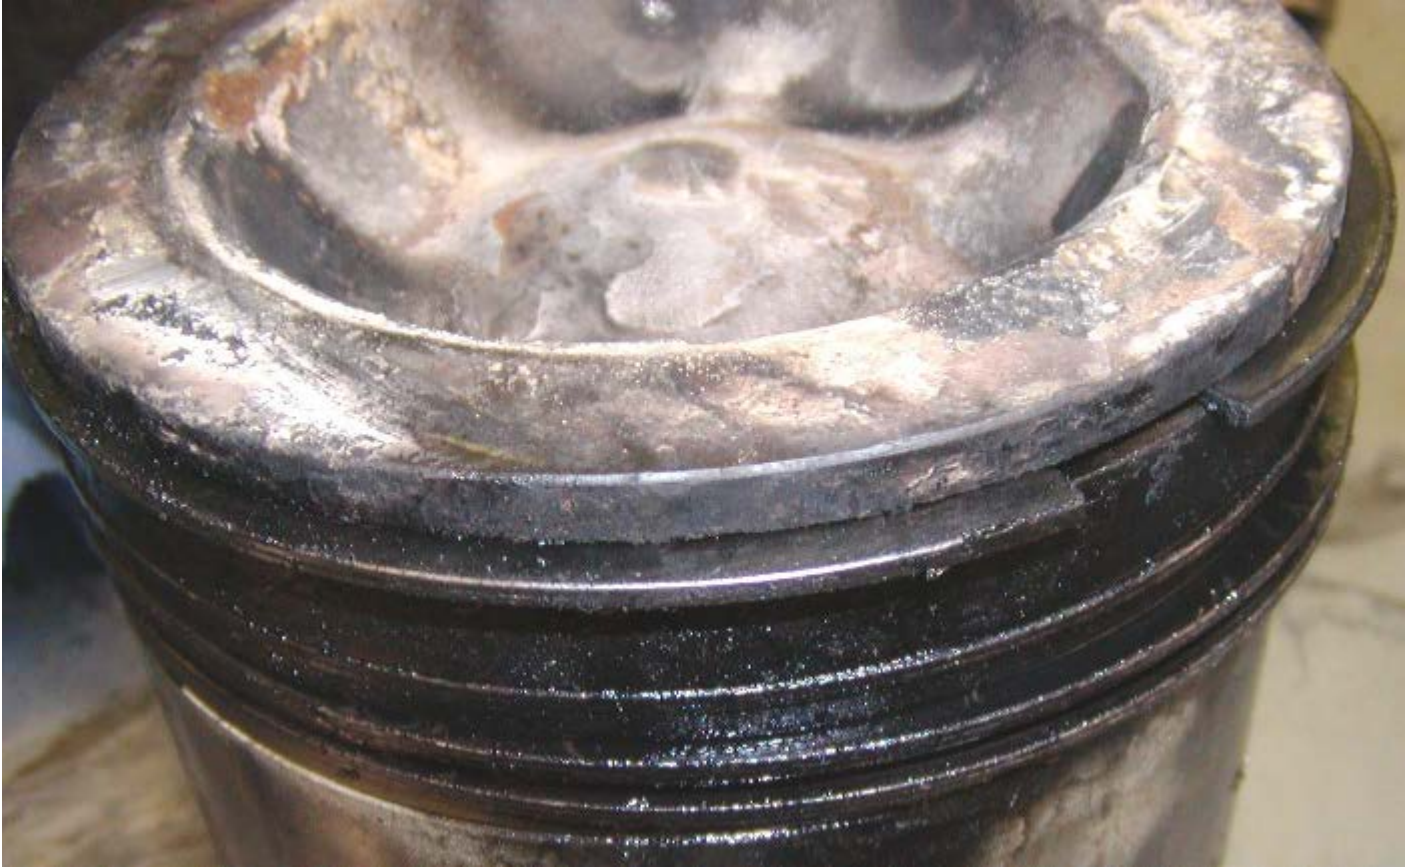
The final picture shows the crown and rings on one of the pistons; all the pistons are similar in appearance. The white deposits are caused by additives in the oil. A perfect seal between the piston rings can never be achieved, thus a certain amount of engine oil will enter the combustion burn. As the engine oil enters the combustion chamber and burns, residue forms an ash-like material. This ash-like material contributes to deposits in the crown land above the piston ring as well as to deposits in the ring grooves. These deposits can lead to rubbing wear on the cylinder liner causing the piston rings to cease operate freely. Ultimately, the cylinder liner-to-ring interface is compromised and high oil consumption can occur.

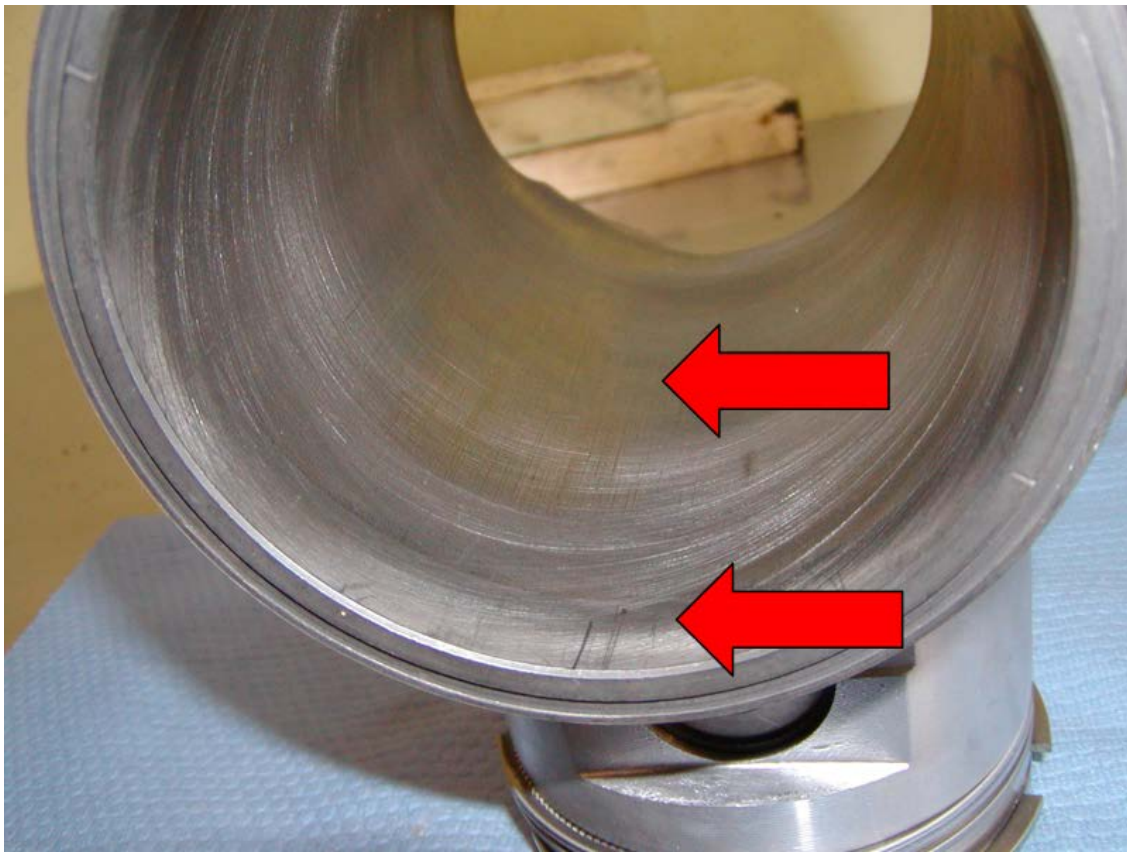
The above picture of the liner shows deep scratches from abrasive foreign material causing a path for blow-by. This is caused by lack of cleanliness during assembly of the engine. The liner also shows where it was honed. The honing angle or cross hatch is not uniform. This will cause uneven wear.
