# INTERSTATE-McBEE

## FAILURE ANALYSIS GUIDE

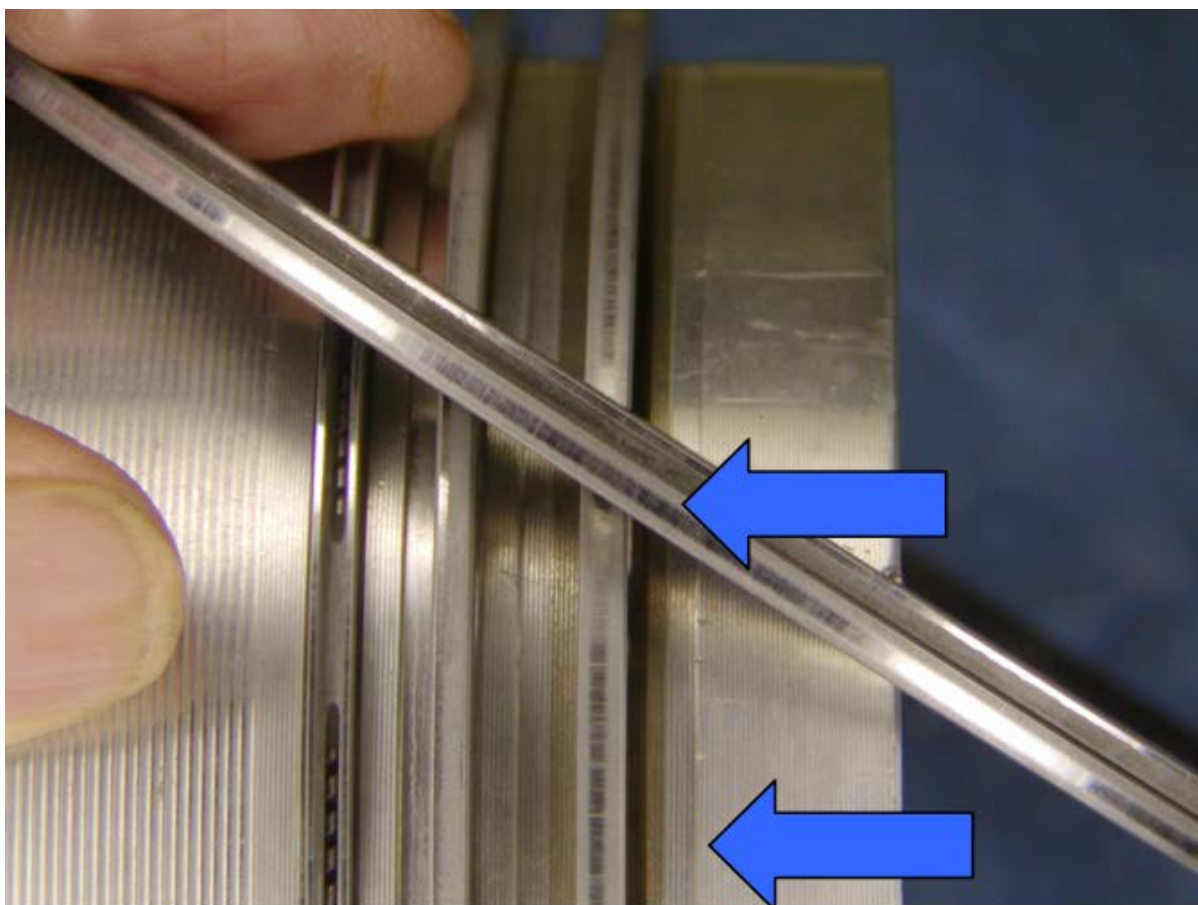
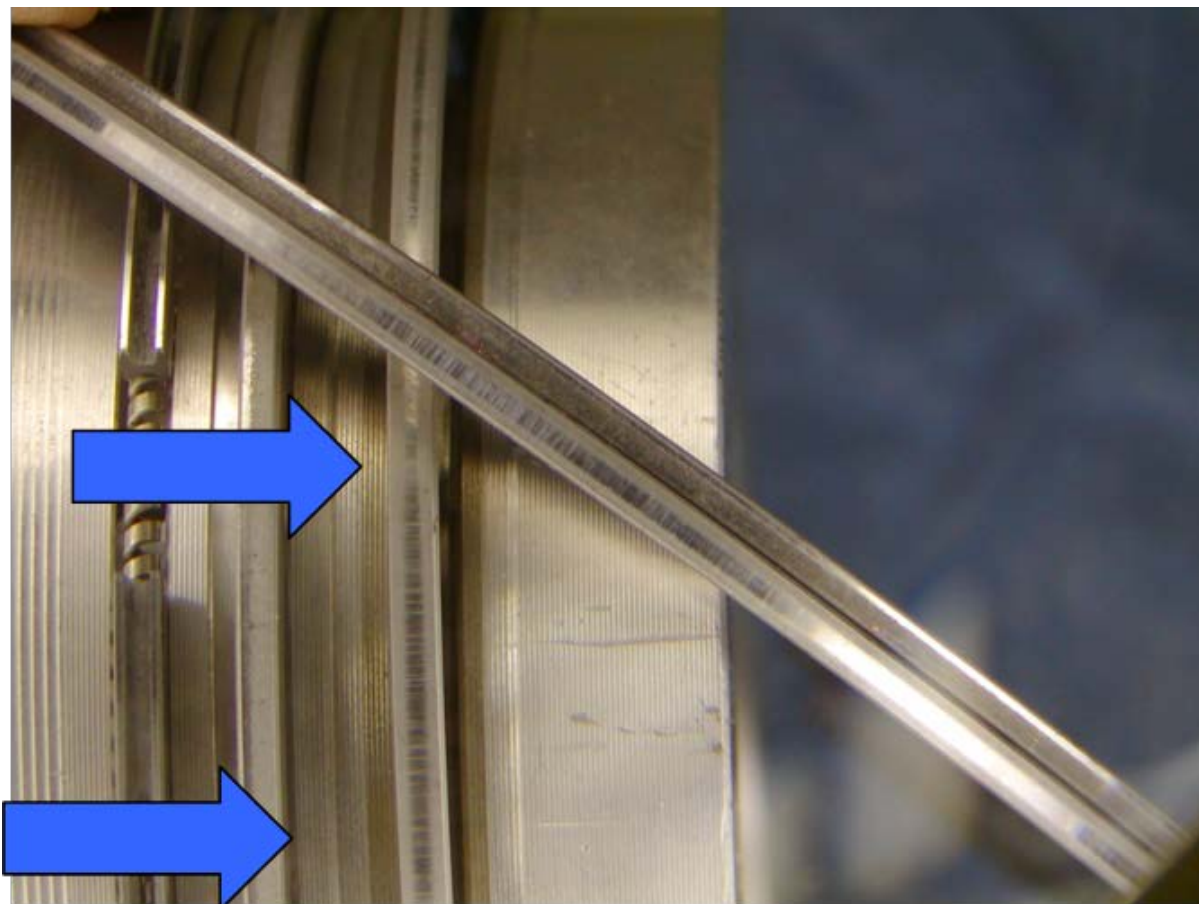
The next group of pictures will show the rings marked "original ring set" set on top of the piston that has the rings installed. Please note the heavy scratch marks on both sets of rings.

The root cause of failure was caused by foreign material contamination due to poor assembly practices and procedures. The contamination caused blow-by in the first set of rings was not corrected and caused the same failure condition in the second set of rings.

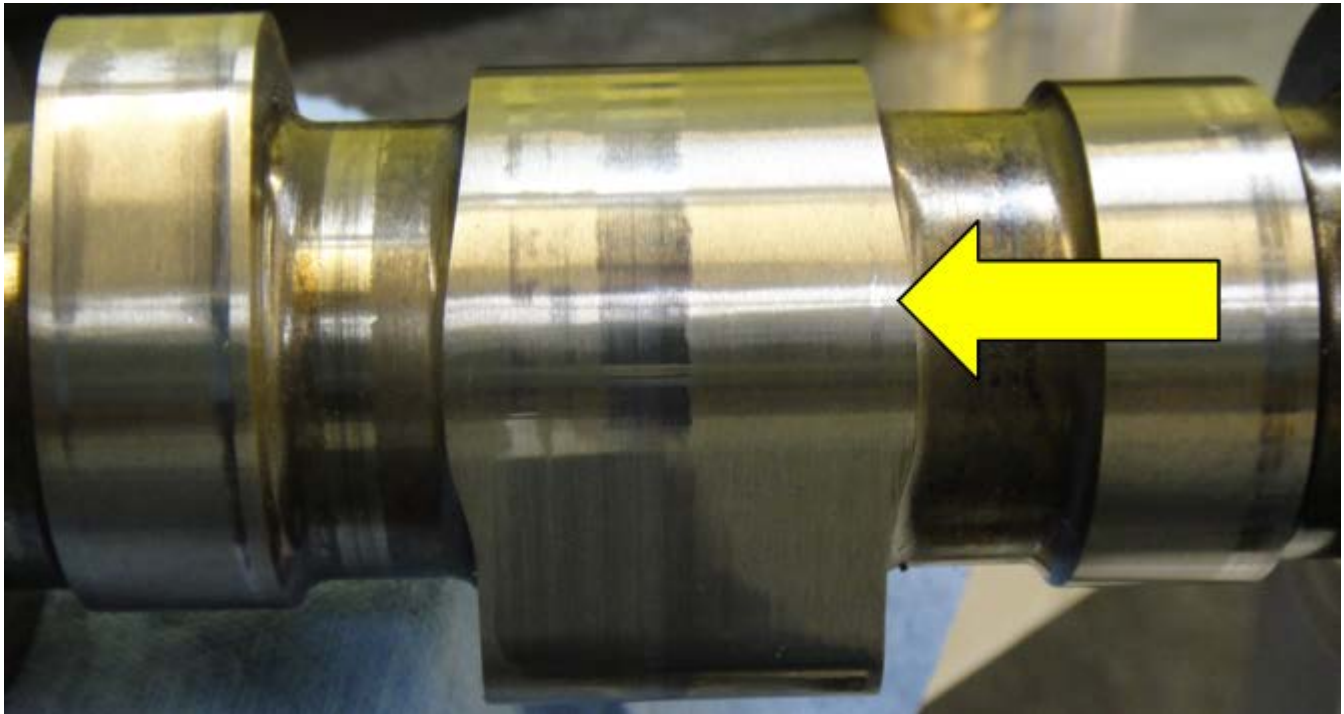
The next picture shows uneven wear patterns on the camshaft reflecting the wear pattern in the previous picture of the pin.

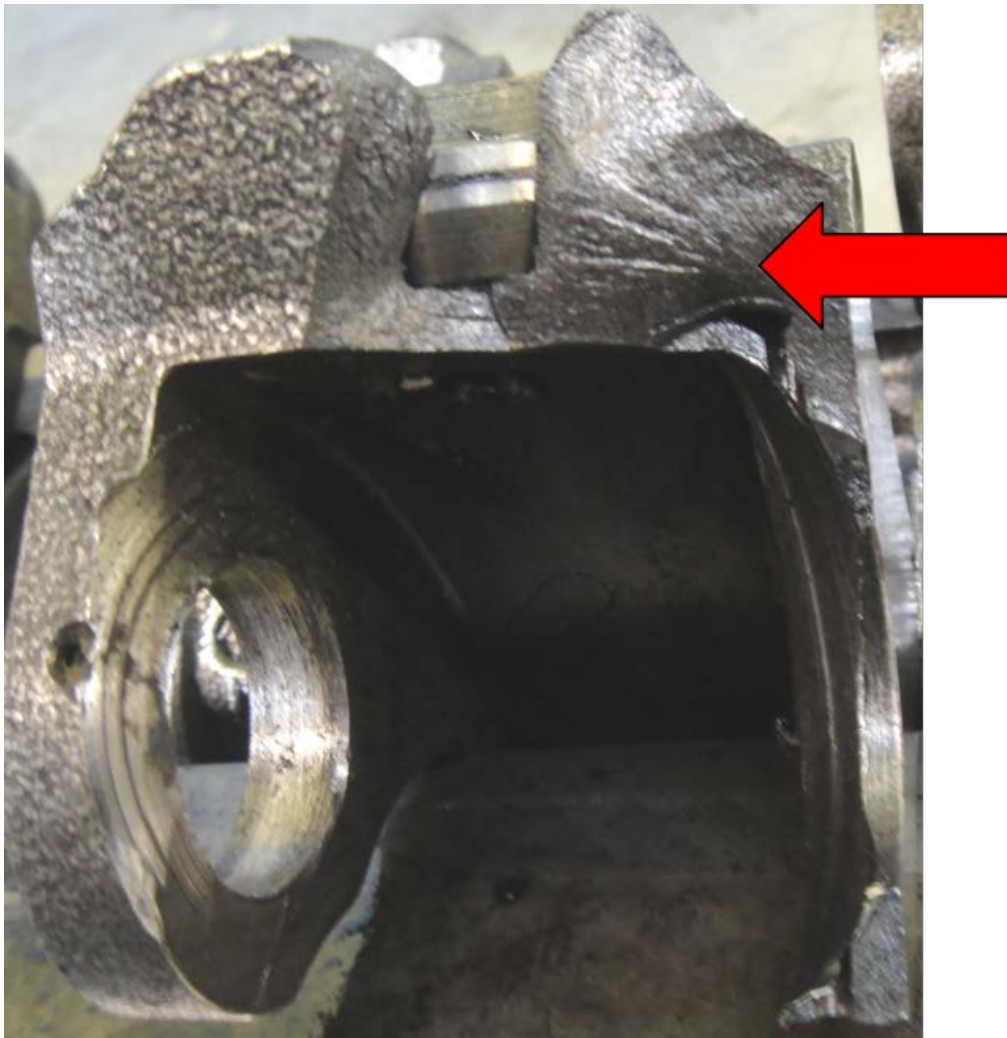
The next three pictures show the fractured surface area of the failed rocker lever. Note beach mark lines in surface pointed out by the red arrow.

The fracture initiated at one location and propagated across the rocker lever until final failure occurred. The rocker lever failed due to mechanical fatigue. The presence of visual beach marks and microscopic striations characterize the progressions of fatigue cracks. These characteristics are present on the fracture surfaces of the rocker lever as shown in the above picture. The most likely root cause of failure is a stress riser in the rocker lever causing the failure of the rocker lever.

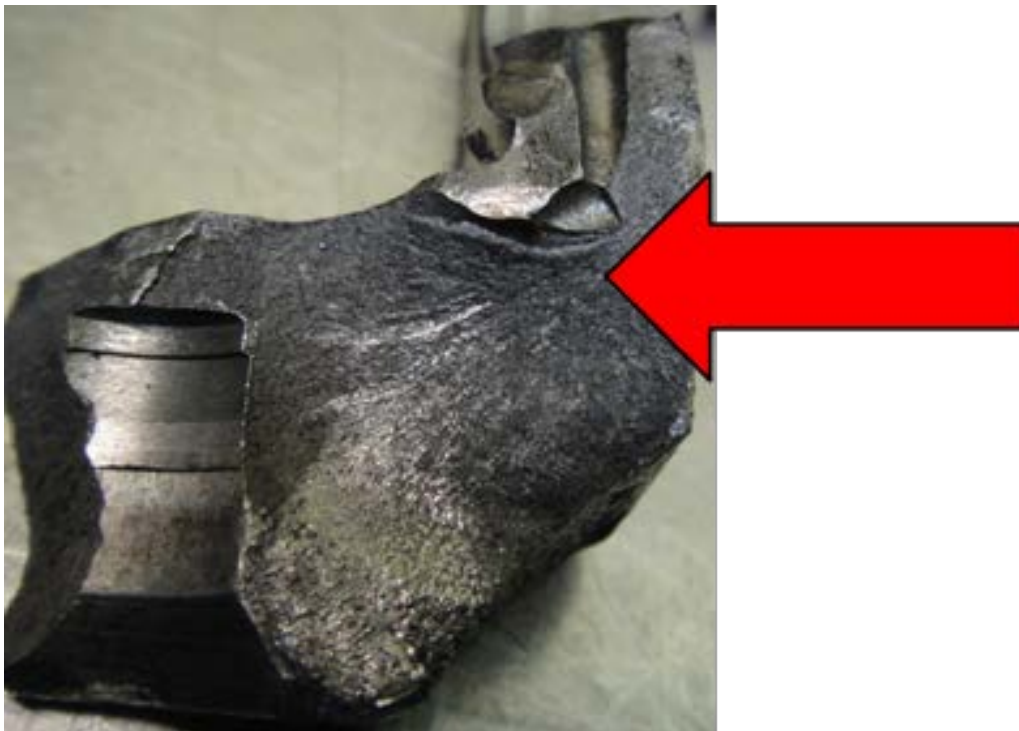
The beach mark lines in the picture are on the mating part of the failed rocker lever.

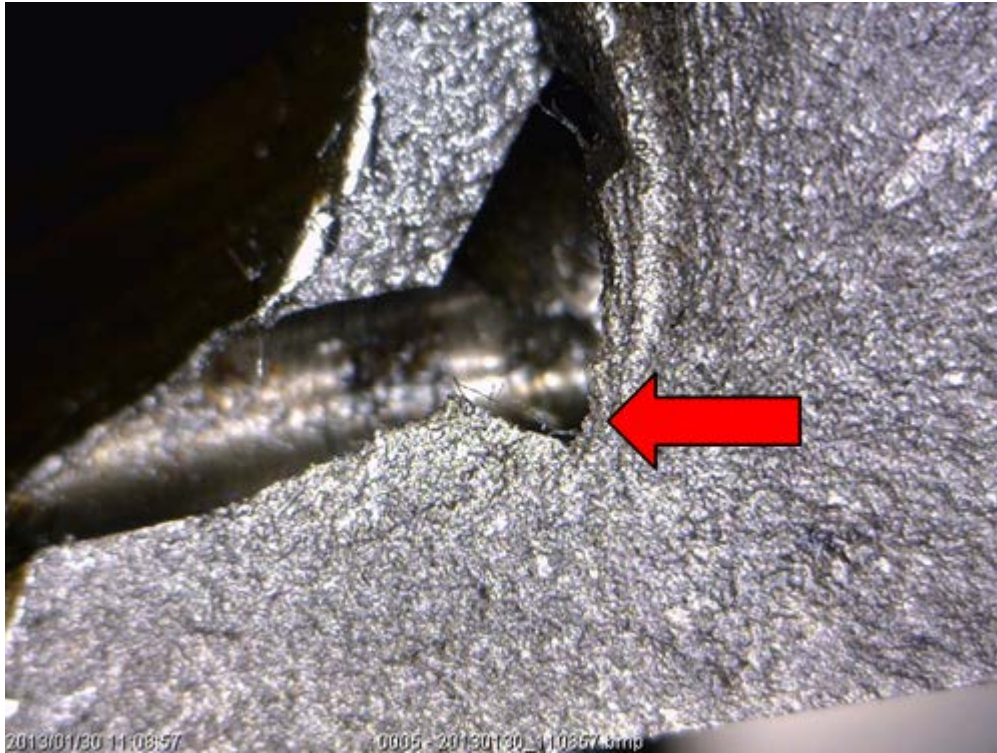
The final picture at 500X magnification shows the stress riser which started the fracture in the rocker lever.

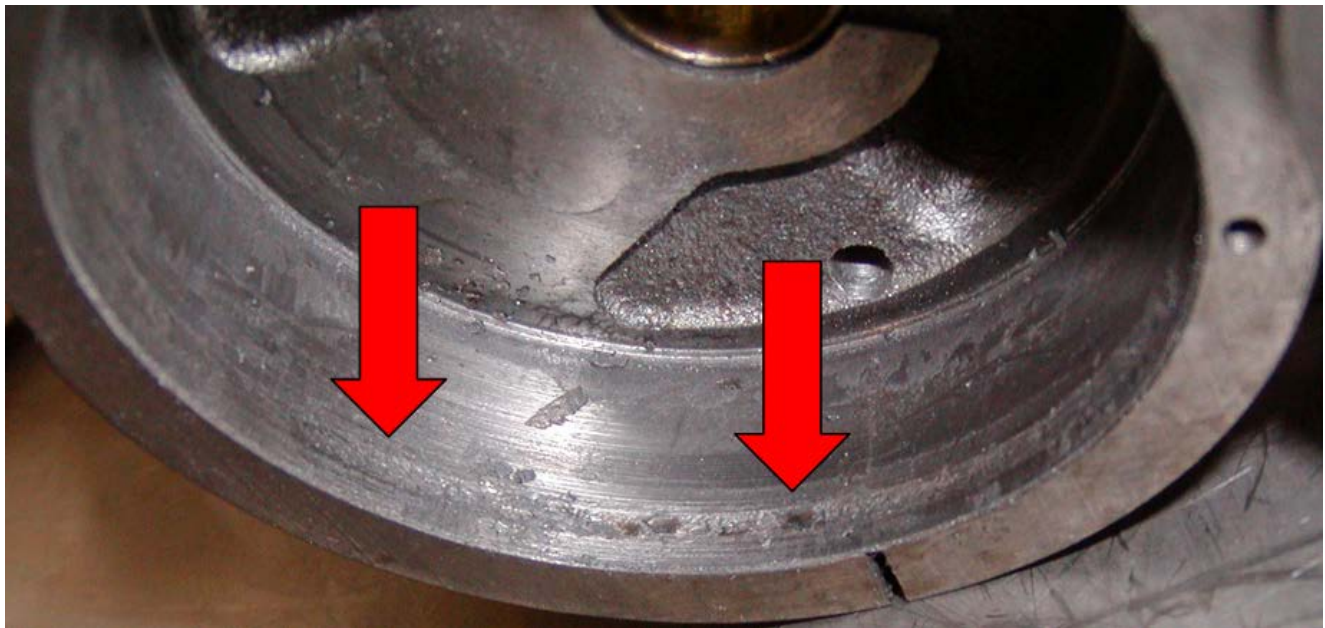
The inner surface of the housing shows where the foreign material channeled the pump housing.

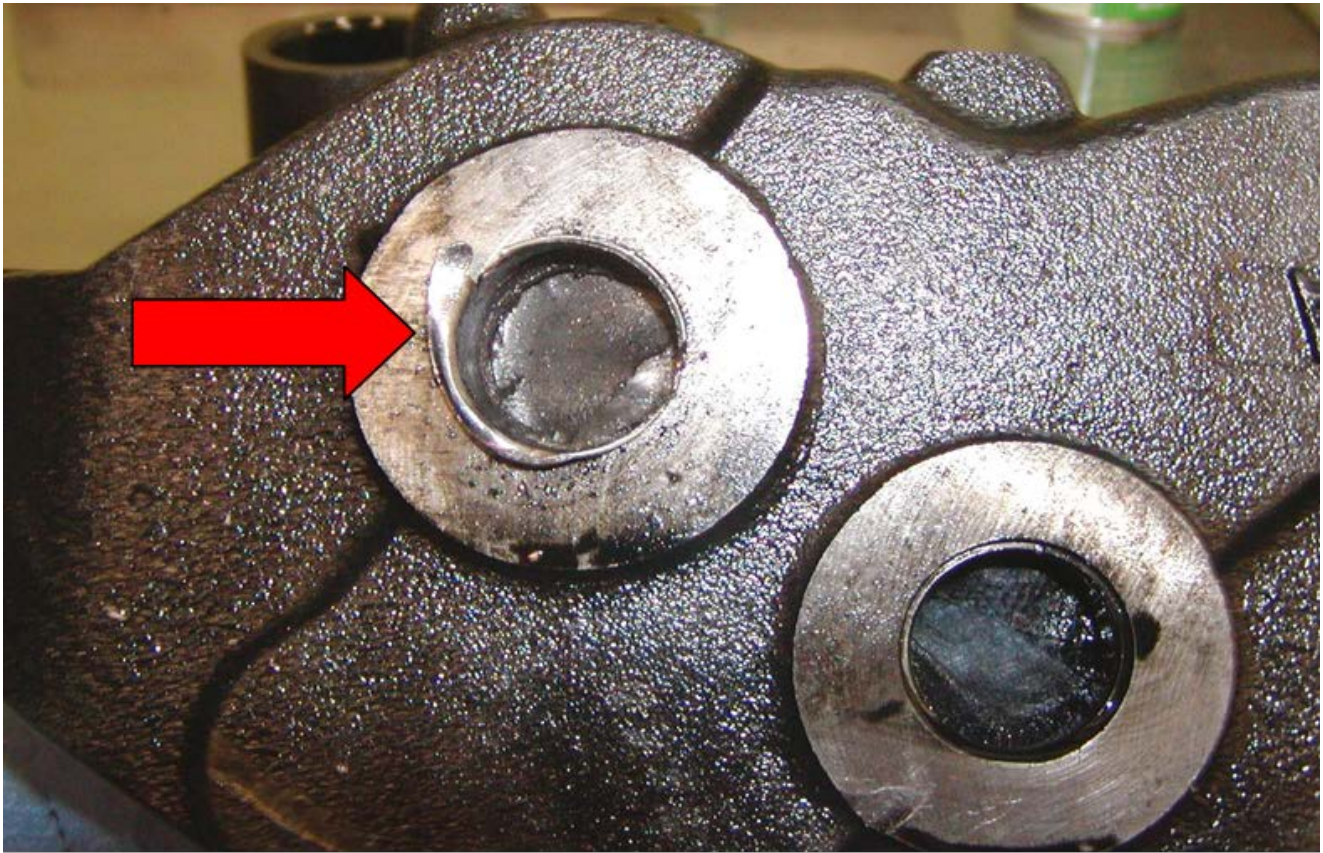
This shows the shaft bushing has failed in the pump housing with the internal part of the shaft stuck in it. The red arrow is pointing at the failed bushing.

The bushing failed from insufficient lubrication caused by excessive side loading. A shaft that breaks at or near a 45 degree angle indicates it has been under excessive torsional stress, a twisting break. The fact the bushing failed from side loading, one would expect a clean shaft break. However, when the shaft seized in the bushing the force of the engine twisted the shaft and caused the break to be torsional. The root cause of the pump failure was determined to be the pump was not shimmed properly and the gears did not have sufficient backlash.
