TECHNICAL PARTS GRAM #59

CUMMINS® ISX15 / QSX15 CONNECTING RODS

Saw Cut vs. Fracture Split

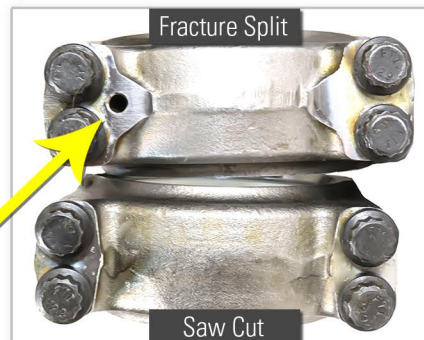
Picture A illustrates properly installed bearings in both rod styles.

Connecting rods are either **saw cut** or **fracture split** design at the parting line. Identification of the rods is easy. Look for the **drilled hole** in the cap of the **fracture split** rod. The **fracture split** rod also has serialized numbers etched in the face. Different styles of connecting rods have also been found mixed in an engine, so always use caution.

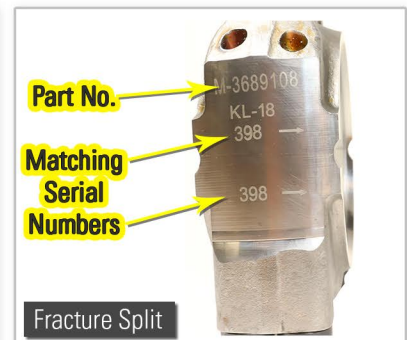
Picture B shows an incorrect installation in the connecting rods.

The **fracture split** style rod was first used in production in October 2012. However, there were many engines produced prior to October that contained fracture split rods, so the ESN might not always be accurate as to the rod types the engine has in it. These connecting rods use different rod bearing part numbers, and this is where assembly errors can happen. Both rod bearings are shown to the right. Note the alignment tang locations are similar so if the installer is not careful the wrong bearings can be installed in the connecting rod.
