## Technical Parts Gram #62:

### Connecting Rod Bearings for ISX Fracture-Split Rod Applications

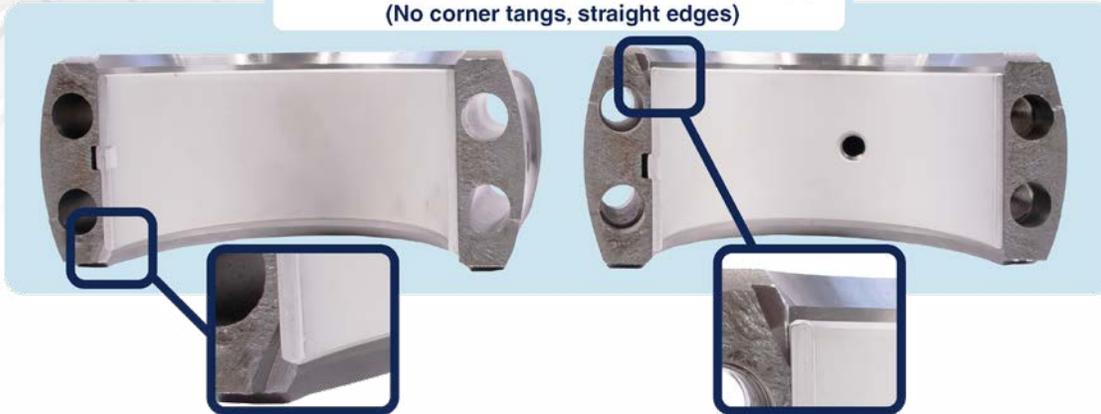
**INTERSTATE-McBEE BEARINGS**  
(No corner tangs, straight edges)

Part number 2882087 fracture-split connecting rod bearings have a small tab at the corner, which may serve only for identification purposes. However, aftermarket manufacturers like Interstate-McBee may produce bearings without this tab. Extra caution should be taken during installation to ensure the correct orientation and fitment of the bearings. Installing rod bearings incorrectly can lead to oil starvation, excessive wear, and potential engine failure. Extra care ensures proper function and longevity.

- **Verify Orientation:** Even without the tab, ensure the bearing shells align properly with rod and cap.
- **Check Part Numbers:** Confirm the bearings match the engine specifications before installation.
- **Inspect for Oil Holes & Notches:** Some bearings may have specific features for oiling that must align properly.
- **Follow Torque Specs:** Always use the recommended torque values and procedures to prevent premature failure.
- **Lubricate Properly:** Use correct assembly lube/ engine oil to avoid dry starts.

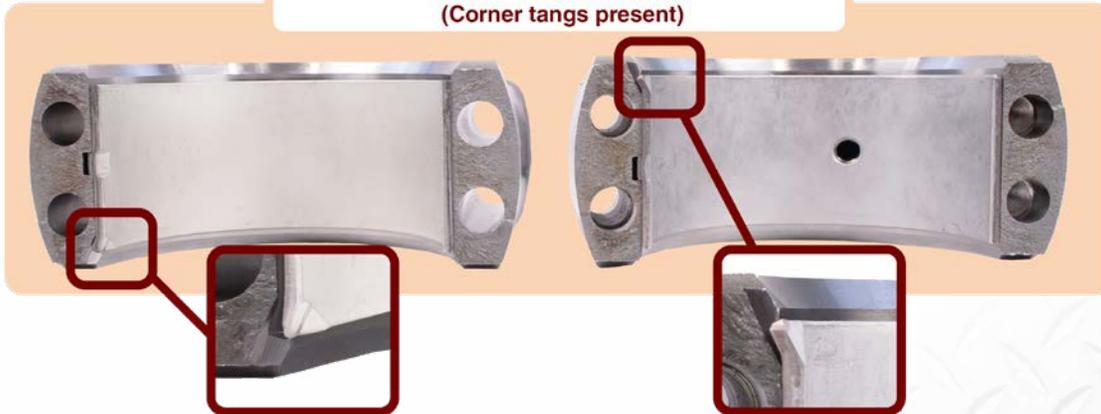
**OEM BEARINGS**  
(Corner tangs present)
