# INTERSTATE-McBEE

## FAILURE ANALYSIS GUIDE

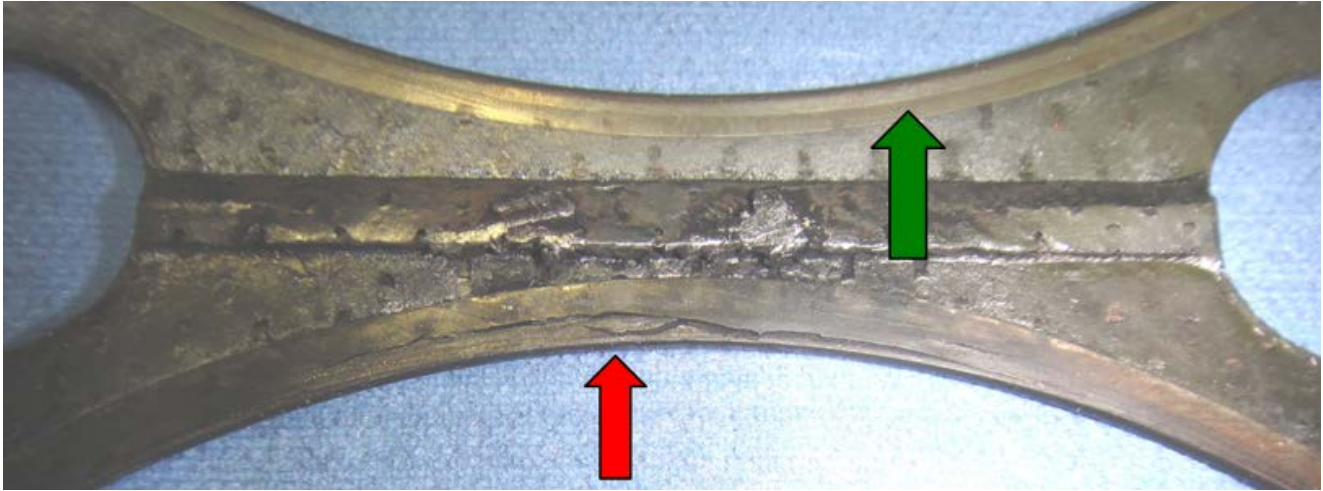
The first picture shows the damage to the fire ring on #4 cylinder of the returned head gasket. Note: the condition of the fire ring in the adjoining cylinder which did not fail. The head gasket failed from detonation causing thermo push fracturing the fire ring.

Conclusion: Inspection revealed the head gasket failed due to detonation resulting in thermal push. Detonation is uncontrollable combustion creating combustion temperatures and pressures exceeding cylinder components design capabilities.

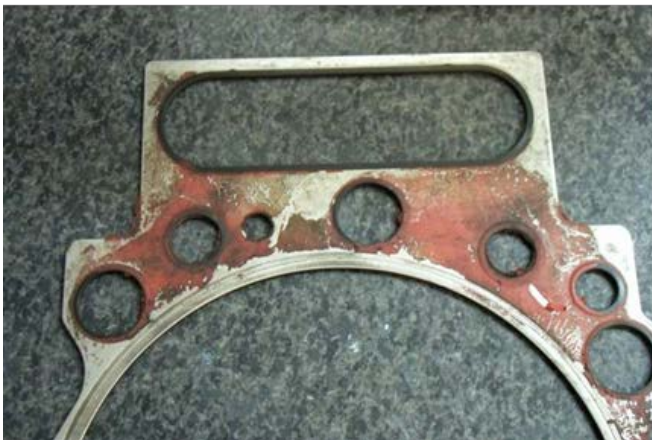
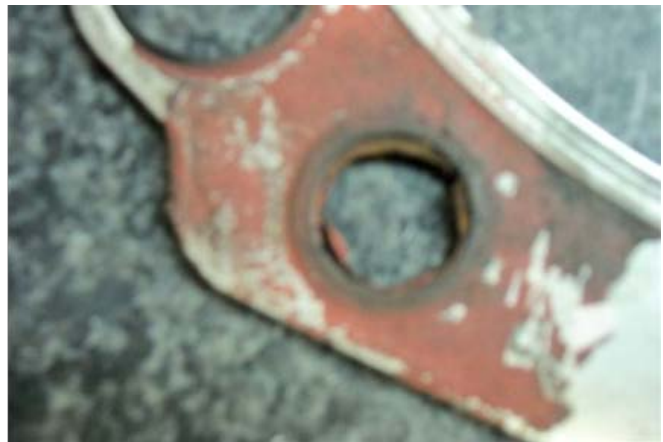
Observations: Gasket was examined for possible leak cause. Red Silicone sealant was found around the water and oil sealing areas. Gasket was assembled using a liquid gasket compound. This is never advised and prevents proper seating of the gasket, as well as uneven loading and increases stress on assembled joint and gasket. Liquids are not compressible and therefore can cause many problems on assembled joints. The liquid also creates a low coefficient of friction and will actually lessen proper torque value. Gasket sealer has extruded into the seal area, potentially the reason of the complaint of seals "contracted" when in actuality, liquid rubber has cured inside of the seal area.

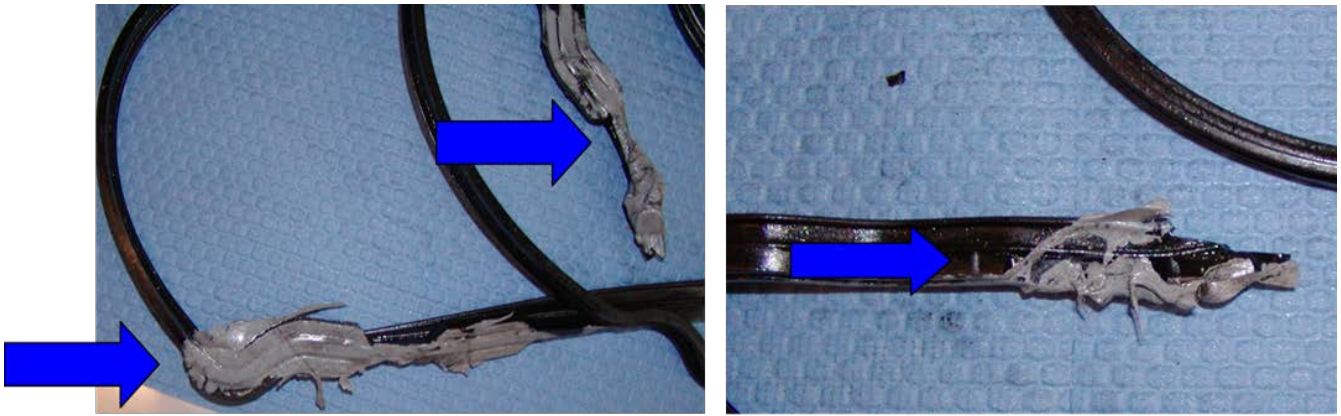
Complaint: Oil pan gasket leaks and comes apart. The following pictures show the oil pan gaskets were installed using a glue/sealer.

Conclusion: Use of any type of glue or sealer on this type of pan gasket will cause oil leaks and gasket failure. Gasket should be installed on a clean dry surface.

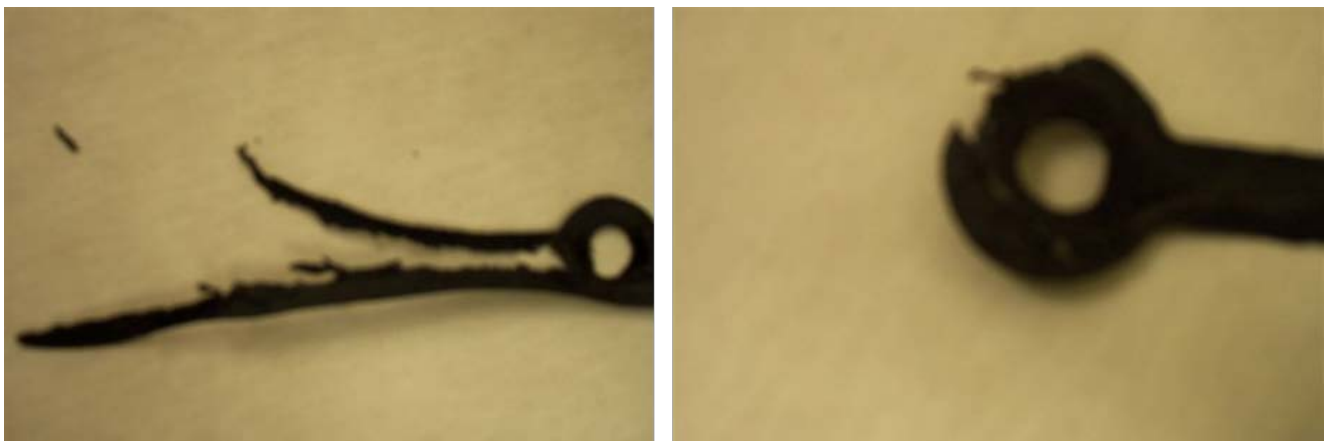
Observations: Inspection revealed there has been gasket sealer applied to the gasket. Both sides of the gasket are “sticky” to the touch. Application of gasket adhesives is not recommended as it can cause the gasket to be over loaded particularly around the bolts where the flange pressures are at the highest. The adhesive will not allow the gasket to conform properly to the flange surfaces and will cause the gasket to tear or split as observed in the gasket sent for evaluation.

Gaskets must be installed completely dry. If adhesives are needed to temporarily hold the gasket in place during assembly, it is recommended the adhesive be used sparingly and placed away from bolt holes.

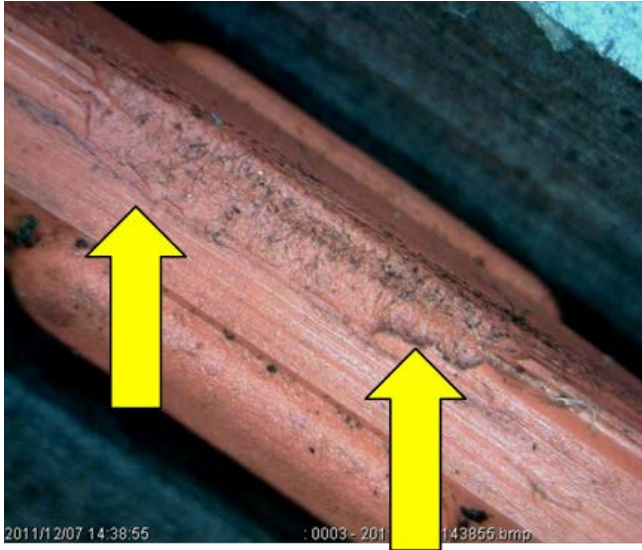
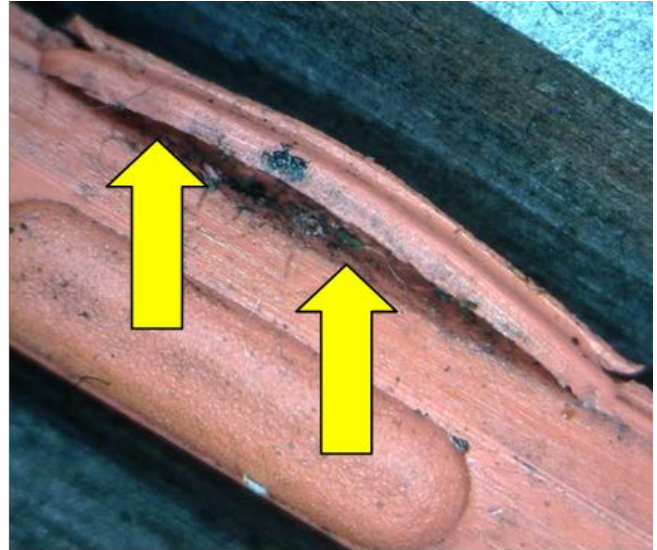
The following two pictures show two locations on the seal that are damaged and provide a leak path for oil. The cause of failure, oil leak, is the result of the damage to the seal during assembly.

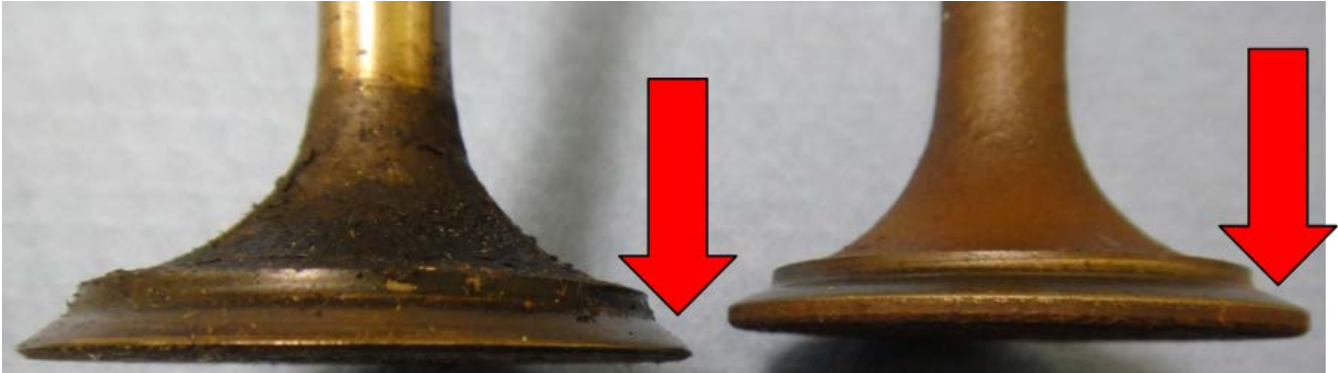
The first picture shows two valves with extreme recession.

Conclusion: The most likely cause of the premature valve wear is improper maintenance procedures for the engine conditions.

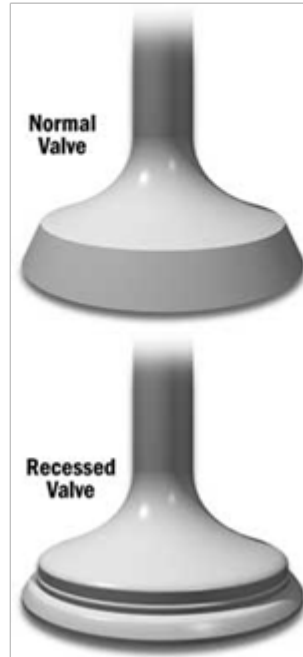
**Figure 1. Typical Valve Recession  
in a Natural Gas Engine**

Valve recession is the premature wearing of the valve seat into the cylinder head. The sulfated ash residue helps to prevent premature valve recession by "cushioning" the valve seat area.

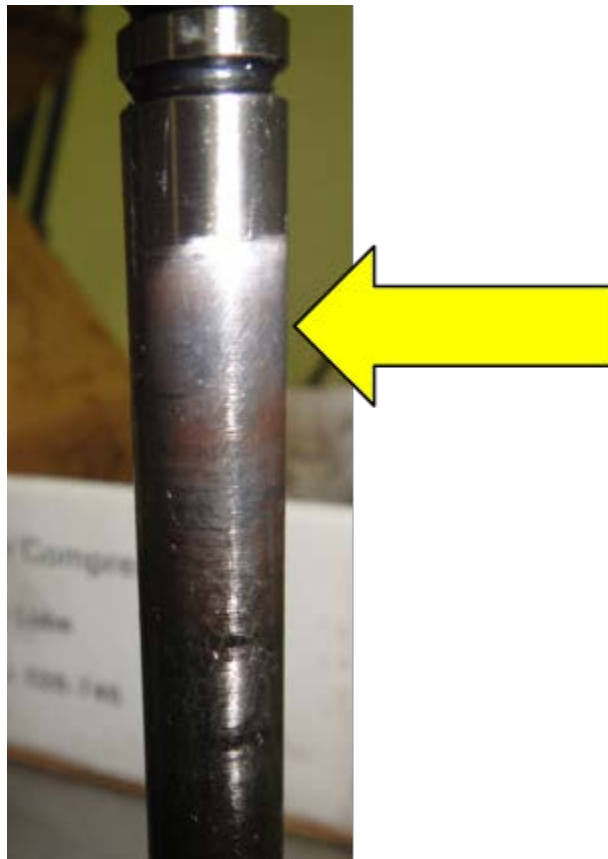
The first picture shows abrasive wear on valve stems. Wear of this type is due to improper adjustment and is not a defect in material.

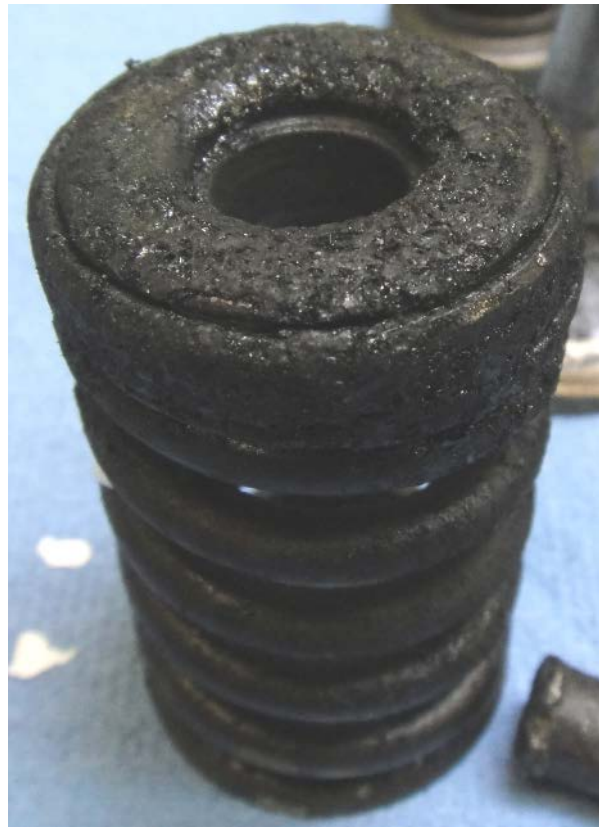
The next several pictures will show the heavy abrasive carbon build up on the valve, valve spring and rotator and the valve guide. Note the heat discoloration of the guide (blue arrow). These parts failed due to carbon build up due to external conditions and not defects in the product.

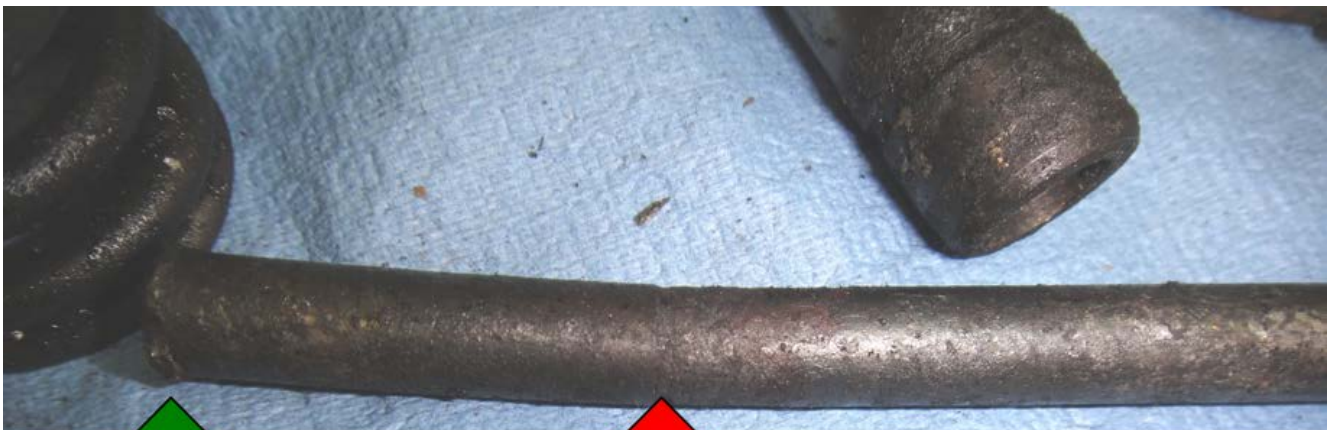
The next picture shows the stem of the broken valve. Note the break (green arrow) is just above the valve face (strongest part of a valve). Also note the erosion of the valve stem from carbon cutting (red arrow).

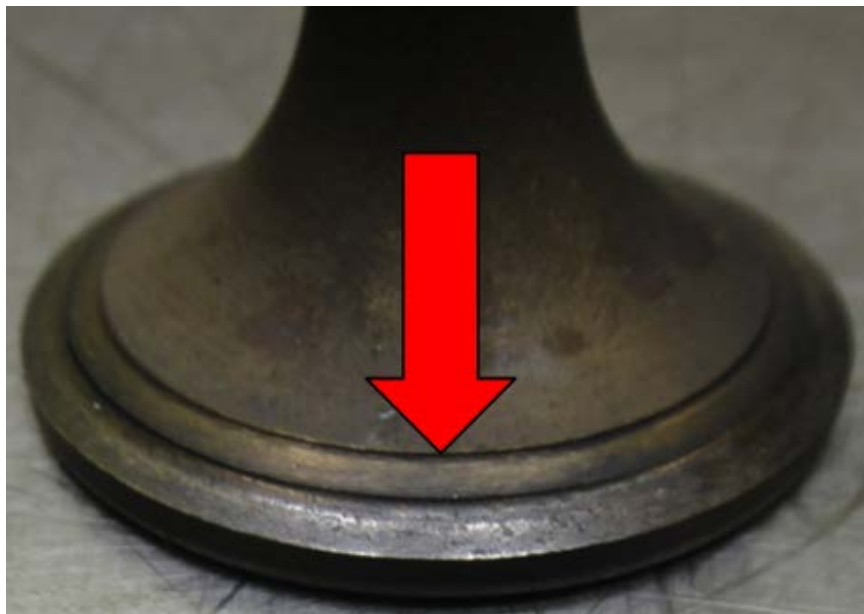
This picture shows the seat wear on one of the valves. Most of the valves had similar wear and a few had severe wear.

Valve seat wear will reduce valve lash and effect when a valve opens and closes which changes timing. It also effects scavenging, valve overlap and both valve and valve seat cooling. Lack of proper scavenging can also cause excessive heat build up in the exhaust ports and damage the valve guides. If there is a variation in wear of the two valves that share a common crosshead it can create side loading of the valves and wear in the valve stems. Crossheads must also be inspected prior to installation for both wear and orientation.

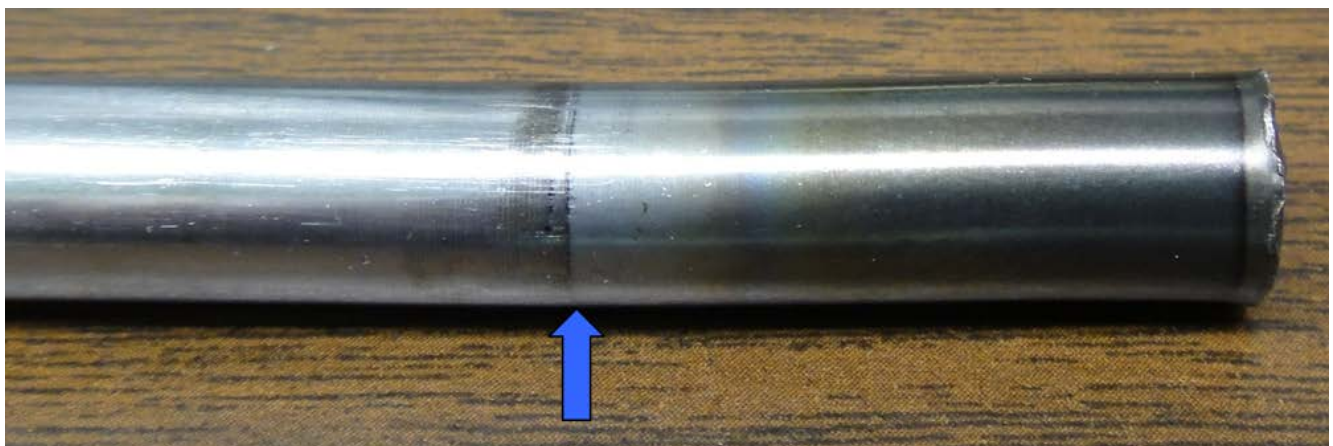
The next picture of the stem of the failed valve shows the welded area of the stem a little clearer.

The failed valve had no inclusions or flaws in the break area. The valve did not break at the weld attaching the valve head to the shaft as claimed. The most likely cause for the failure is bending fatigue caused by misalignment.

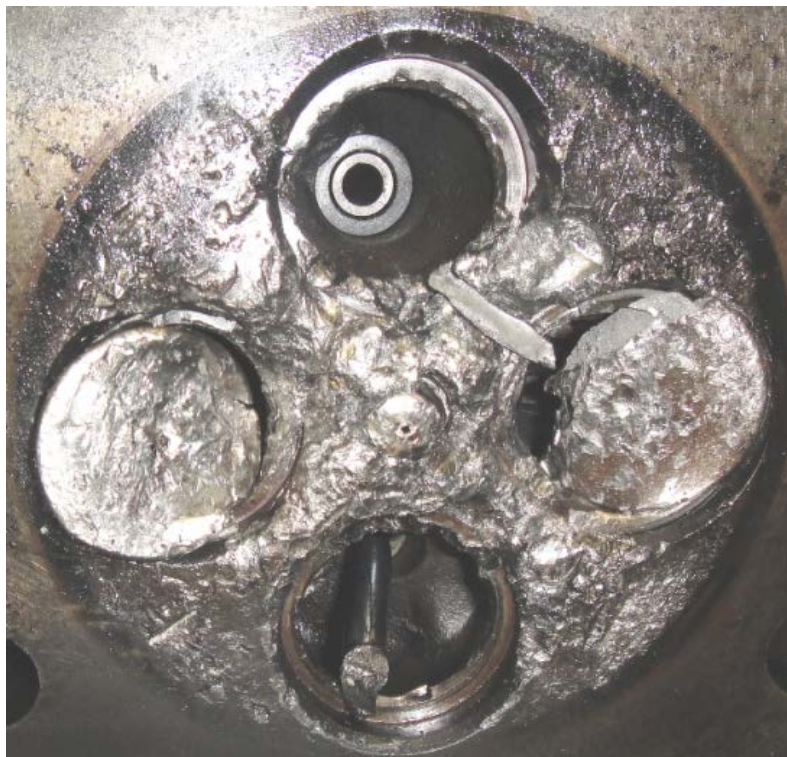
Final picture of damage to cylinder head at failed cylinder. Note valve missing head at bottom shows remains of stem, this occurred as a secondary failure.

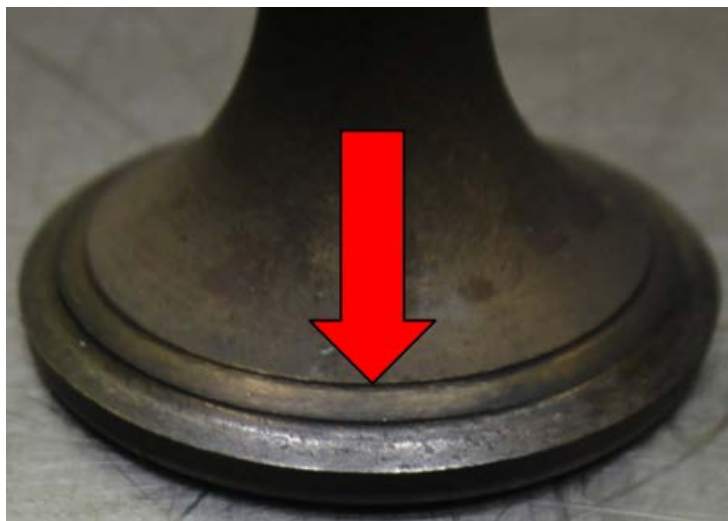
This picture shows the seat wear on one of the valves. Most of the valves had similar wear and a few had severe wear.

Valve seat wear will reduce valve lash and effect when a valve opens and closes which changes timing. It also effects scavenging, valve overlap and both valve and valve seat cooling. Lack of proper scavenging can also cause excessive heat buildup in the exhaust ports and damage the valve guides. If there is a variation in wear of the two valves that share a common crosshead it can create side loading of the valves and wear in the valve stems. Crossheads must also be inspected prior to installation for both wear and orientation.

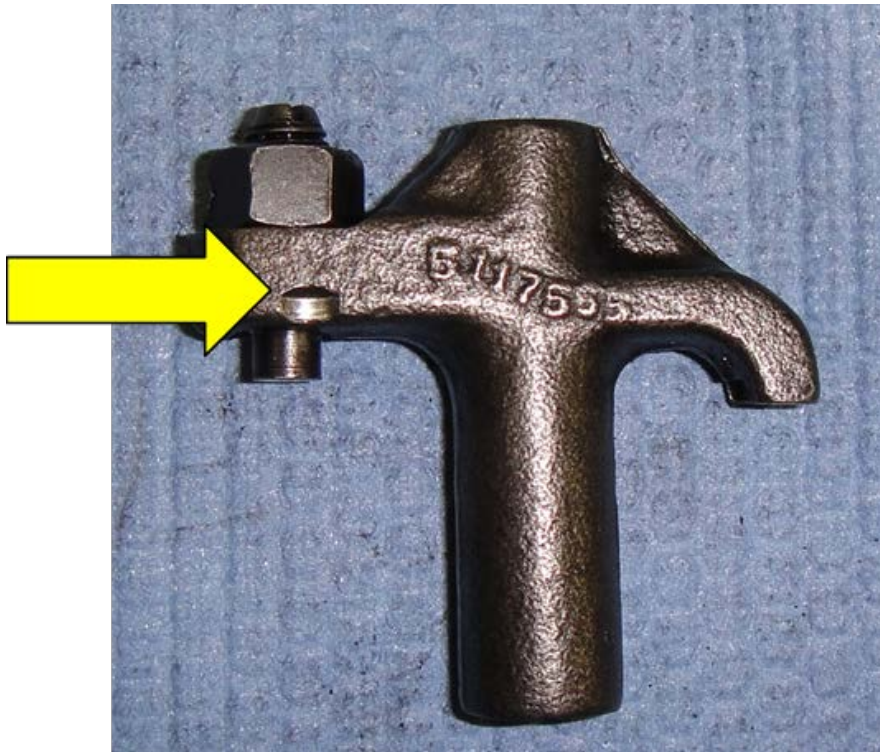
The next few pictures show a damaged valve bridge.

Conclusion: The most likely cause for the valve failure was found to be impact loading caused when the valve was momentarily locked in the open position by the turned valve bridge allowing the piston to strike the valve breaking it off from the stem.

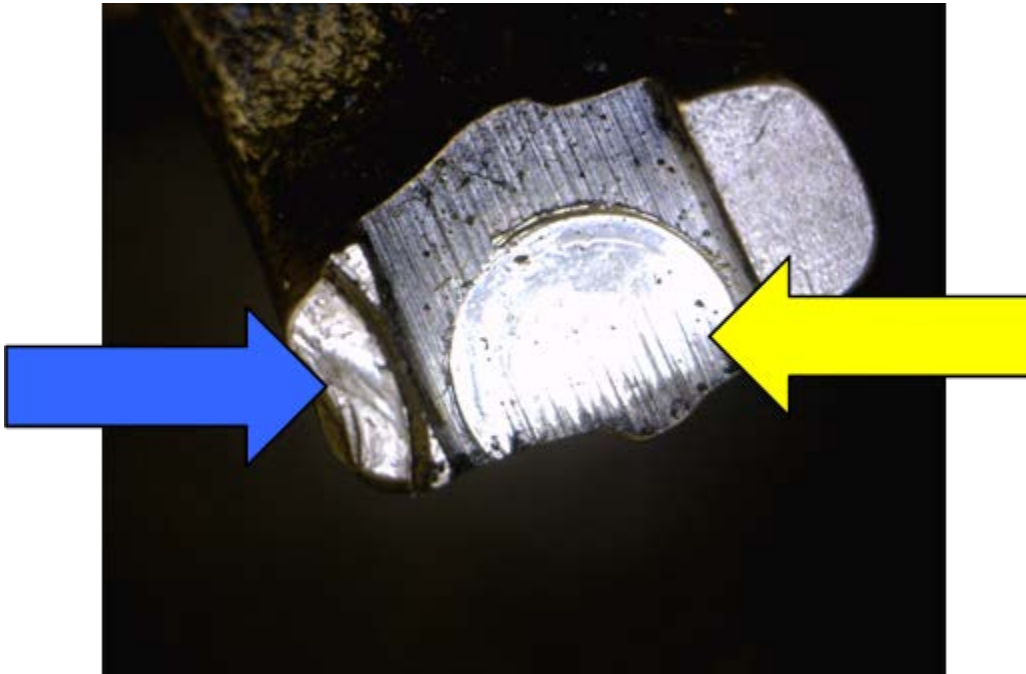
On inboard side of valve bridge note limited contact area, yellow arrow and edge damage blue arrow. The edge damage was caused when the bridge turned and the valve was in running contact with the outside of the bridge.

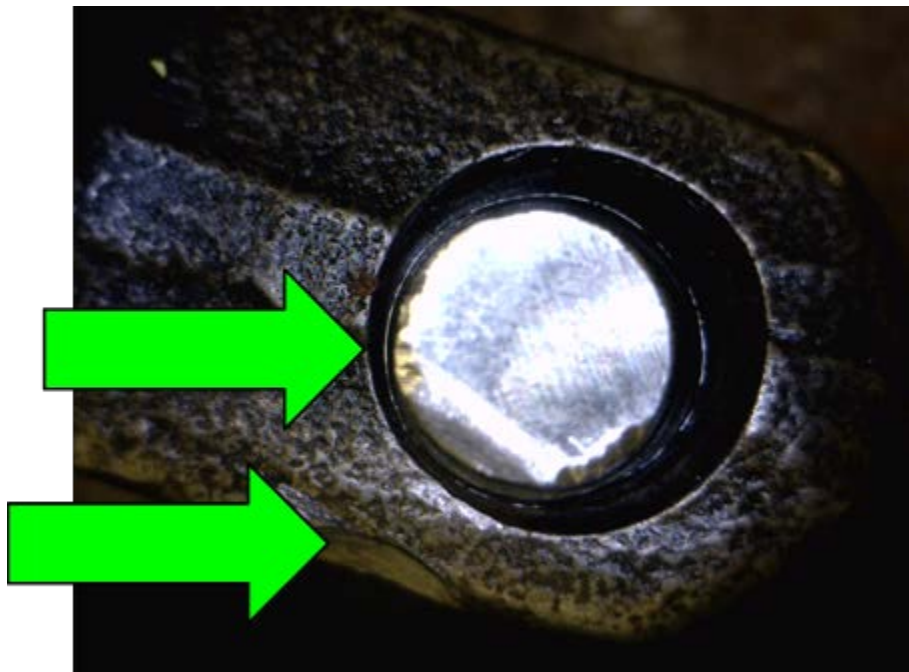
The next picture shows the out board side of the bridge, note witness marks, green arrows, showing running contact wear on edge of normal contact area and on outside edge of bridge.

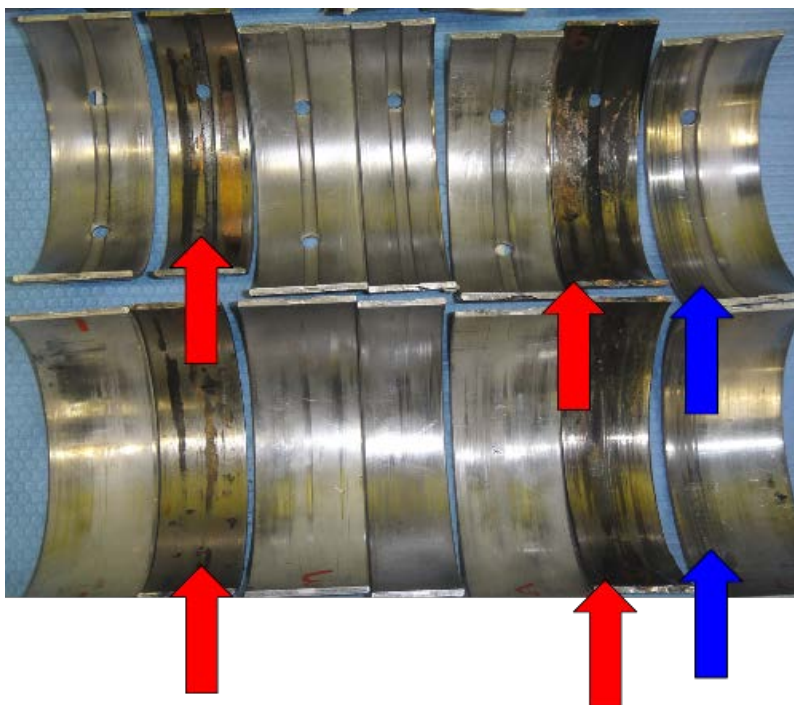
The following picture shows all of the main bearings laid out in the order they were removed. Red arrows point to bearings experiencing catastrophic failure. The blue arrow shows number seven bearing set starting to failure. Note all the bearing show shiny rub spots that are a further indication of lack of lubrication.

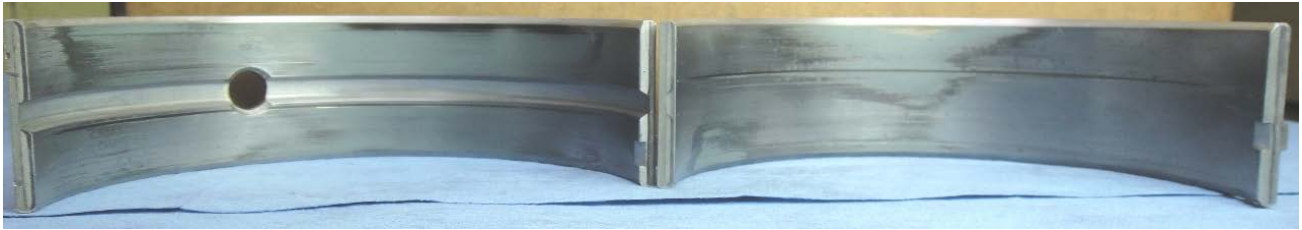
Example of uneven wear caused by bore distortion

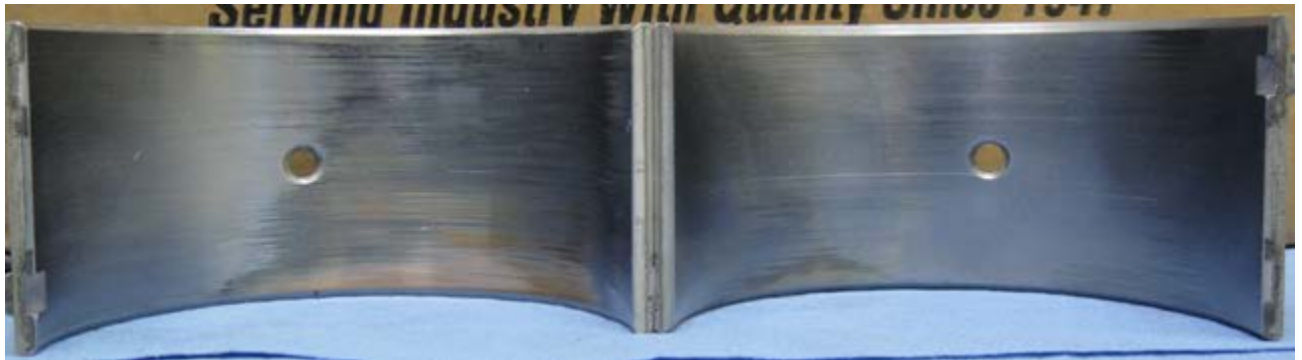
Example of uneven wear caused by a bent connecting rod

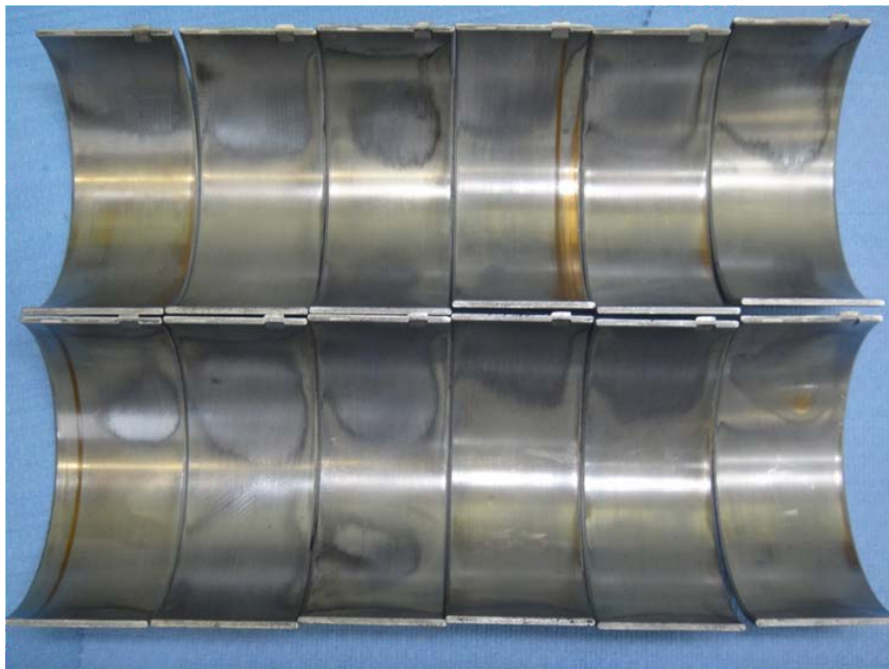
The final picture shows the uneven wear patterns on the rod bearings. Gouges in the bearings are caused from abrasive contamination not properly removed from the engine during overhaul.

Conclusion: The bearings have uneven wear spots most likely caused by either a worn crankshaft or out of round connecting rod bearing bores. One bearing had a piece of tape on it that was between the bearing and the rod bearing surface. The pattern of the tape was clearly visible on the reverse side of the bearing.

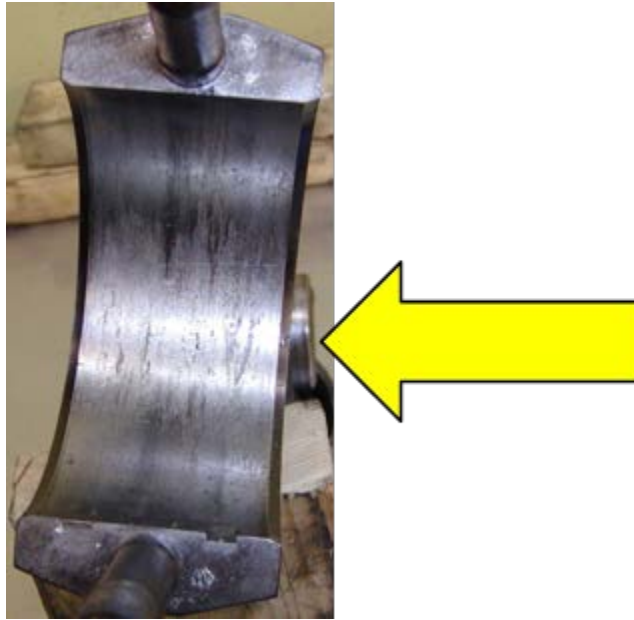
The next picture shows the lower part of the connecting rod that holds the rod bearing. Note; the rod is not drilled for an oil feed hole to the piston pin.

Conclusion: The above pictures show two areas of failure, the connecting rod bearing and the cylinder kit. Also shown is a damaged piston cooler. The piston cooler if bent can cause a piston to seize and cause the piston pin bearing to fail. The connecting rod was not up dated at time of overhaul to the recommended drilled rod. The rod bearing failure caused by lack of proper lubrication.

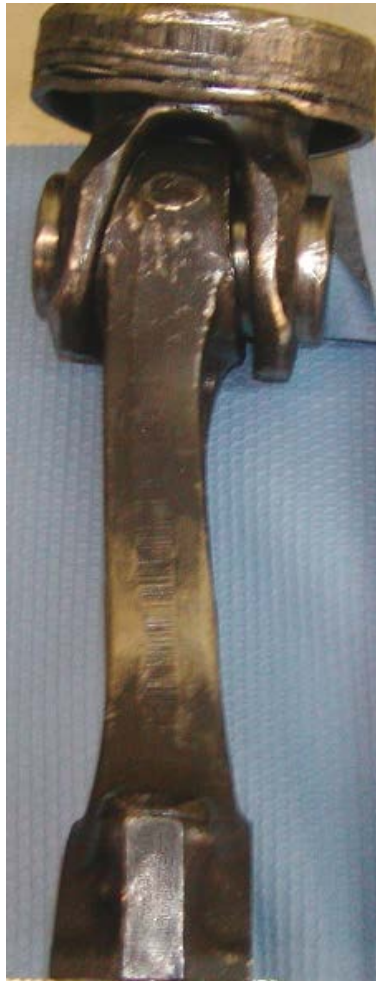
The next picture shows the failed piston and connecting rod. The piston skirt and liner were reduced to pieces.

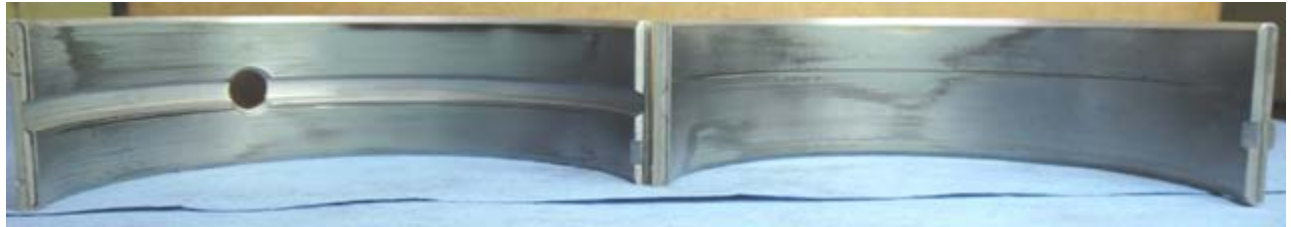
Example of uneven wear caused by bore distortion

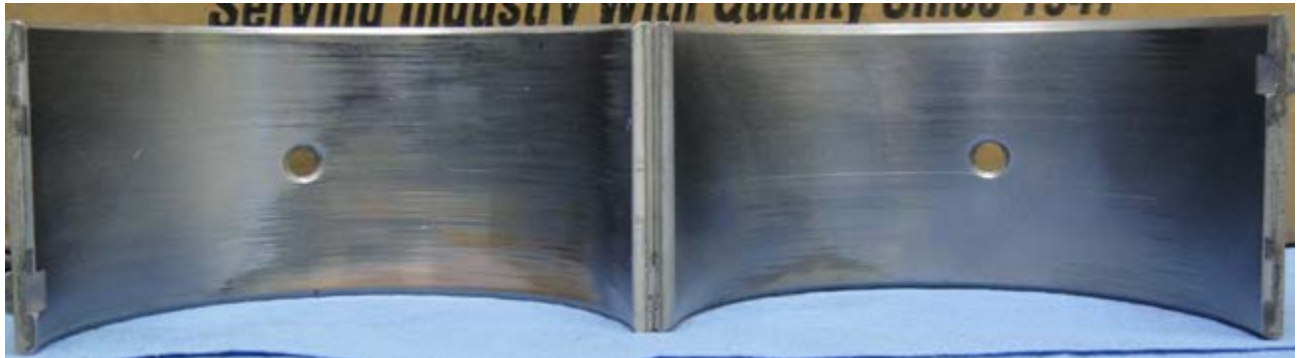
Example of uneven wear caused by a bent connecting rod

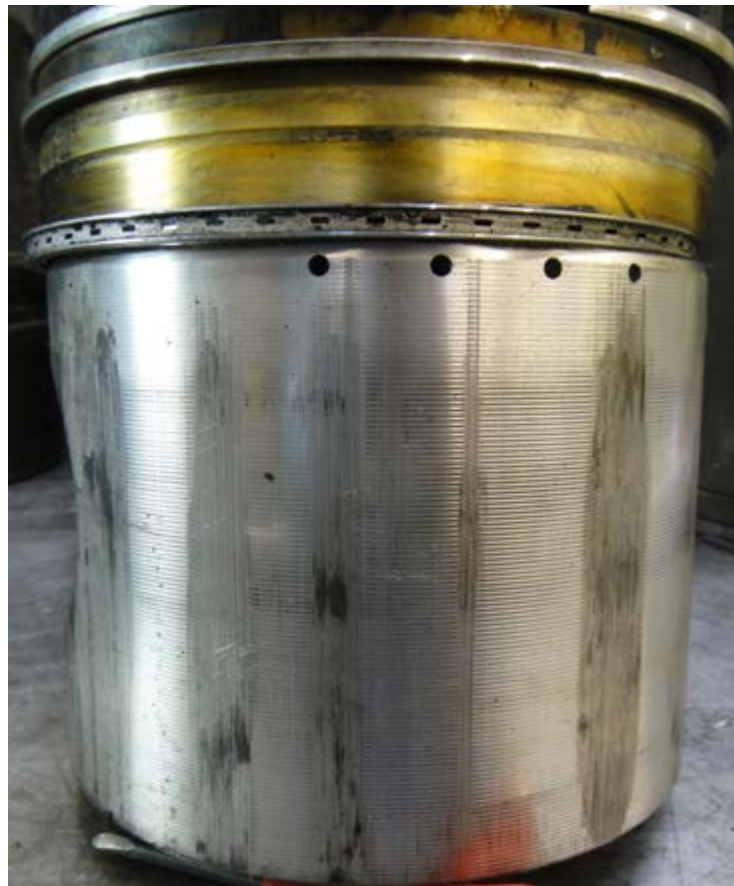
### A. Piston damaged by adding cold coolant to a hot engine

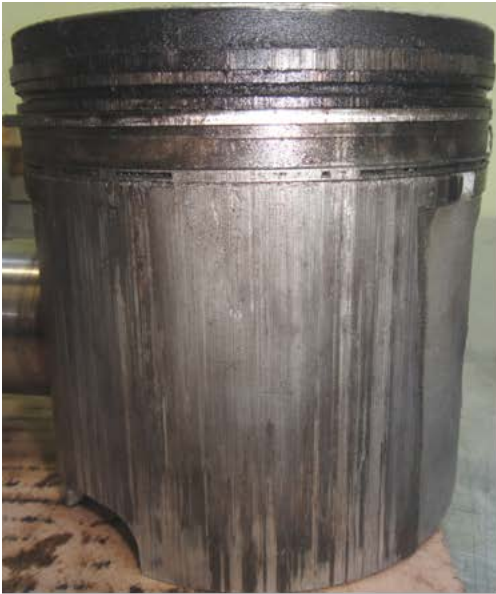
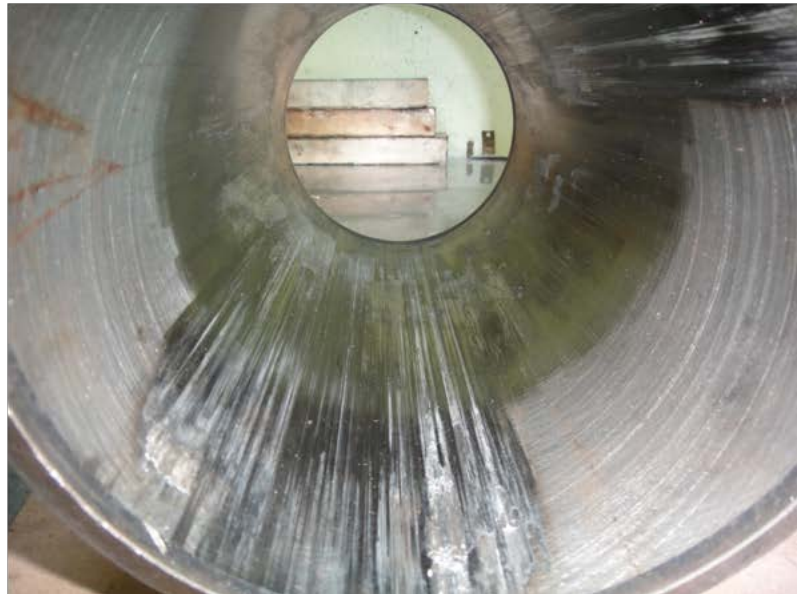
Cylinder kit failure caused by overhear and detonation. The first picture shows the scored piston and the second picture shows scoring on the inside of the liner.

The piston and liner are severely scored from overhear. Top of piston is cracked and has a hole in it caused by detonation. The fuel spray pattern on the piston crown is too close to the center of the bowl indicating a timing issue or a damaged fuel injector. The most likely cause of failure would be incorrect timing.

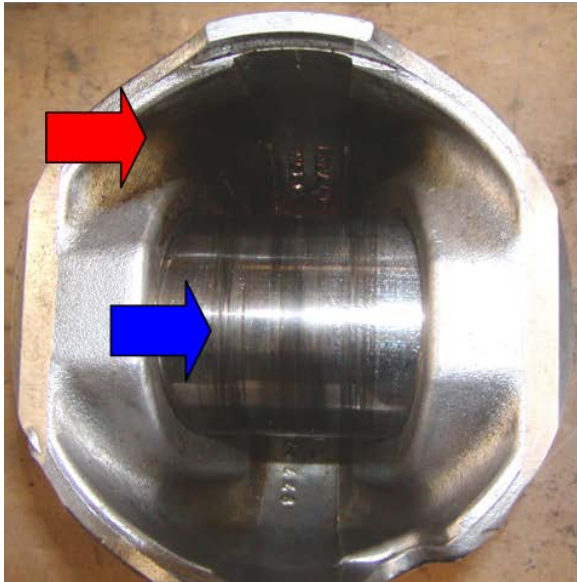
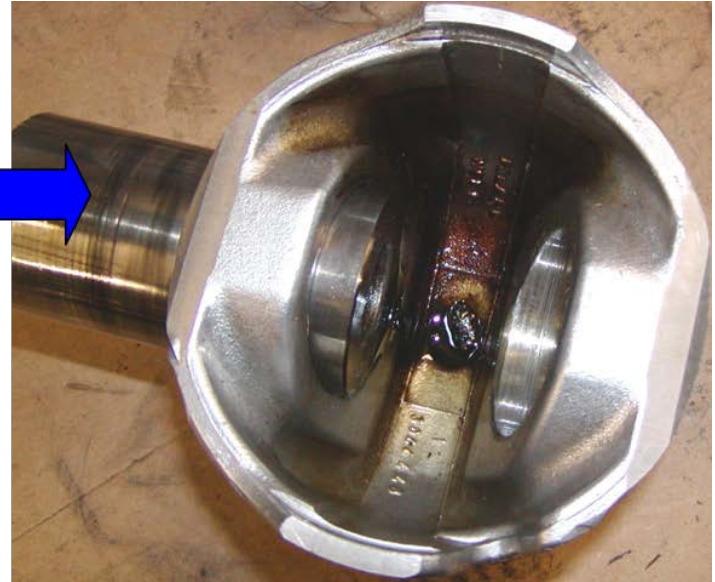
The following pictures show the bottom of the piston with the piston pin in place, note the black streaks on the pin "blue arrow" and the burnt area of the under crown "red arrow".

Conclusion: The connecting rod bearings for this failed cylinder kit were returned with the failed parts were in pristine condition showing normal wear. The top of the piston showed no sign of an injector problem. The piston pin showed signs of lack of proper lubrication, blue arrow. The

underside of the crown was burnt, red arrows. The piston is cooled on the underside by oil from the piston cooler.

The root cause of failure was severe overhear from lack of proper lubrication. The piston cooler should be checked for damage. The engine should also be checked that it contains the correct type of oil, correct amount of oil and that the oil pressure is per manufacture's specification.

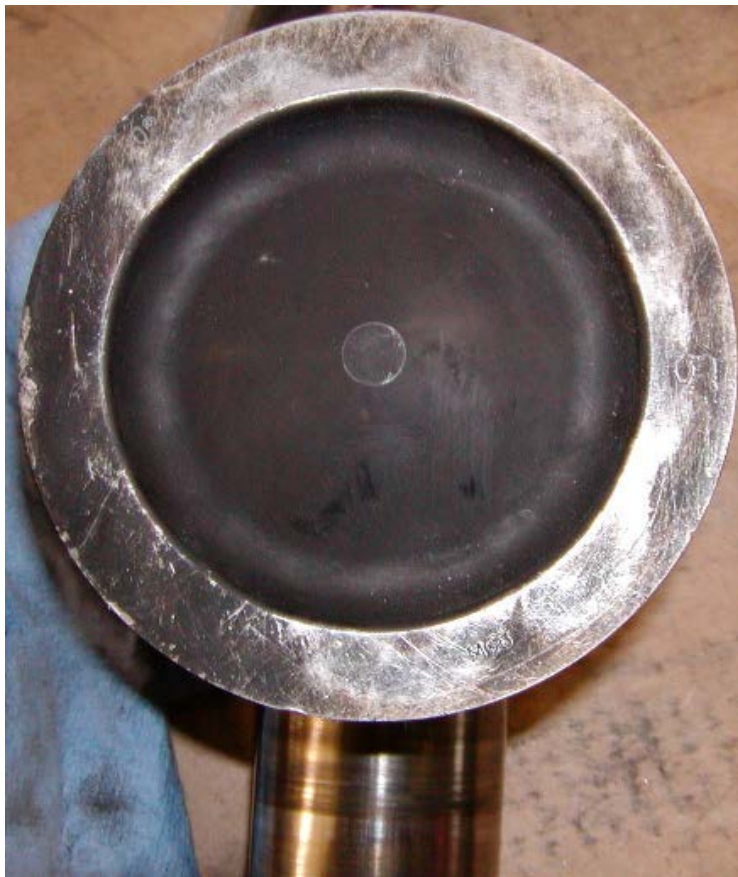
The next picture of the top of the piston shows no unusual injector pattern, indicating it did not overheat from a defective injector.

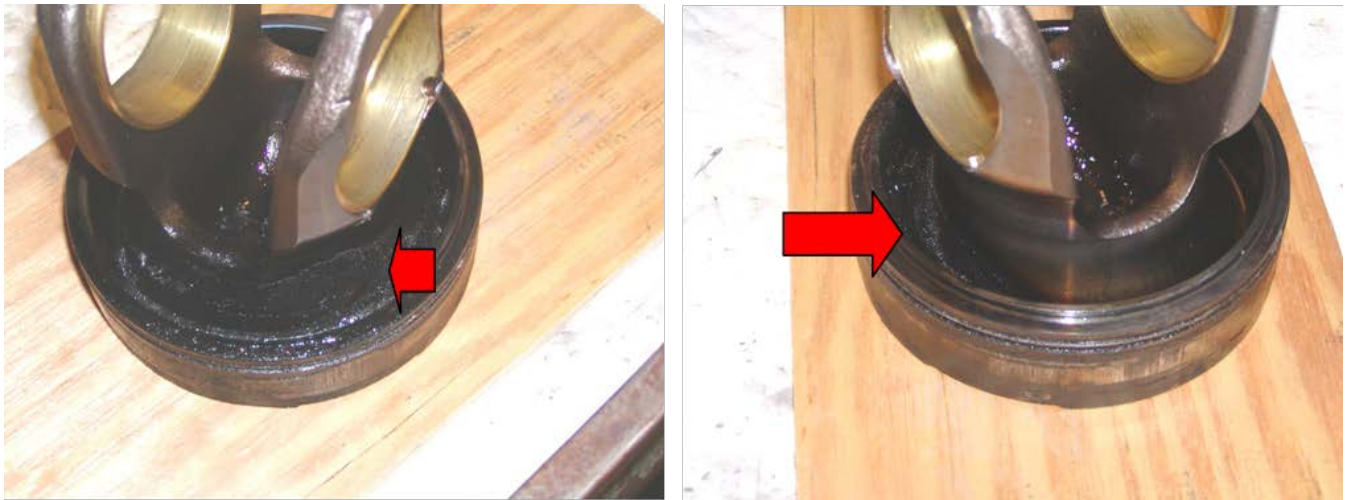
Pictures of underside of piston crown show heavy deposits of burnt oil.

The above pictures indicate the root cause of failure to be extreme overheating of the piston crown. This caused the over expansion of the crown and skirt and heavy scoring of the cylinder kit. This type of single cylinder failure is usually caused by a damaged or plugged piston cooler.

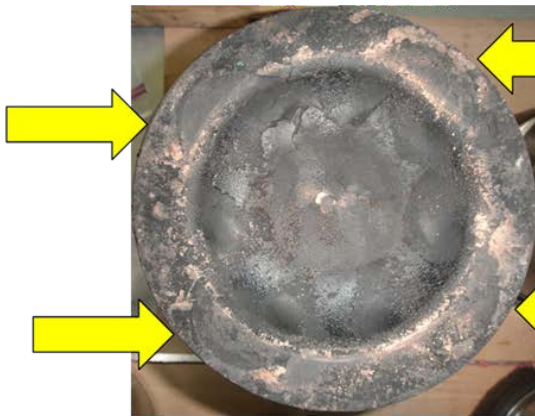
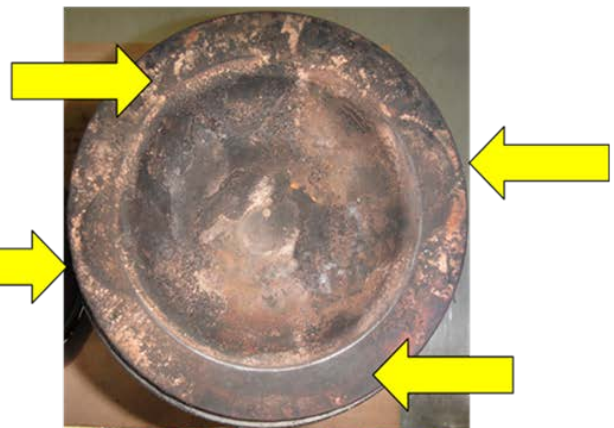
The first two pictures show two piston crowns that have heavy deposits of carbon; with impressions of the valves are in the carbon buildup.

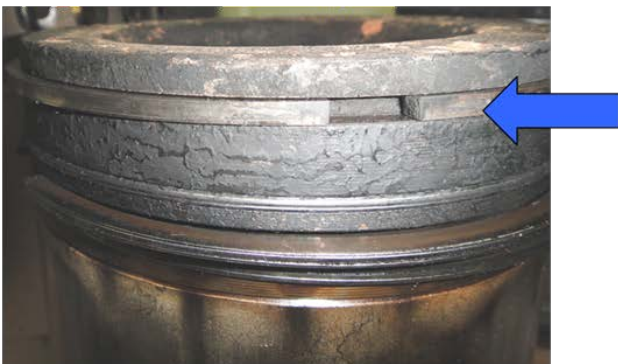
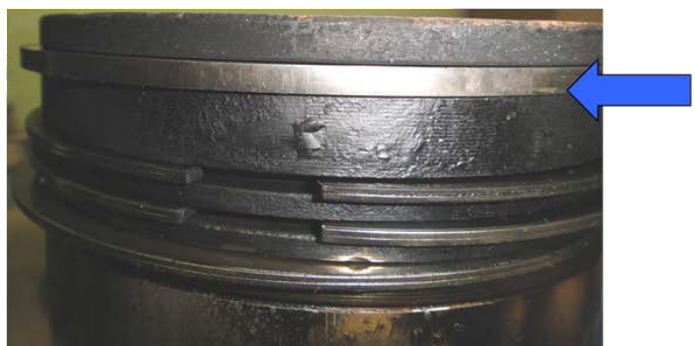
The next two pictures show the effects of carbon cutting and blow by on the compression rings.

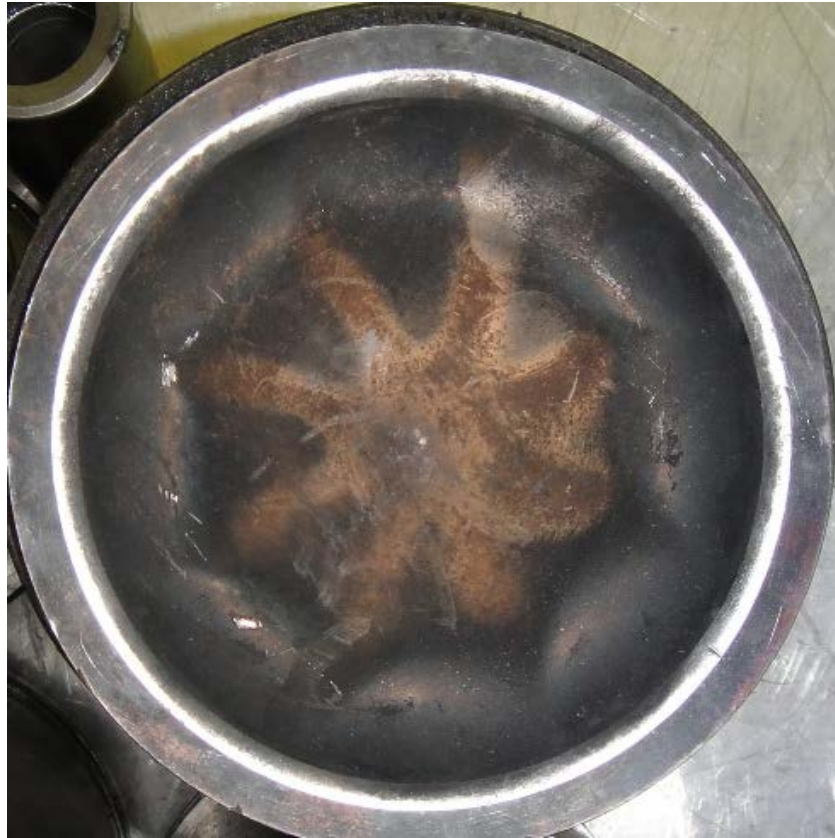
The following is an example of an uneven fuel injector spray pattern.

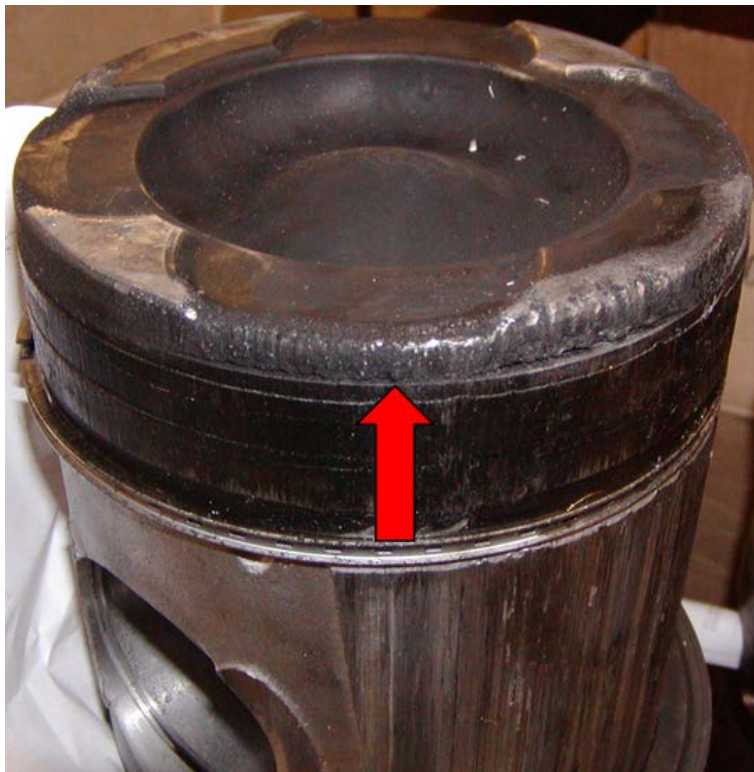
This picture shows crown edge breakdown caused by fuel injector spray outside of bowl. This is caused by a bad spray pattern or a timing error.

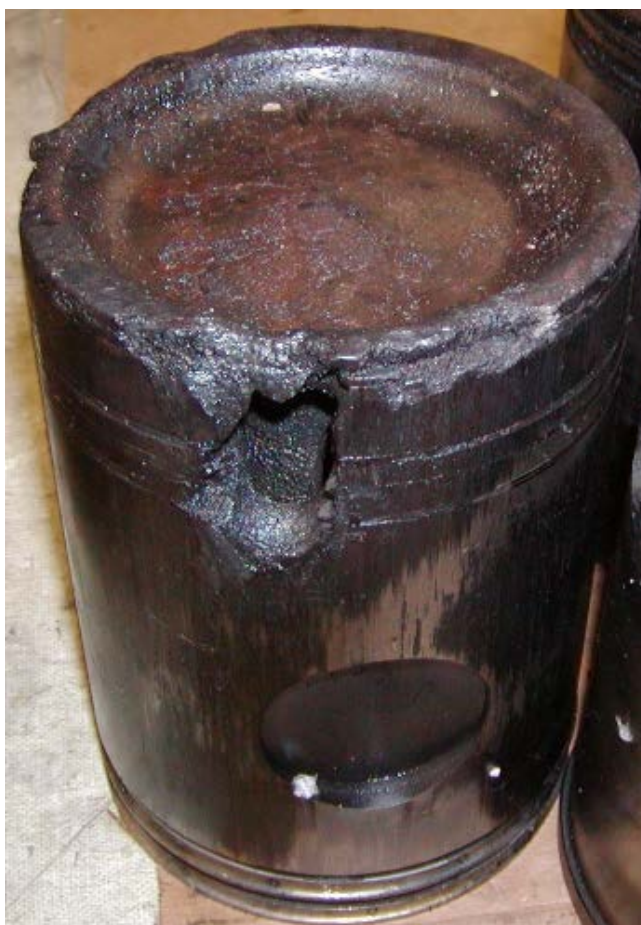
This piston failed due to a bad injector tip spraying fuel out of the combustion bowl and between crown and liner creating a hot spot that burned through the piston.

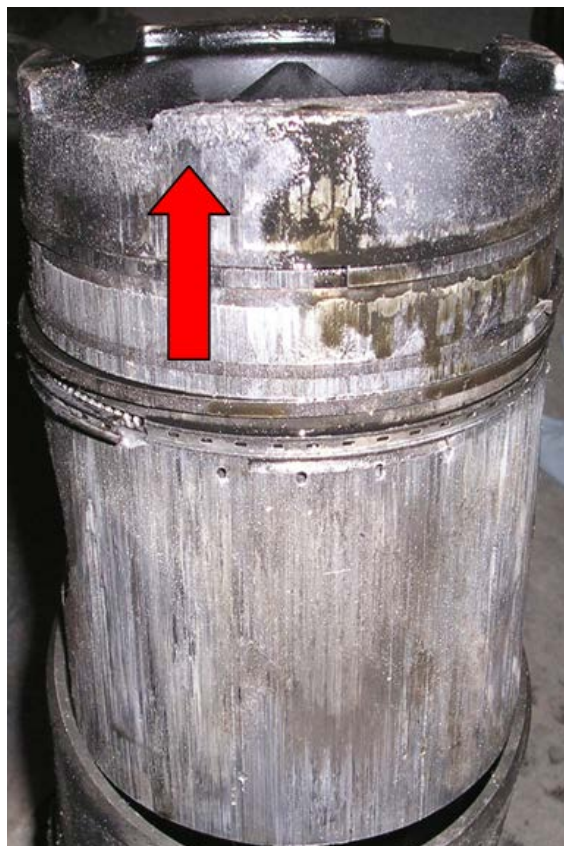
Piston below shows edge nibbling from a faulty injector spray pattern.
