# INTERSTATE-McBEE

## FAILURE ANALYSIS GUIDE

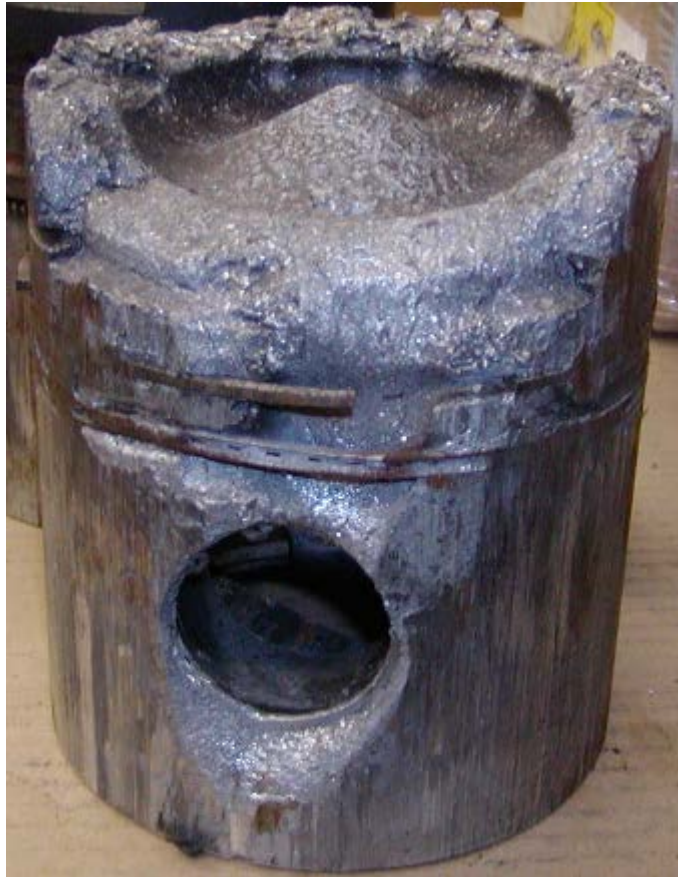
More extreme damage due to fuel injector failure

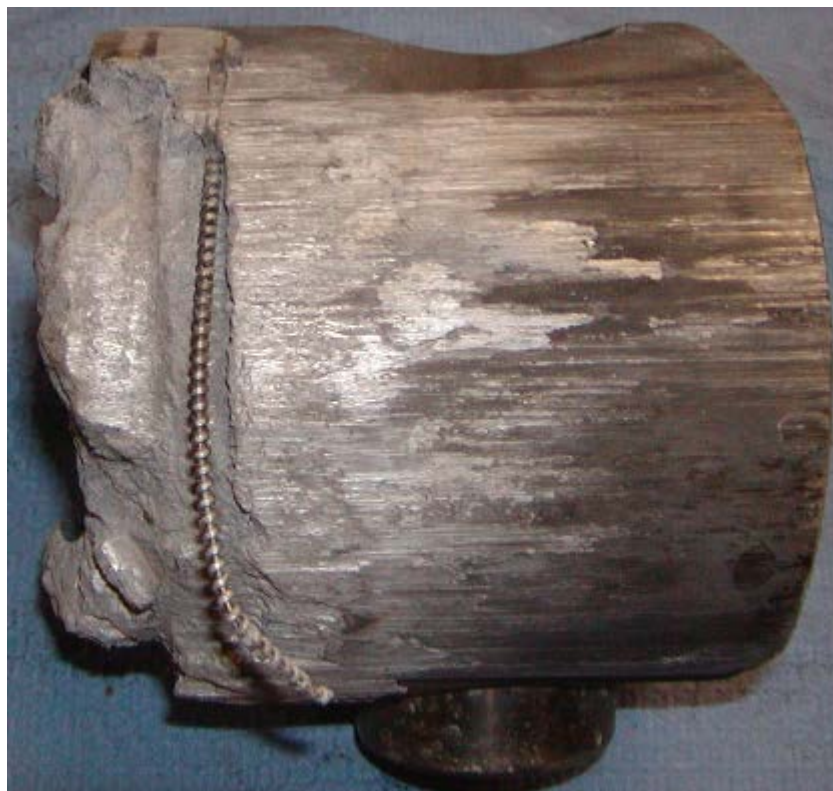
Final example of fuel caused failure.

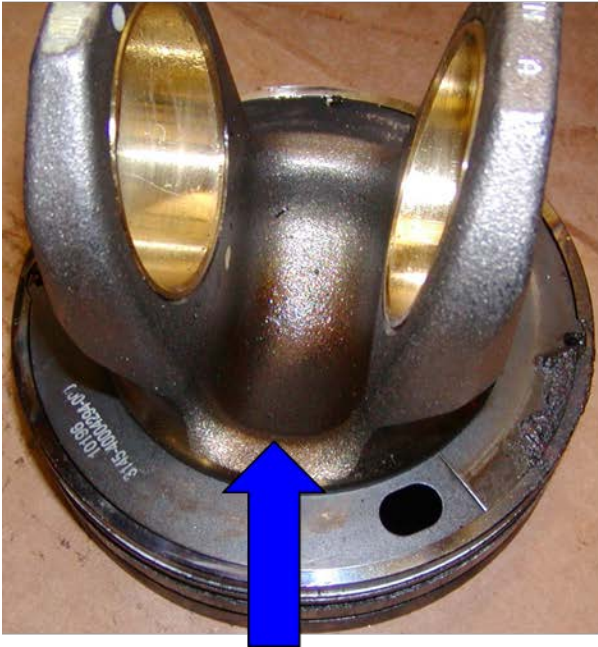
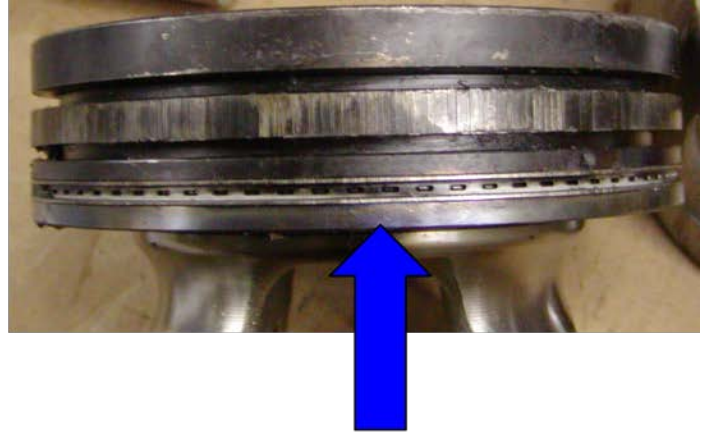
The following pictures show the piston crown burnt on underside and blue in color from severe overheating. The cylinder kit failed due to overheating. A spray pattern could not be detected on the crown. The piston pin and bearing appear to have normal wear, however the underside of the crown is burnt and the piston began to turn blue. This by itself would indicate low oil pressure. Another area that could cause overheating would be a timing issue. Valve marks on the crown of the piston indicate the root cause of this failure, incorrect timing.

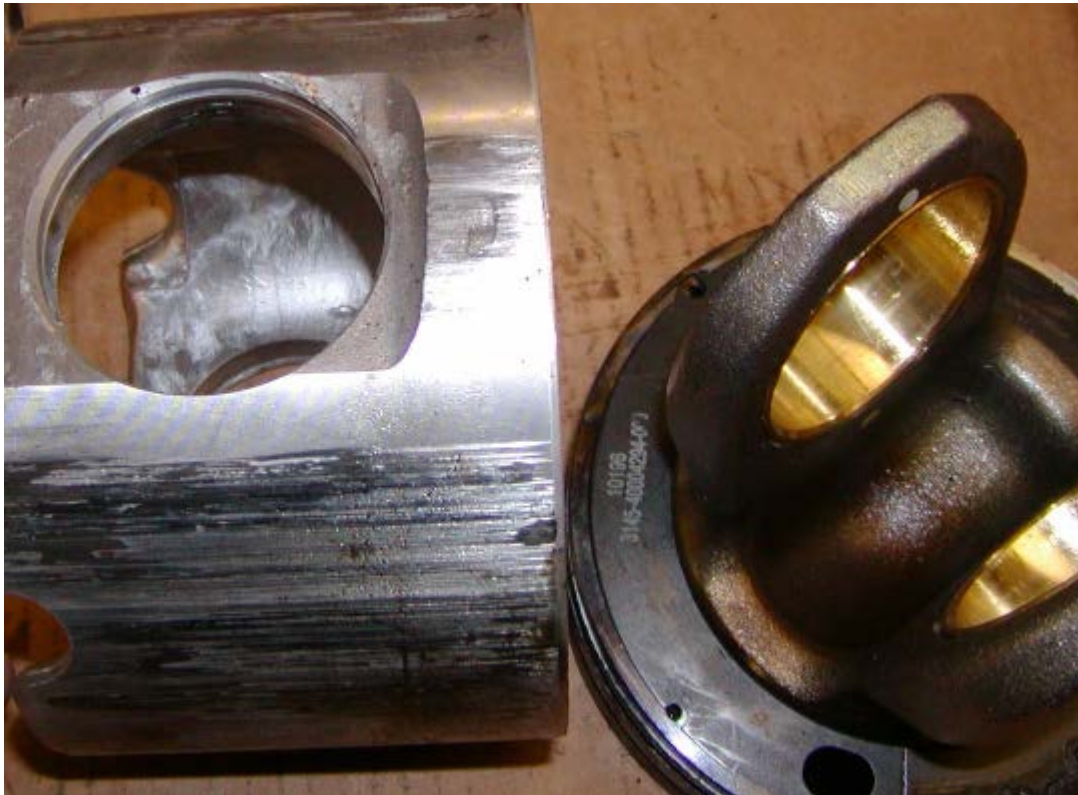
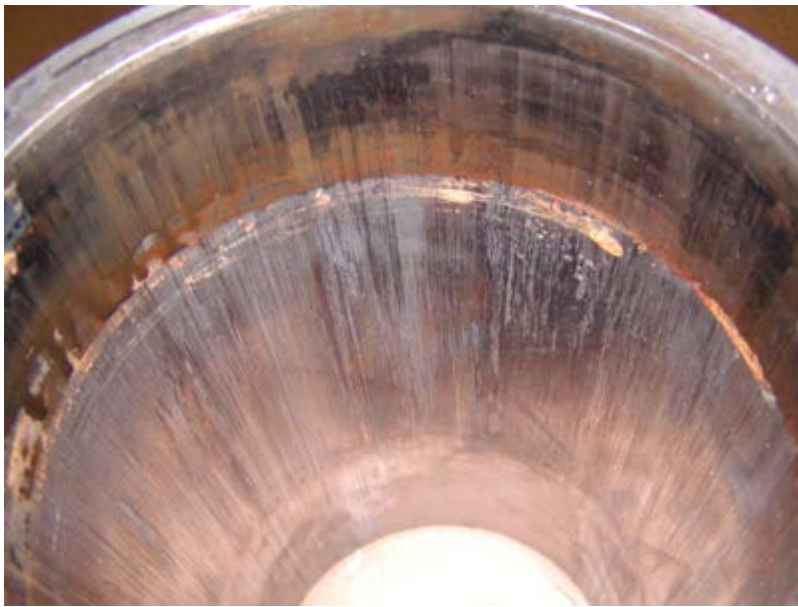
The next pictures show the piston skirt and liner scored from abnormal expansion.

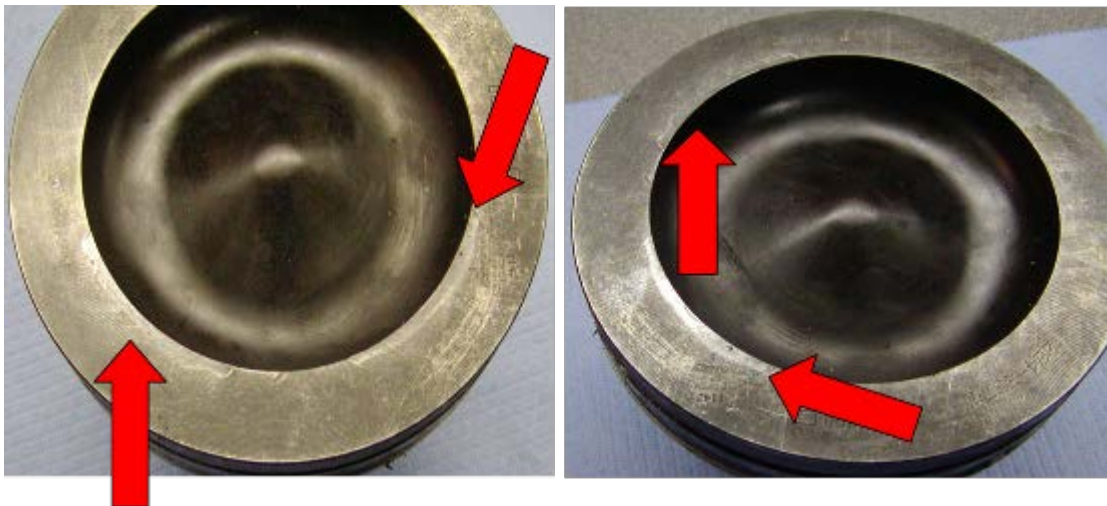
The final pictures will show valve contact marks on the crown of the piston.

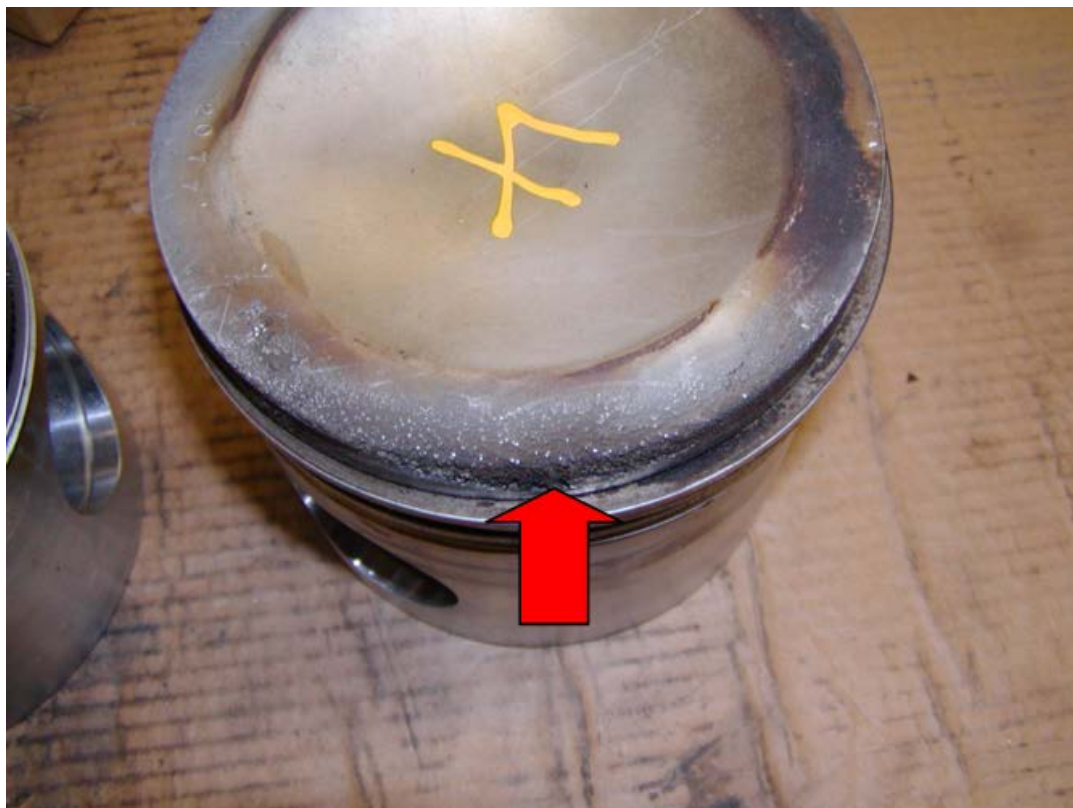
The picture below shows the piston crowns starting to melt from overheating.

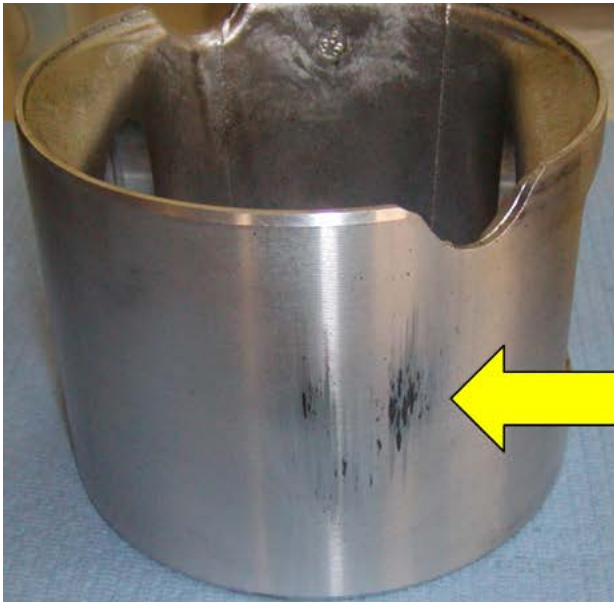
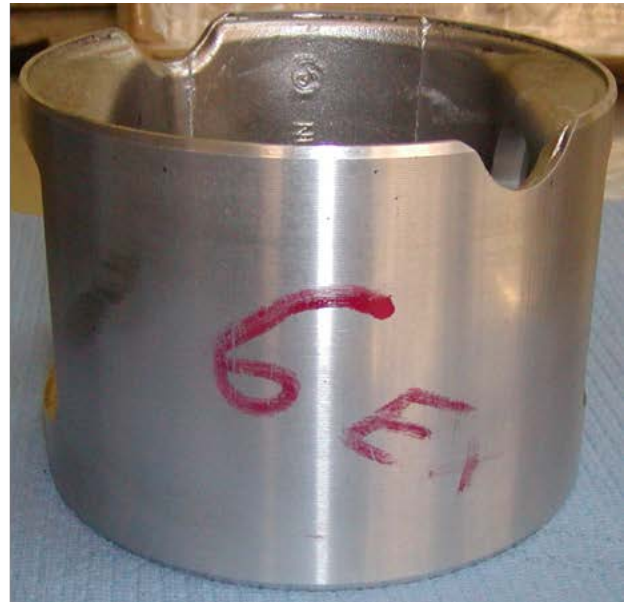
The following pictures show scuffing on piston skirts. The first two pictures show light scuffing on the major thrust side of the skirt and only a few scratches on the minor side.

Conclusion: Both failures are caused by overhear. The most likely cause of the scuffing is low coolant.

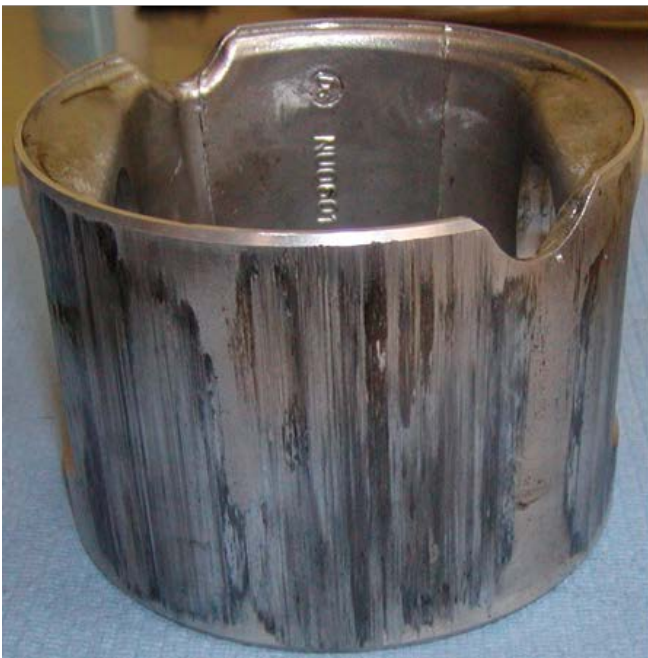
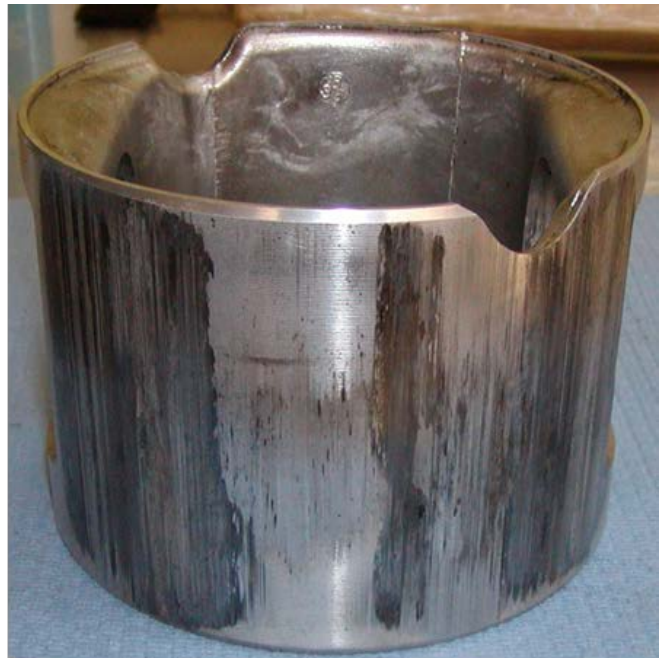
The next picture shows both sides of the piston showing heavy scuffing.

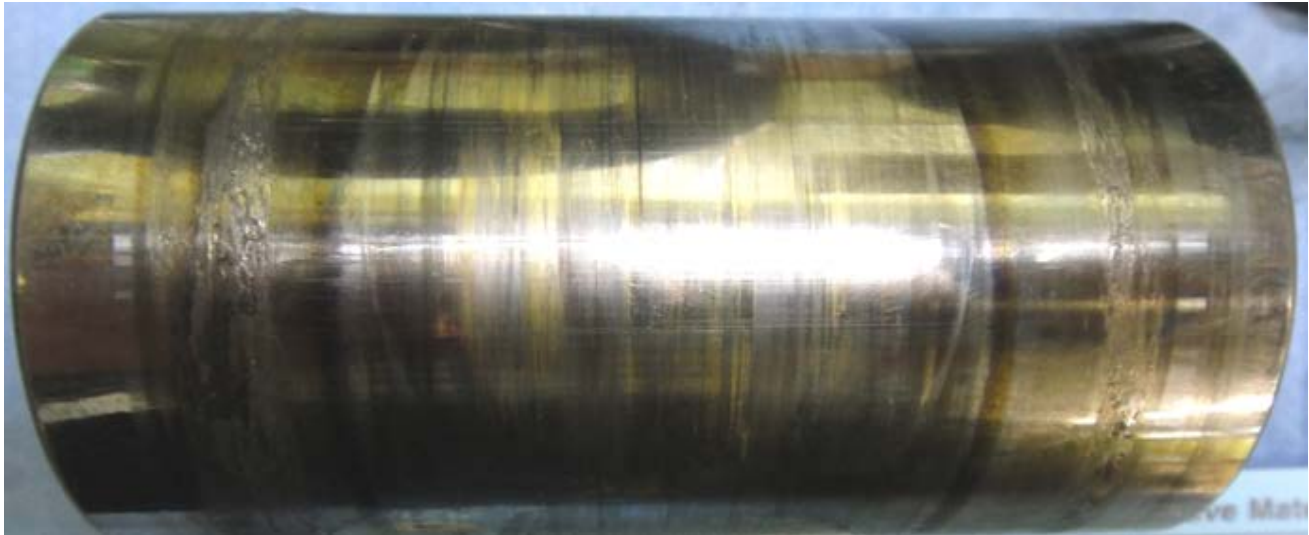
Lack of proper lubrication is cause of the galled and worn piston pin.

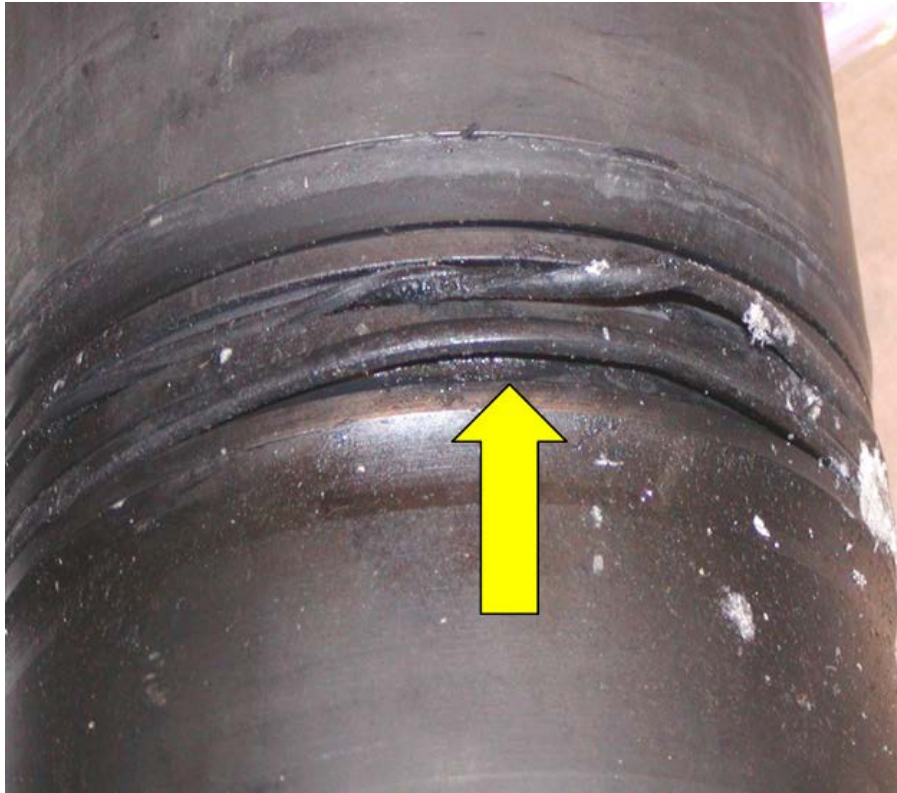
The picture shows one of the liner o-rings that twisted during assembly in engine.

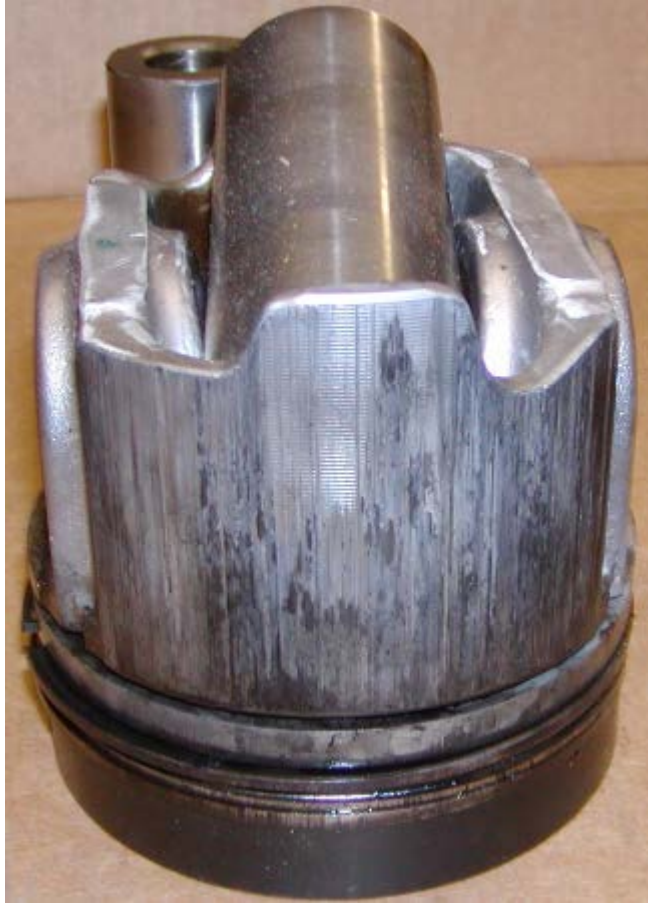
The final result of the twisted o-ring

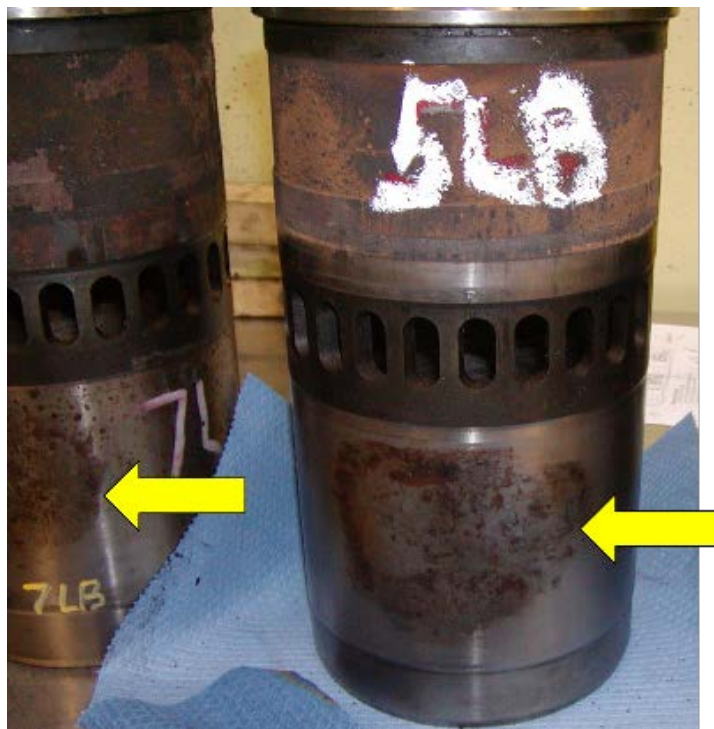
The first picture is of two liners from a 16V149 Detroit Diesel marine engine. Note the presence of heat spots on the lower area of the liners as pointed out with the yellow arrows.

Heat spots occur when there is excessive clearance between the liner and the block. This area will have very poor heat transfer and will allow for liner movement and distortion. This can cause the liner to crack in the port area or other locations on the liner where stress loads exceed design strength.

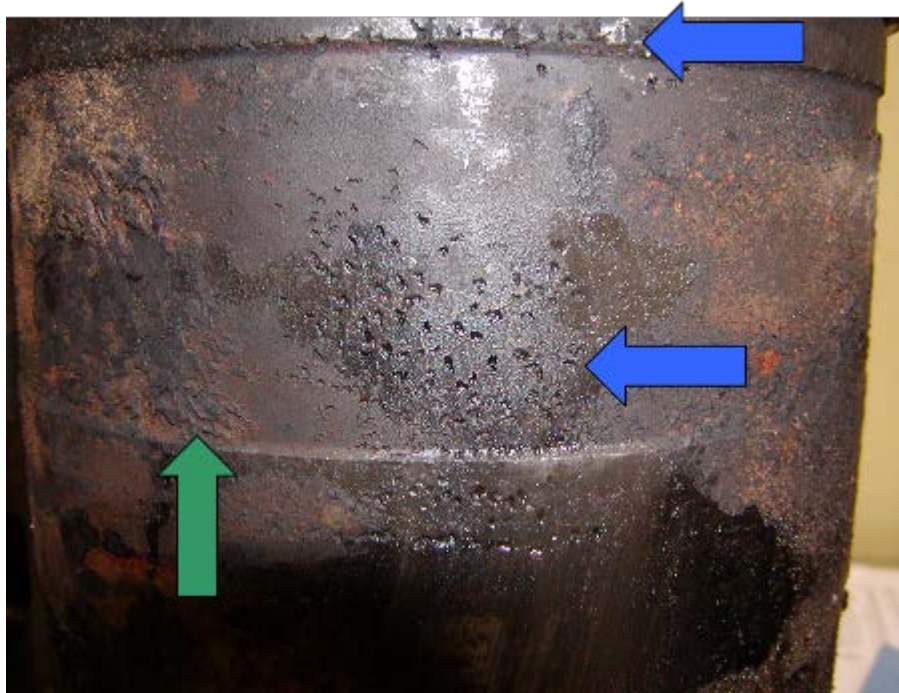
The next picture shows the pitting (blue arrow) and scale build up (green arrow) on one of the liners.

Pitting and scale build up is a clear indication the cooling system has not been maintained and no additives or corrosion inhibitors were used. Scale build up will affect heat transfer and cause higher than normal cylinder temperatures potentially leading to scoring and premature failure of cylinder components. The pitting can and will cause stress risers to develop in the liner potentially leading to cracks and premature liner failure.

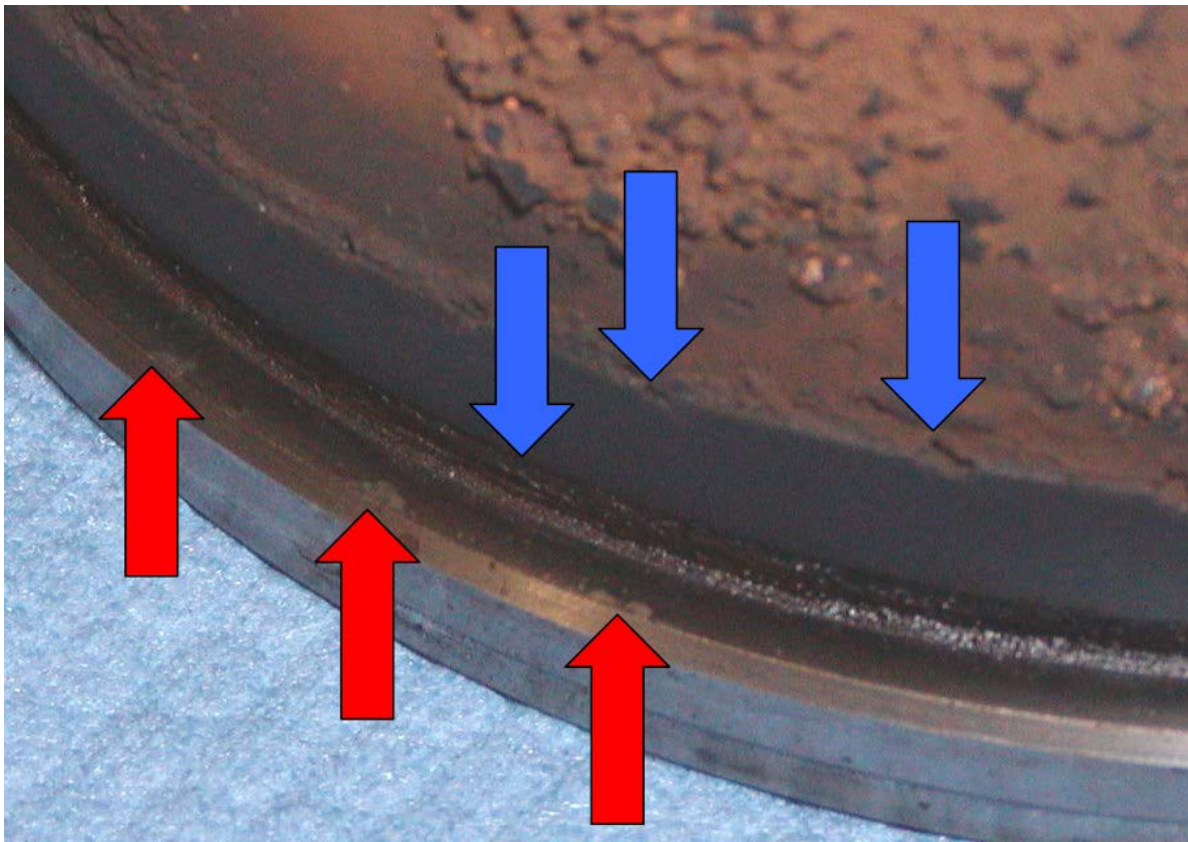
The next picture shows the underside of the liner flange in front of the fractured area of #5 left bank liner. Note the pits (blue arrow) and the four clean marks indicating foreign material was trapped between the flange and the block (red arrows).

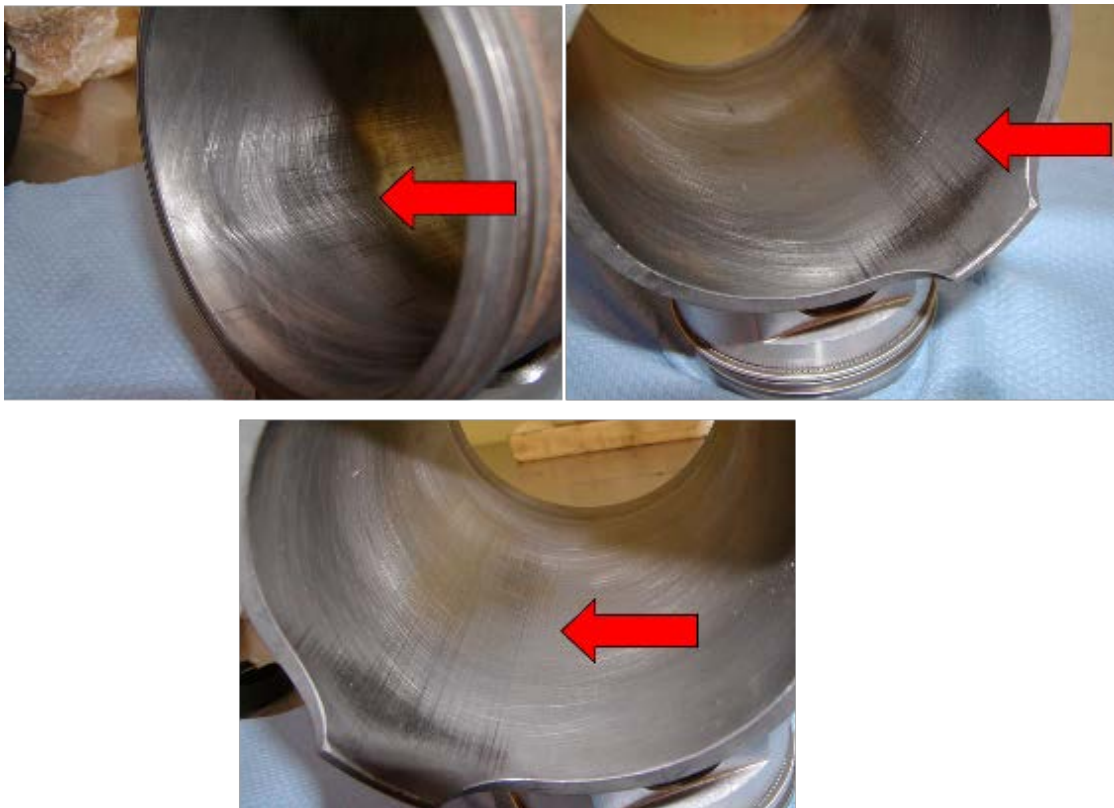
More pictures of foreign material scoring.

The root cause of failure was caused by foreign material contamination due to poor assembly practices and procedures. The contamination caused blow-by in the first set of rings was not corrected and caused the same failure condition in the second set of rings.

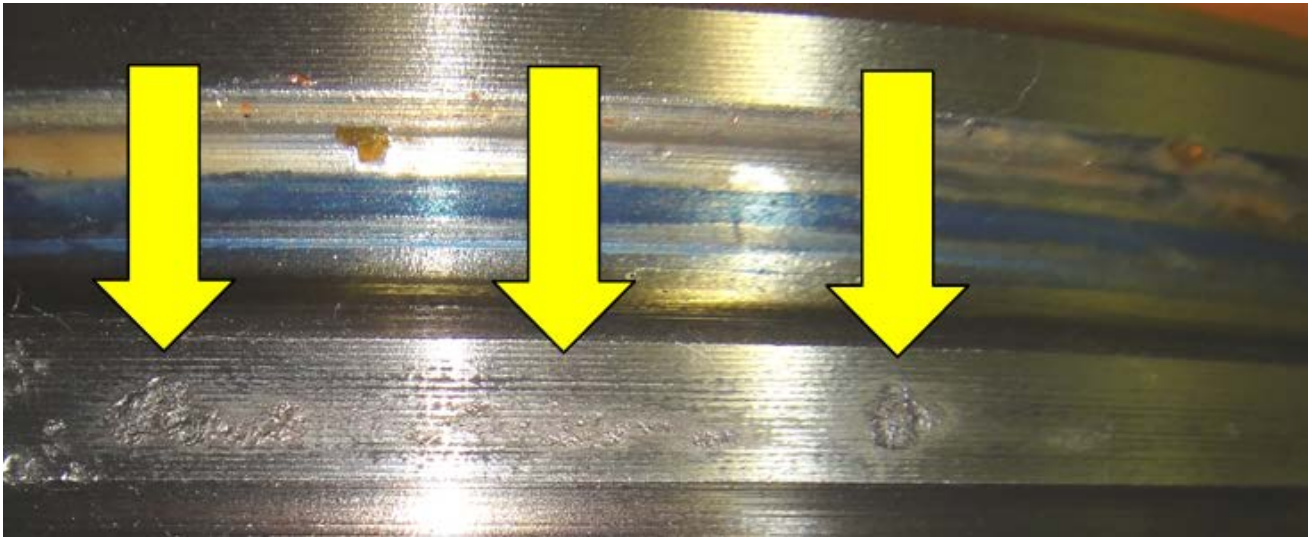
The lower part of the liner has fretting where it interfaces with the lower receiver bore in the block. Lack of support allowed the liner to move, eventually causing the liner flange to fracture.

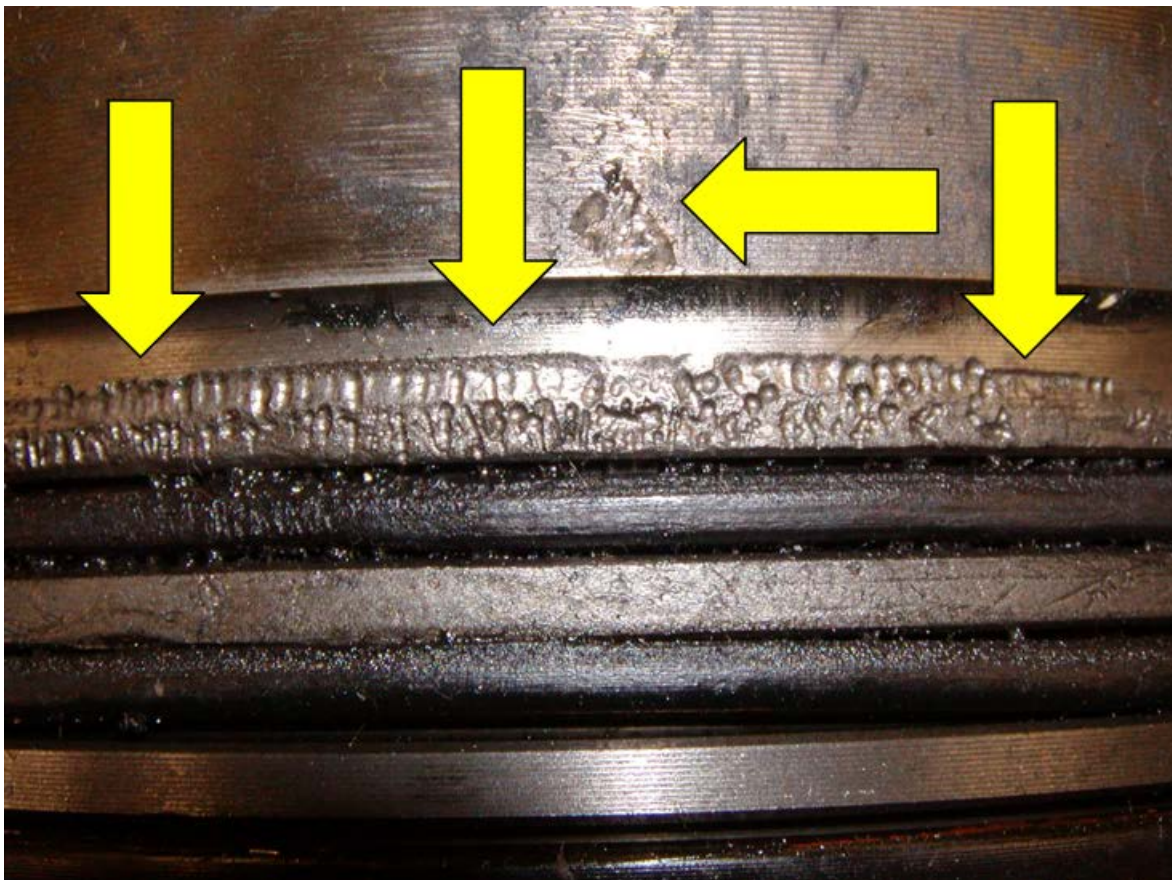
An example of severe fretting on the lower part of the liner

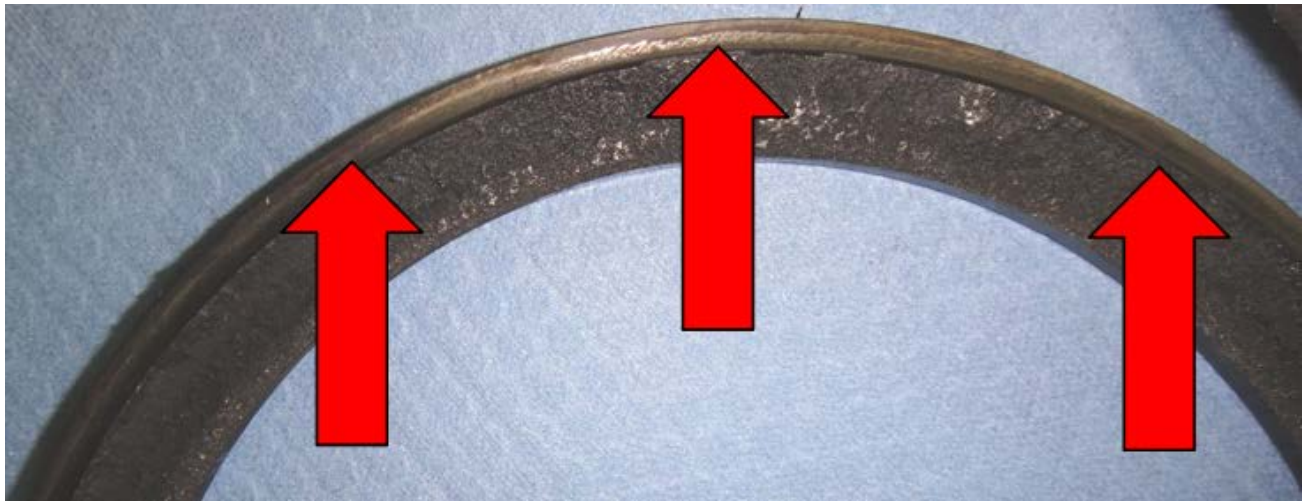
Liner flange failure caused by uneven mounting surface.

The flange is intact and has broken free of the liner. The under side of flange displays an uneven contact pattern. The un-even wear pattern on the under side of the flange indicates mating block surface is worn and caused the failure.

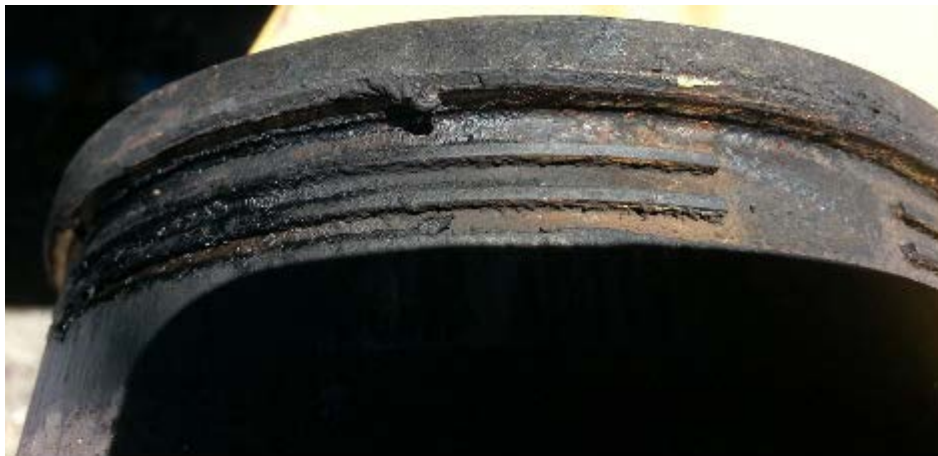
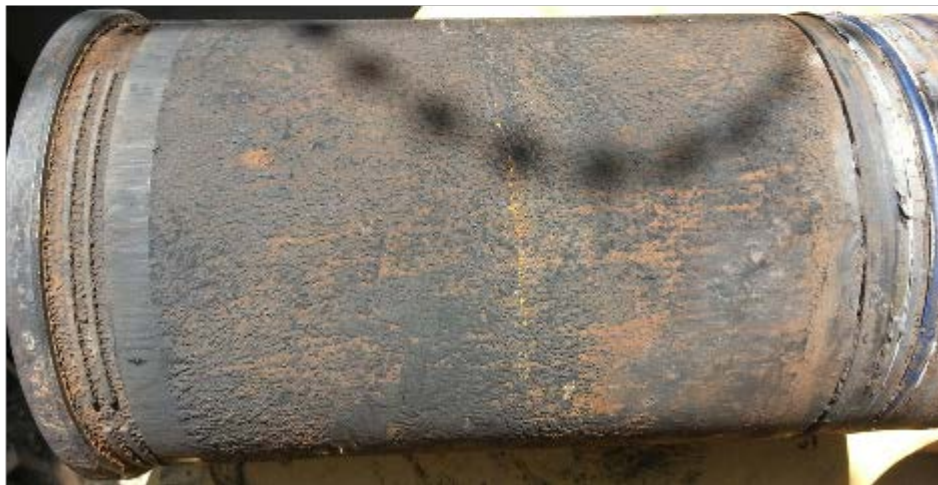
The liners in this engine failed within 800 miles. Improper cooling system maintenance is the root cause of failure. Cooling system corrosion inhibitors are needed in all situations even if antifreeze is installed. This liner was subjected to plain water with an extremely high mineral content.

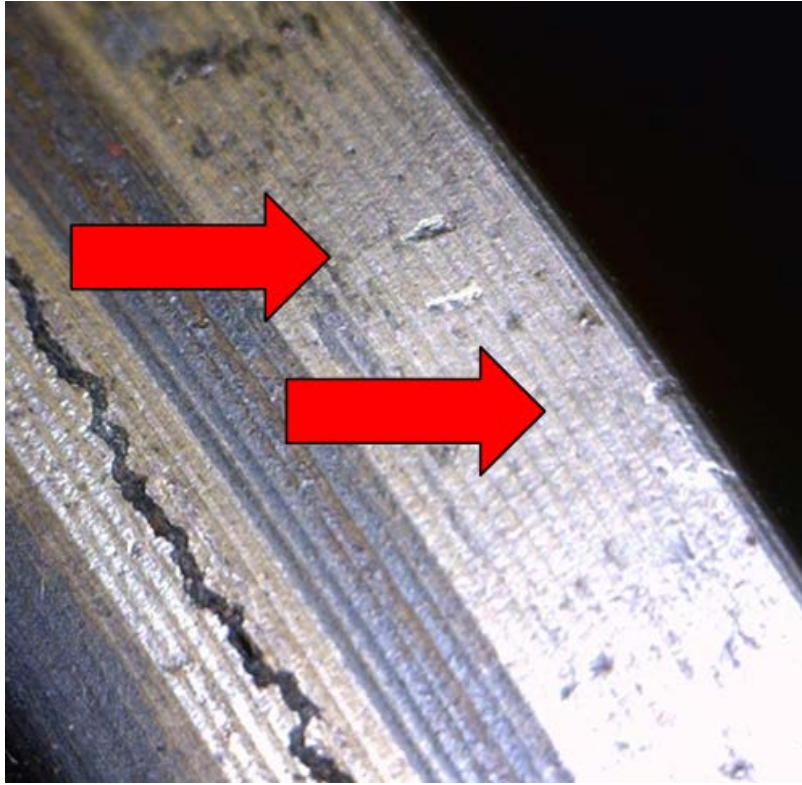
The impressions on the liner flange are from trapped foreign material between the liner flange and the cylinder head.

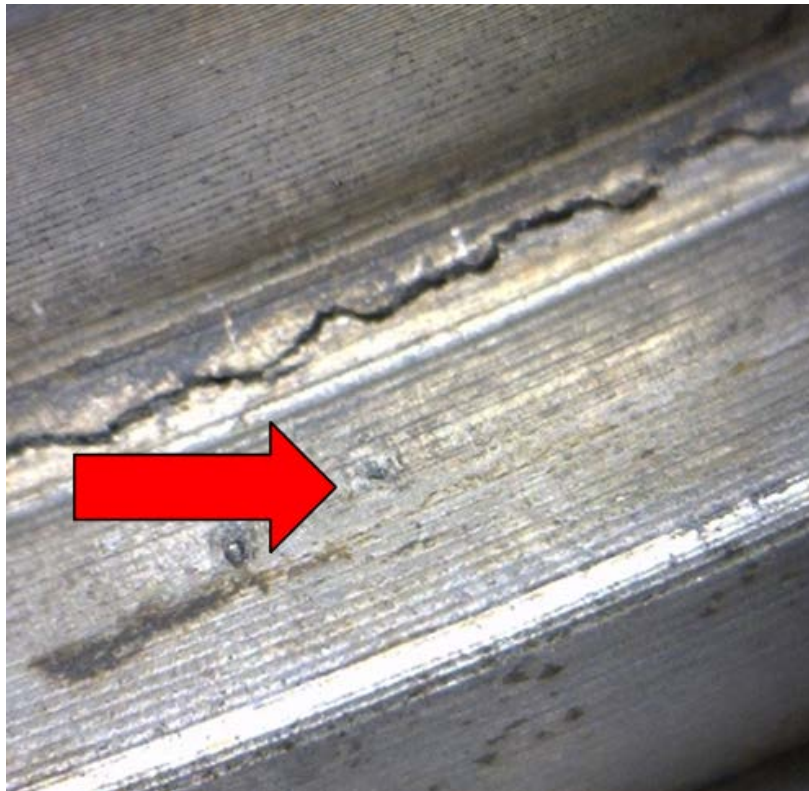
Foreign material trapped between the liner flange and the block surface.

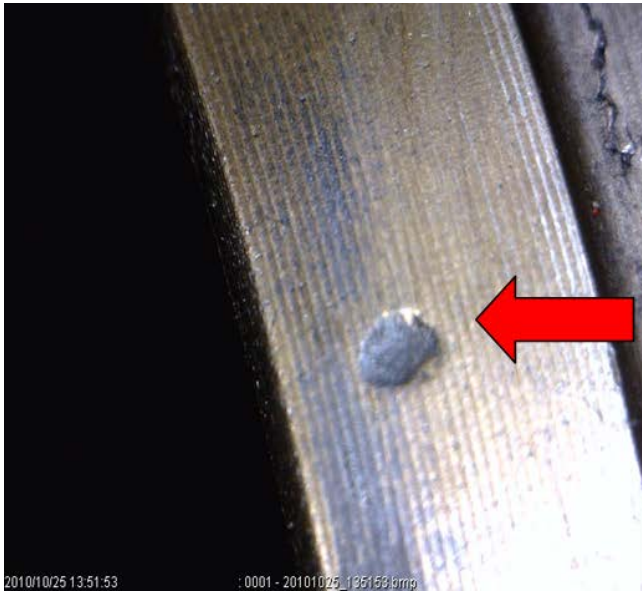
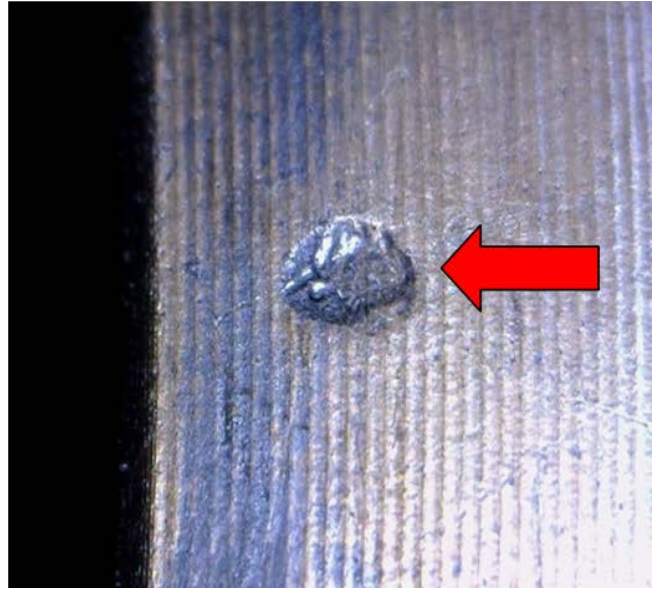
The impressions on the liner flange are from trapped foreign material between the liner flange and the cylinder head.

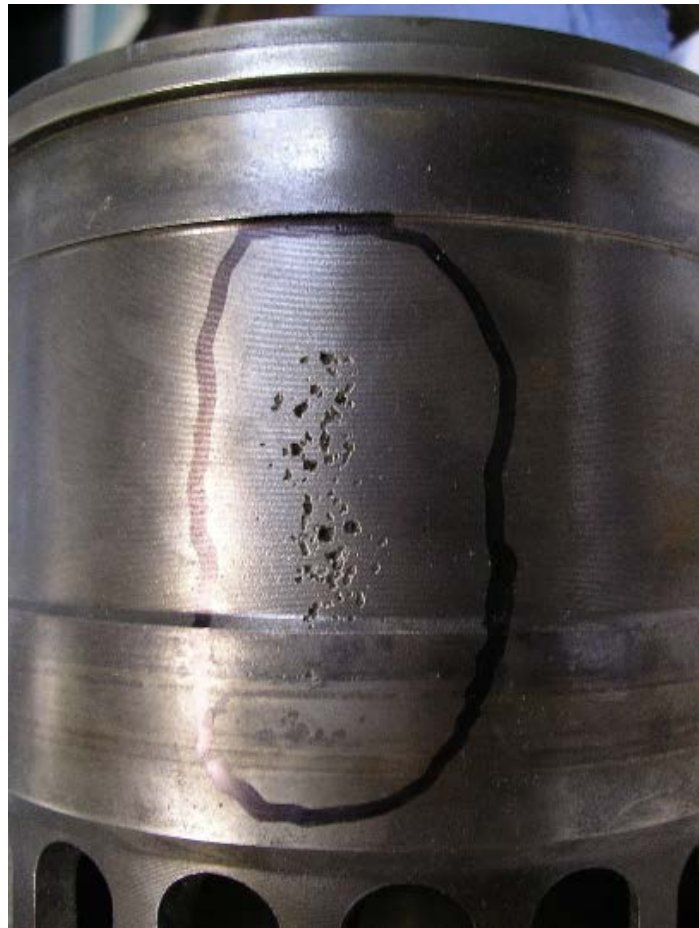
The pitting caused coolant to leak into the cylinder.

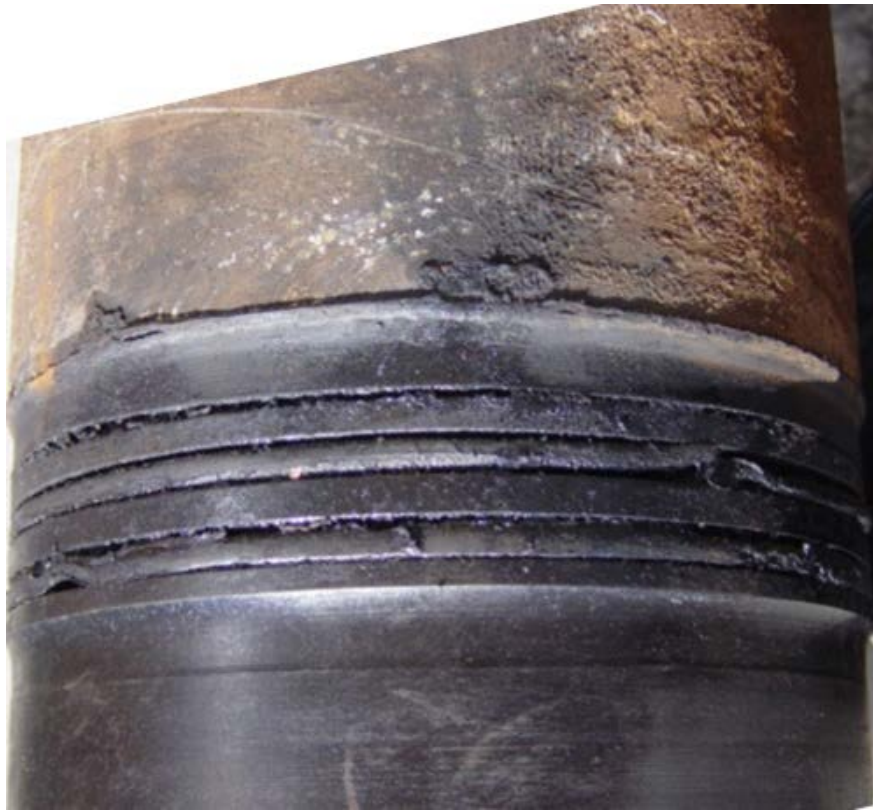
Corrosion shortens engine life and damages cooling system components. The complaint sent in with this liner was leaking liner seals.

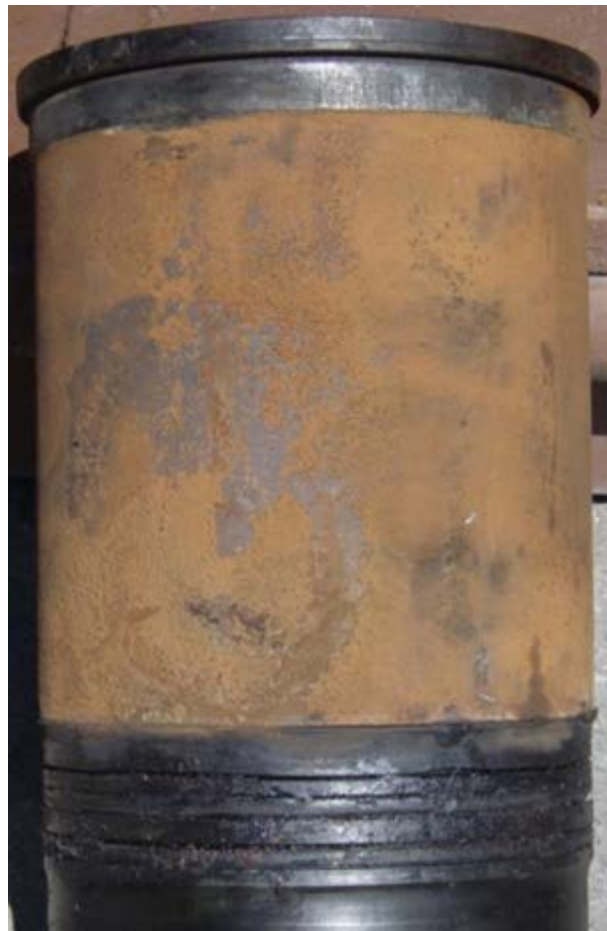
Rust causes poor heat transfer and engine overheat.

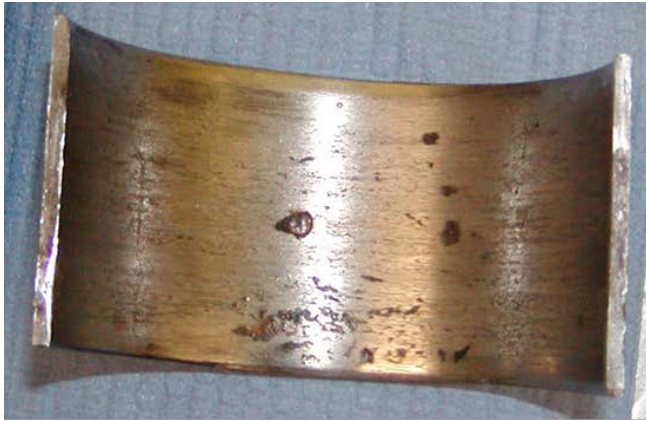
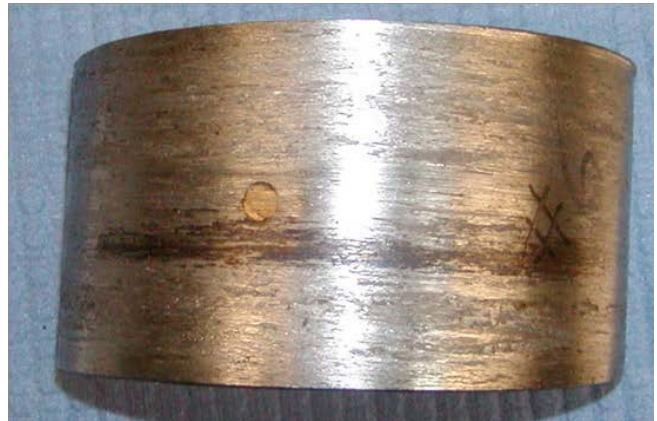
The first two pictures show the spun connecting rod bearings.

The connecting rod was not up dated at time of overhaul to the recommended drilled rod. The rod bearing failure was caused by lack of proper lubrication.

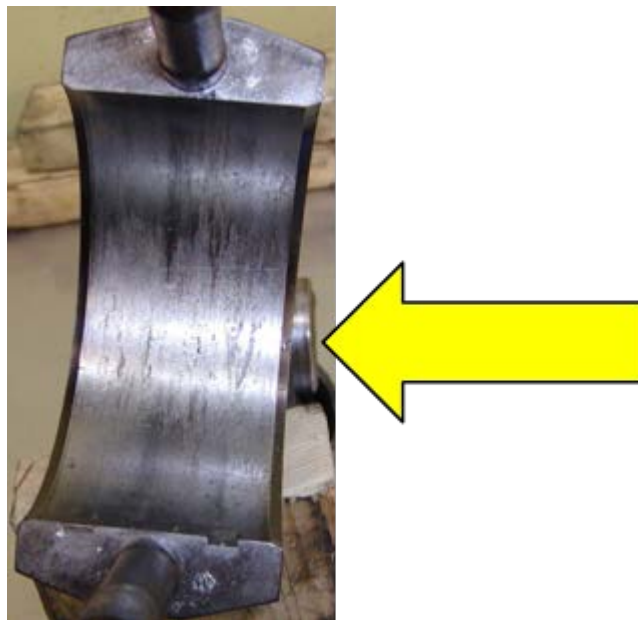
The next picture shows the lower part of the connecting rod that holds the rod bearing. Note the rod is not drilled for an oil feed hole to the piston pin.

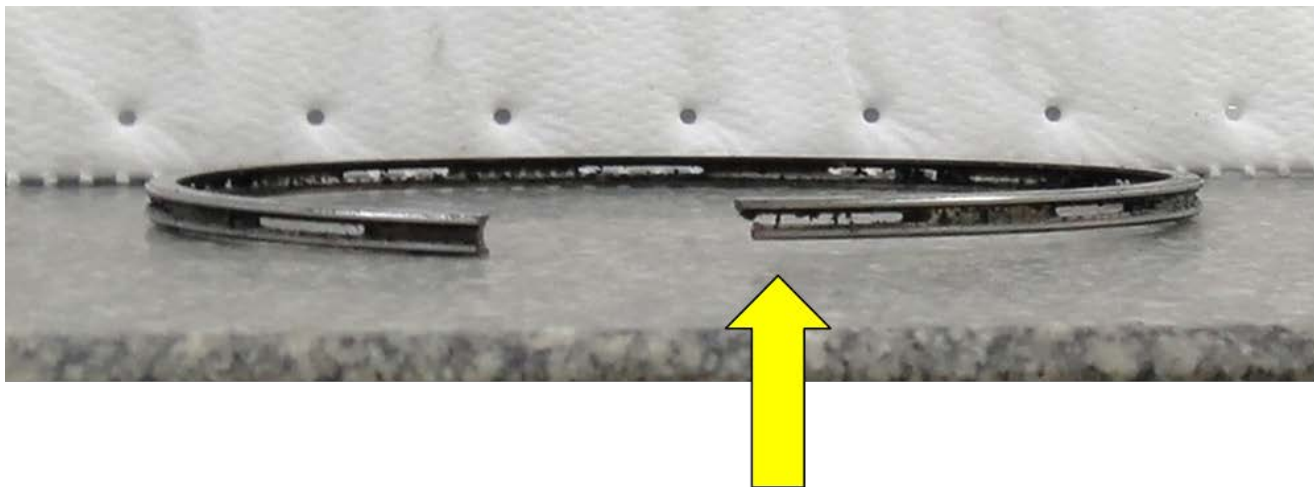
The following picture shows the broken oil control ring positioned on a granite flat surface. Note the upward bend on the broken side of the ring.

The cause of failure would be the ring not being sufficiently compressed and was damaged during installation.

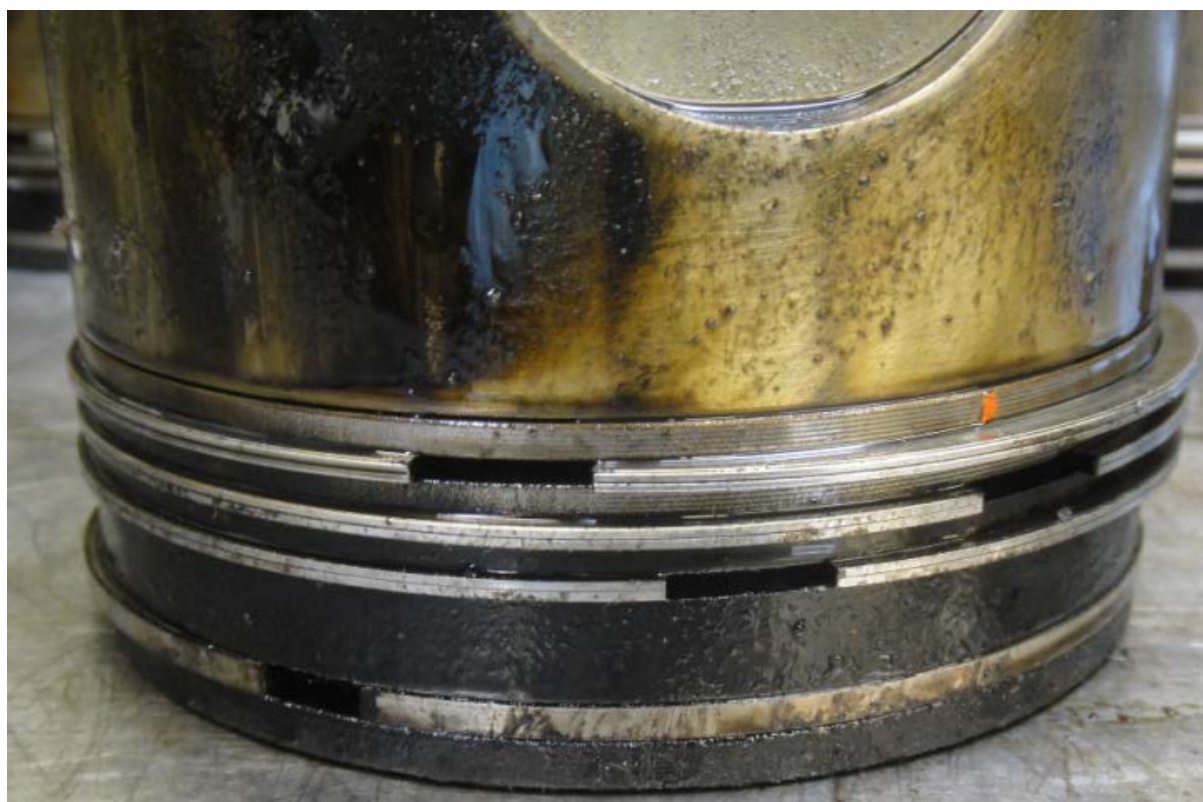
Rings not installed correctly allow a combustion path to the crankcase causing high crankcase pressure "blow by" and loss of power.
