# INTERSTATE-McBEE

## FAILURE ANALYSIS GUIDE

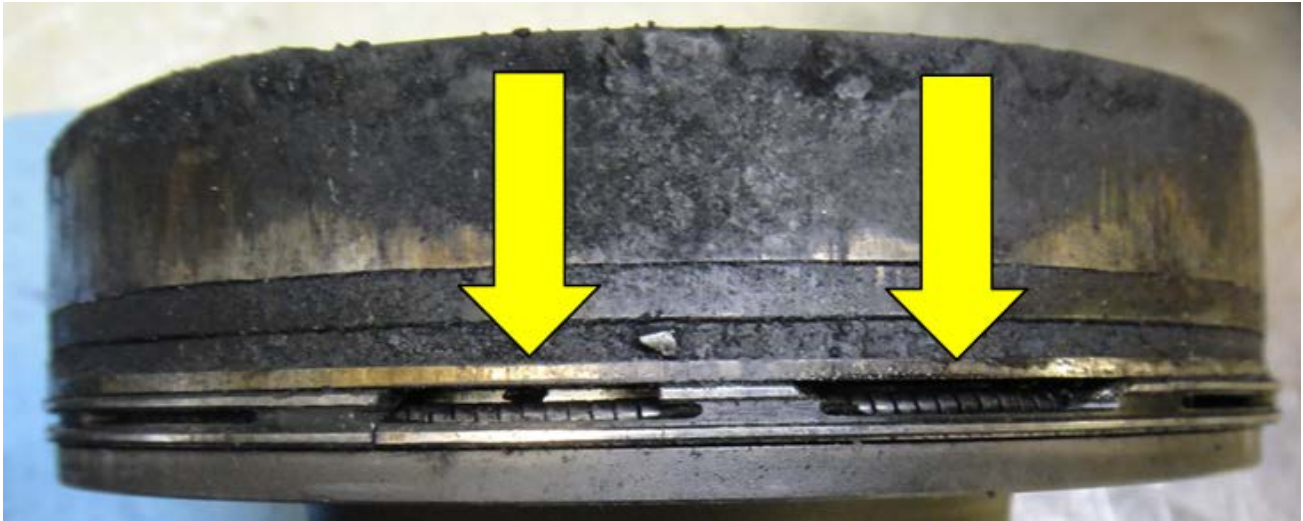
### **C. High oil consumption caused by broken oil control ring**

The picture shows the oil control ring broken in several areas (yellow arrow). The most likely cause of failure would be the ring was damaged during installation.

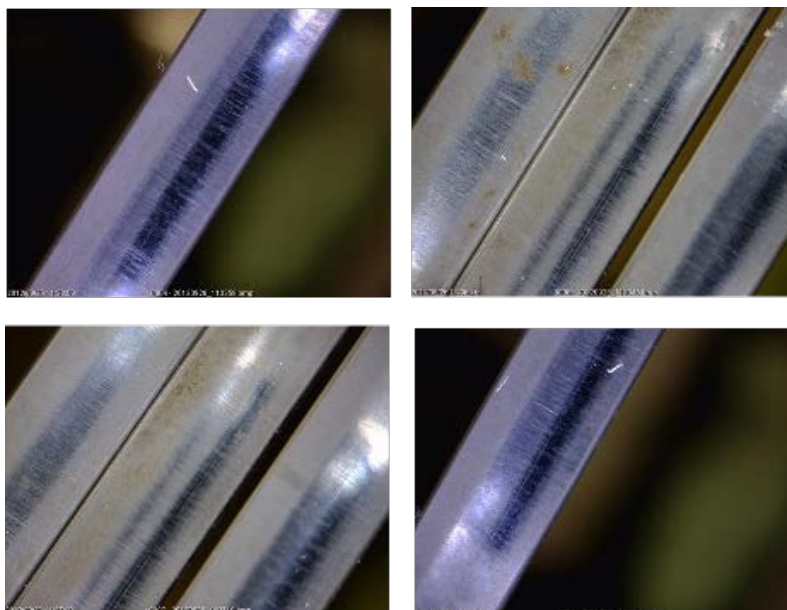
### **D. Ring failure caused by abrasive contamination**

Observations-4 ring sets were examined for possible cause of excessive oil consumption. The top compression ring and intermediate rings were examined under magnification. During the inspection process, noticeable vertical scratching of the ring faces was found. Scratching of the ring faces will cause incomplete sealing of the power cylinder and can cause excessive oil consumption.

Possible causes of this type of condition:

- 1) Leaks in the air intake system.
- 2) Abrasives in the engine oil.
- 3) Poor cleanliness during assembly.

No manufacturer defects were observed in the inspection process.

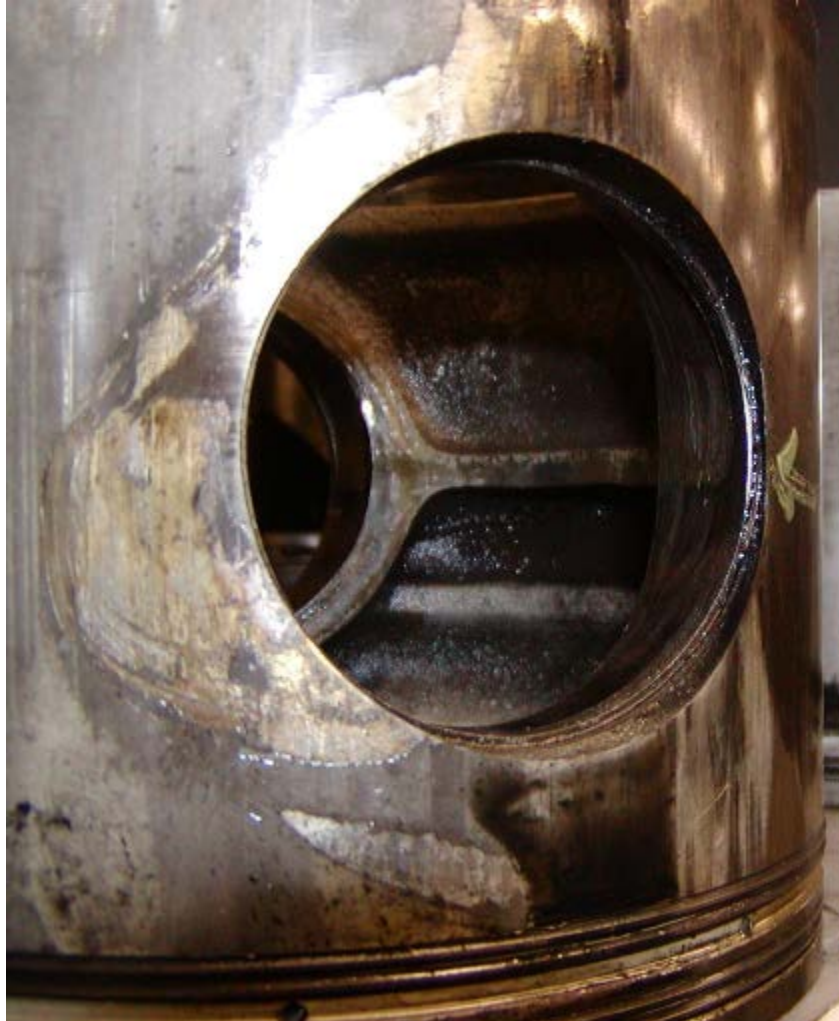
### A. Piston pin retainer improperly installed

The pin retainer came loose and severely damaging cylinder kit.

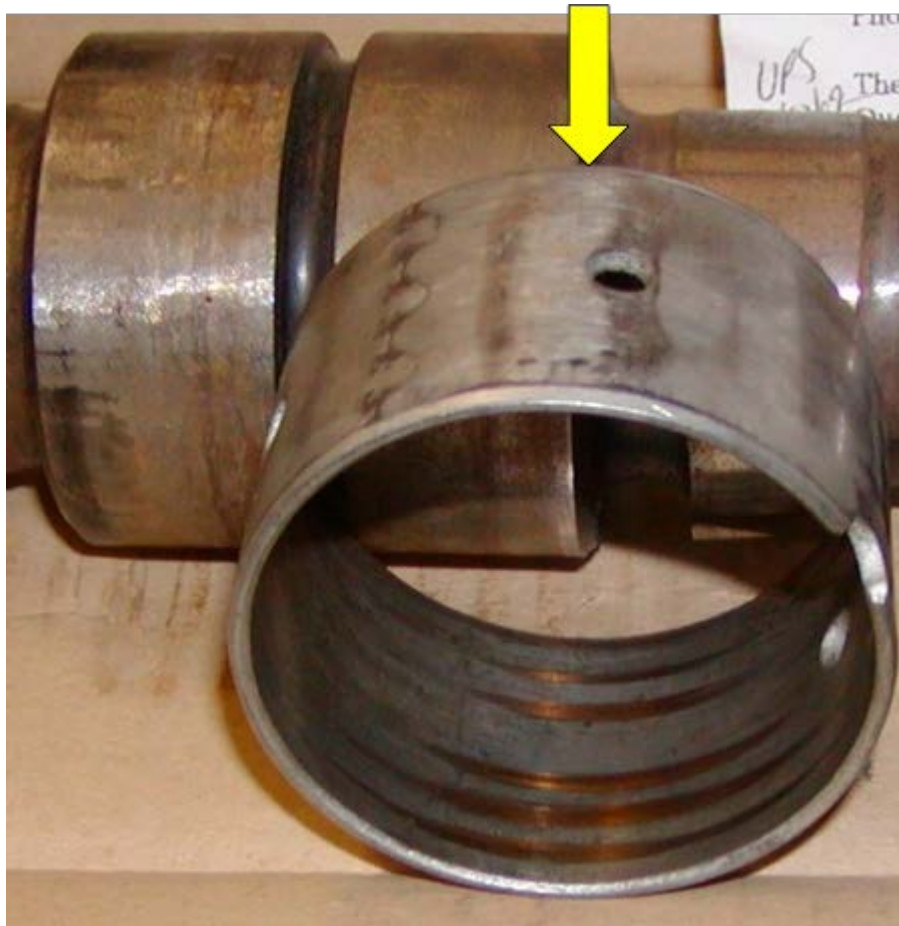
### A. Camshaft bearing journal wear caused by uneven bearing support

Bearings require the proper support, alignment and fit to function properly. The O.D. of the bearing below shows very little fitment marks to the block bearing bore (yellow arrow). The bearing was measured and found to be in specification on the O.D. and I.D. indicating the camshaft-bearing bore in the block was most likely oversize. The wear marks on the inside of the cam bearing further shows uneven wear most likely from distortion. Excessive clearances allow the camshaft to flex and do not allow for proper lubrication and support.

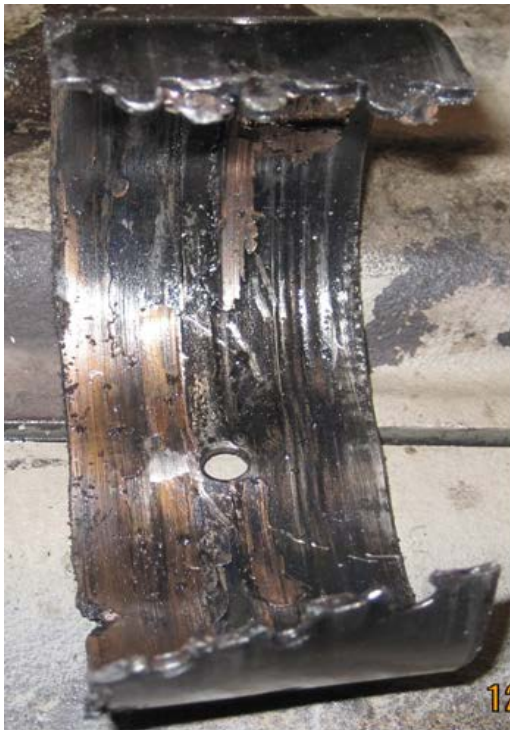
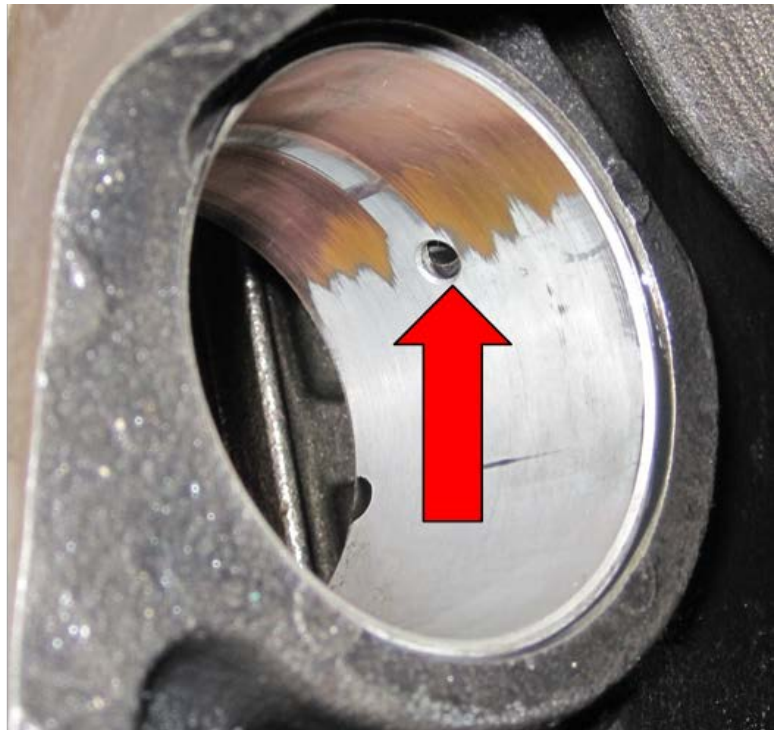
## B. Camshaft failure caused by improperly installed bushings

The picture shows a failed bearing due lack of proper lubrication. The bearing in the second picture has some premature wear, but note the arrow points to a partially covered oil hole.

The cause of the failure is improper installation of the cam bushings. The partially blocked oil holes do not allow for proper lubrication.

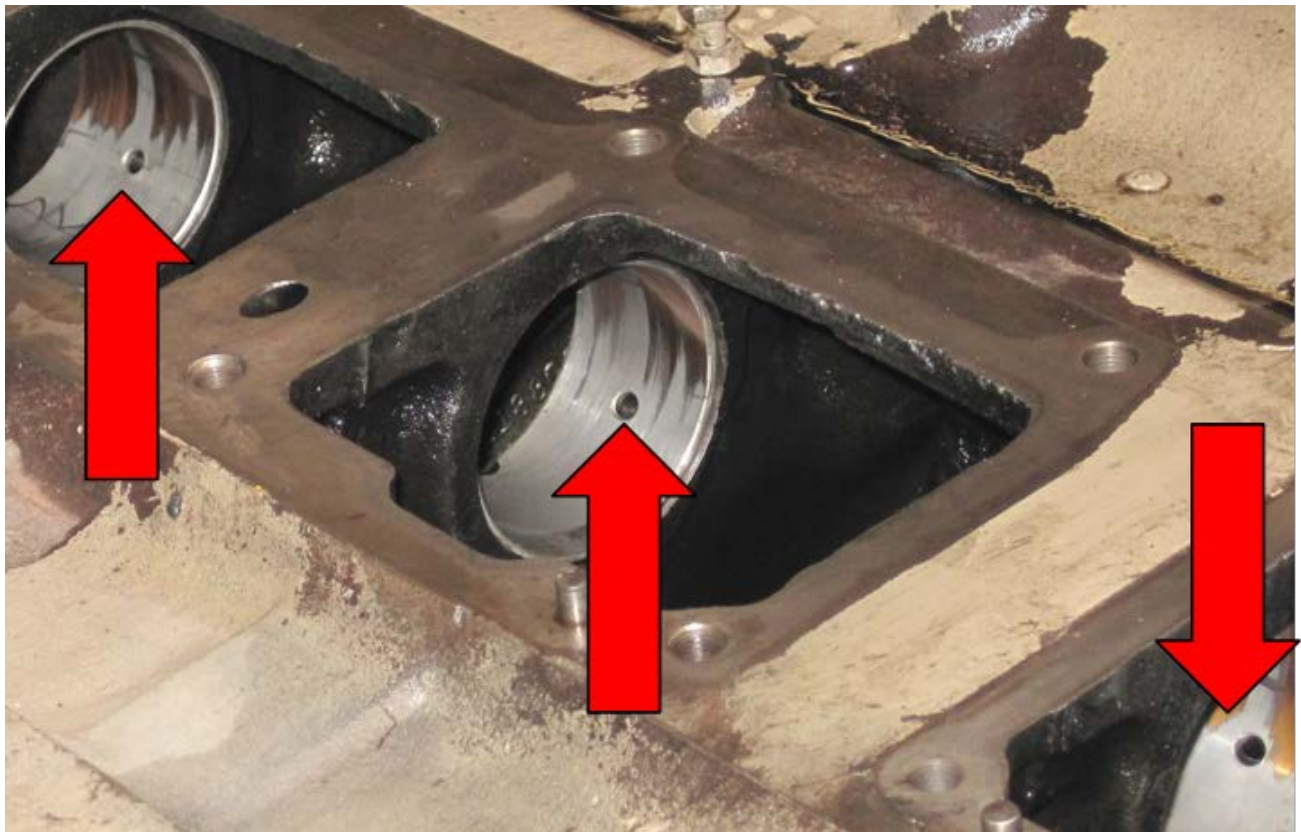
The next picture shows all the oil holes are partially blocked.

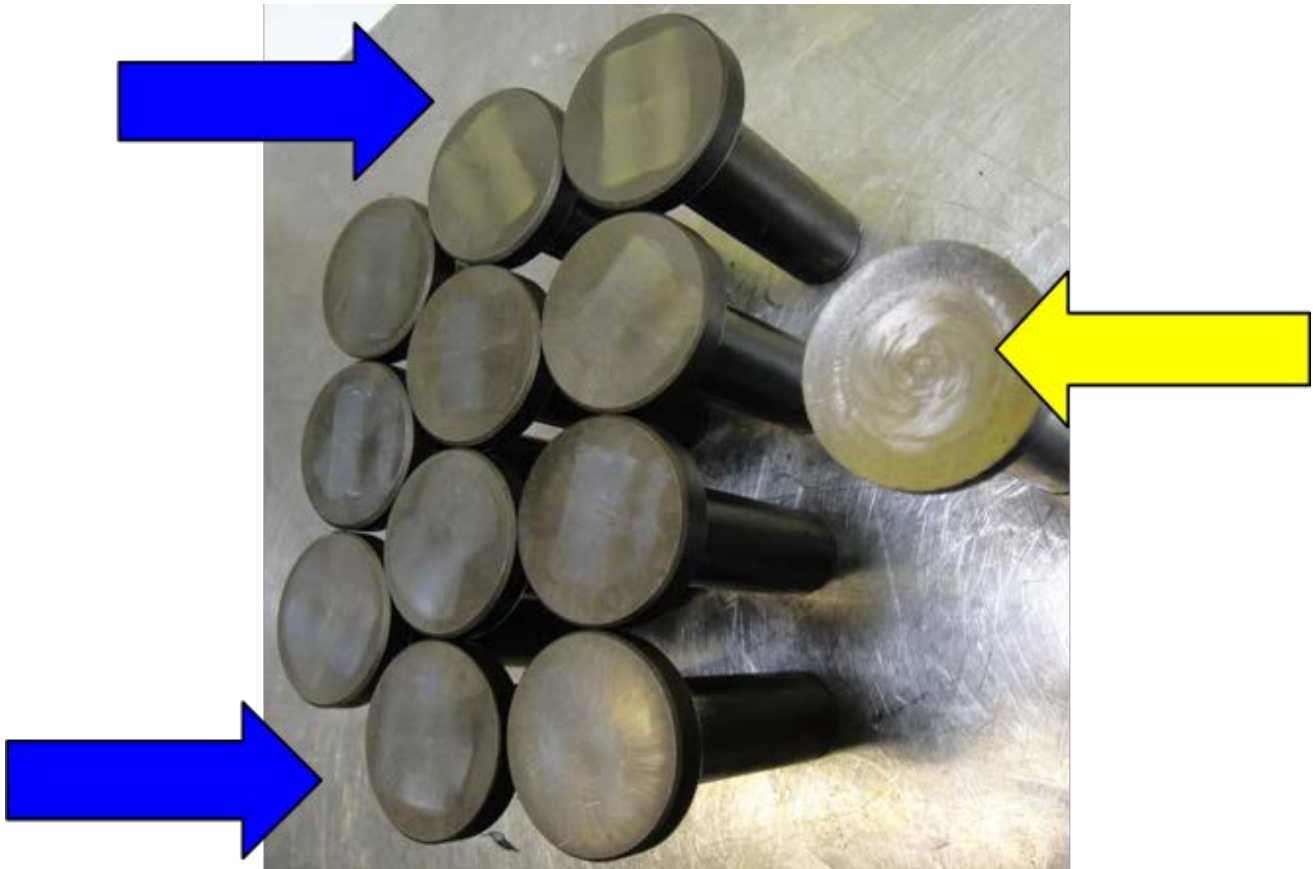
### C. Camshaft failure caused by lack of lubrication

The first picture shows the wear pattern on tappet to camshaft lobe contact area (blue arrow). The yellow arrow points to the only tappet that has been rotating, note circular pattern.

The cause of failure is lack of proper lubrication and tappets not rotating.

On a flat tappet engine, the camshaft must be pre-lubed before starting. Other possible causes of failure could be worn or damaged tappet bores.

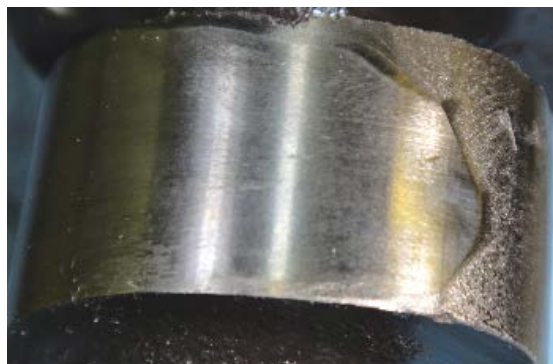
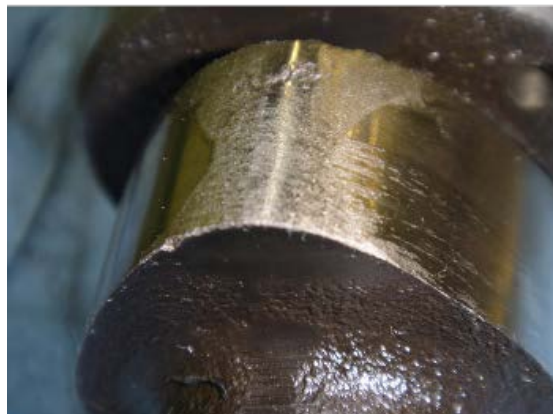
The next two pictures show the wear on one of the lobes of the camshaft.

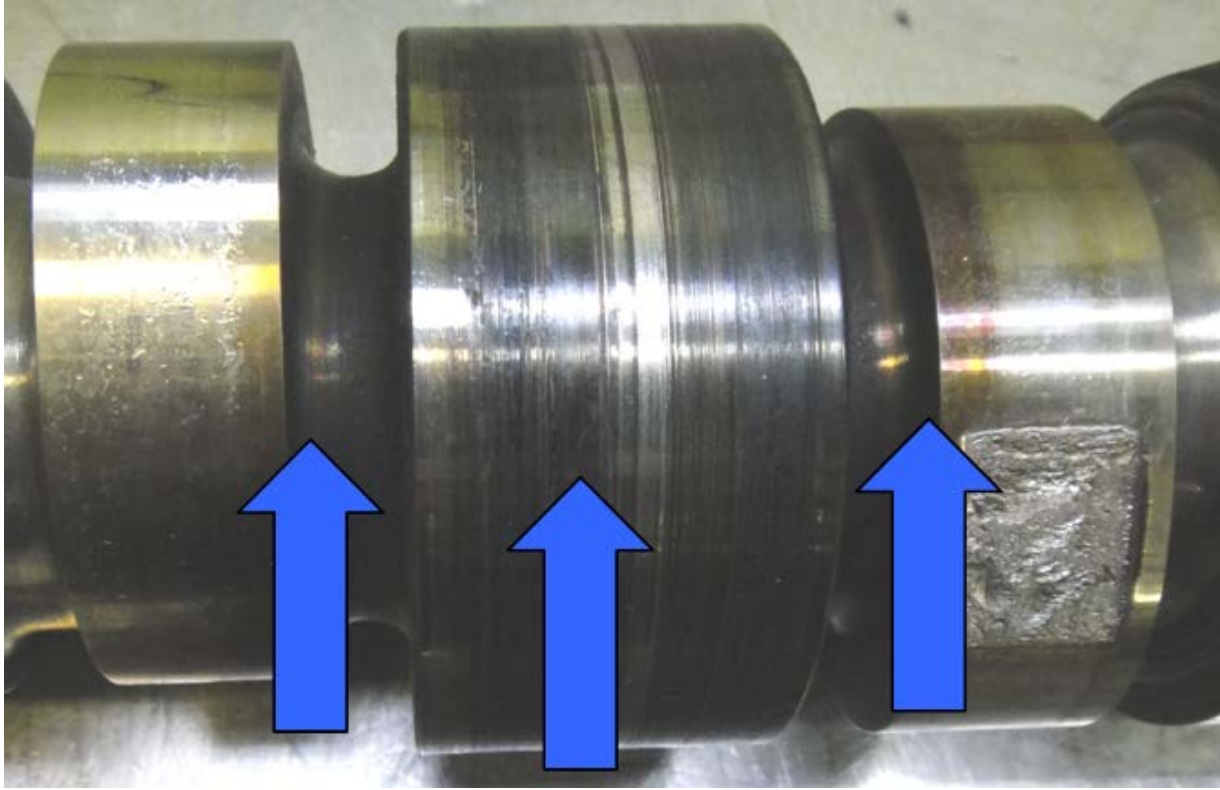
**D. Camshaft failure due to the lack of proper lubrication**

The first picture shows a bearing journal blackened from lack of proper lubrication, also note discoloration extending to surrounding shaft (blue arrow).

There are two areas where the correct amount of lubrication is required to allow the camshaft and the cam follower rollers to wear normally. The first area is between the pin and roller; the second is between the camshaft lobe and roller. The friction between the cam lobe and the follower comes from the normal loading due to the combined cylinder pressure and the valve spring force. A rolling contact is necessary to minimize friction. If there is a lack of lubrication galling will start to occur.

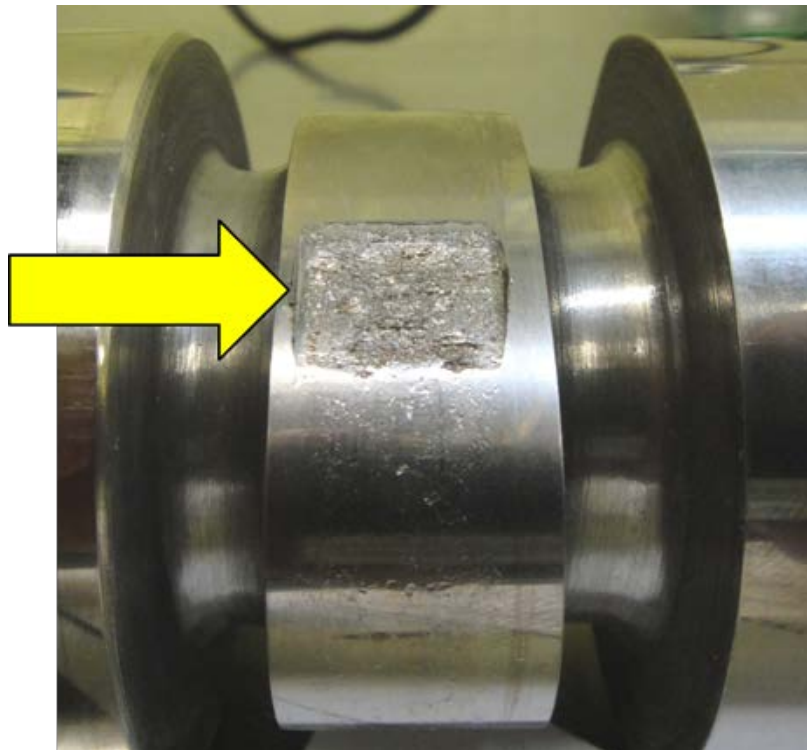
The next picture shows galling on valve lobe (yellow arrow).

Galling is defined as material transfer as a result of two surfaces coming into direct contact after penetrating through the lubricating film. Typically, the roller material transfers to the cam surface. Once the surfaces encounter galling, the load carrying capacity of the system is greatly reduced. The breakdown progresses to spalling caused by high contact fatigue stress. Continued running eventually causes the lobe to disintegrate as seen in the above pictures.

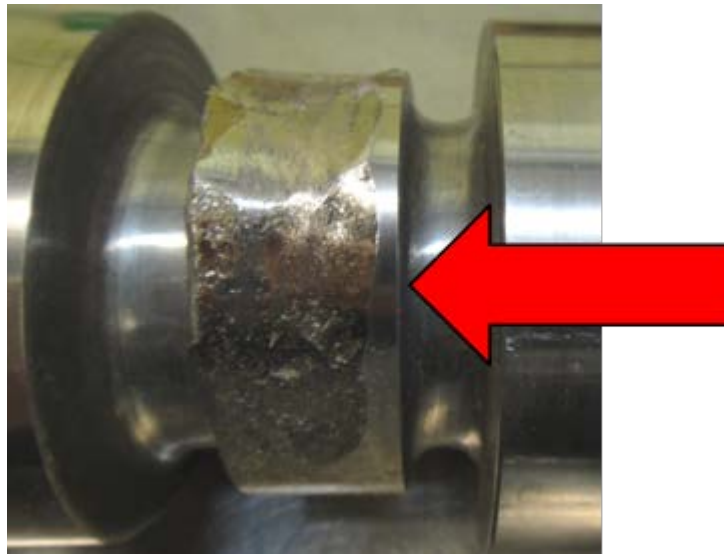
The final picture shows a lobe that is severely gouged from a follower that has turned sideways (red arrow).

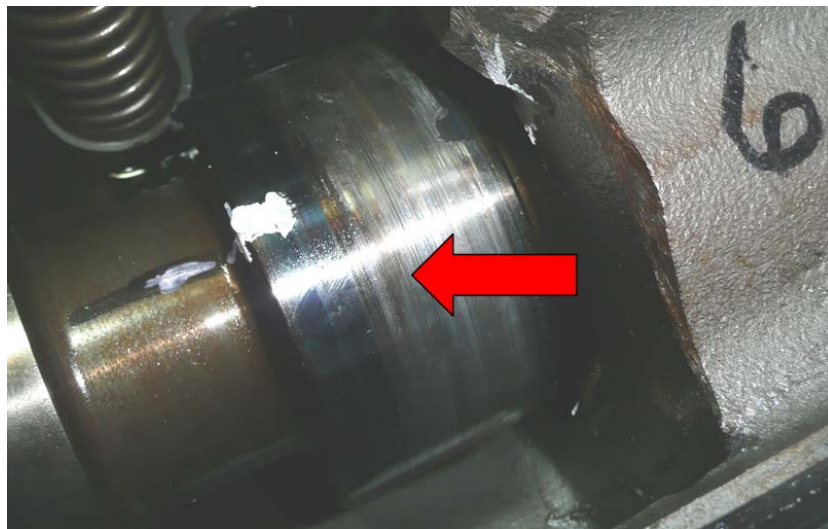
#### **E. Camshaft failure from misalignment**

The following picture shows the bearing was subjected to severe over heat, note the discoloration of the bearing material.

This type of failure is caused by misalignment, contamination or lack of proper lubrication.

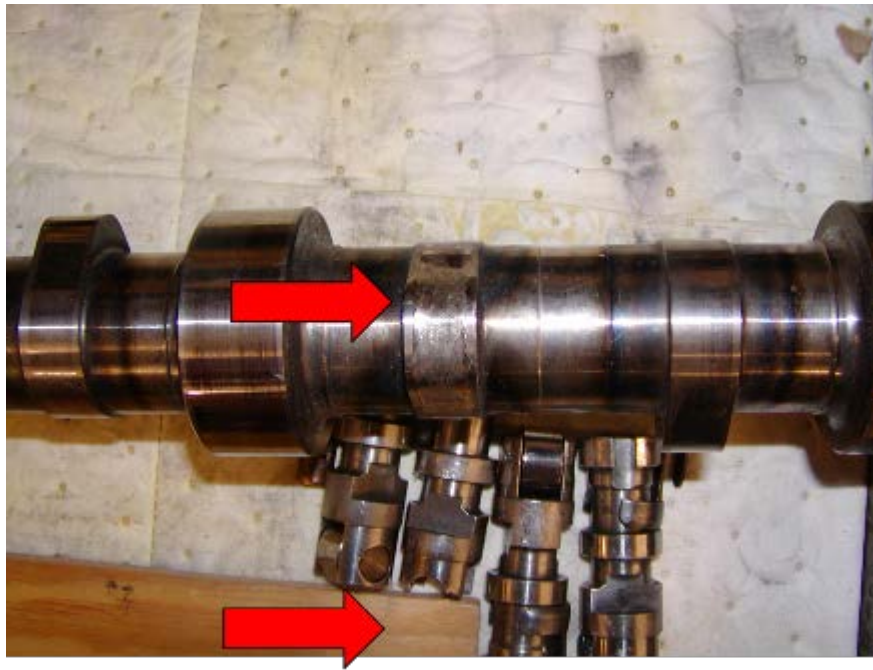
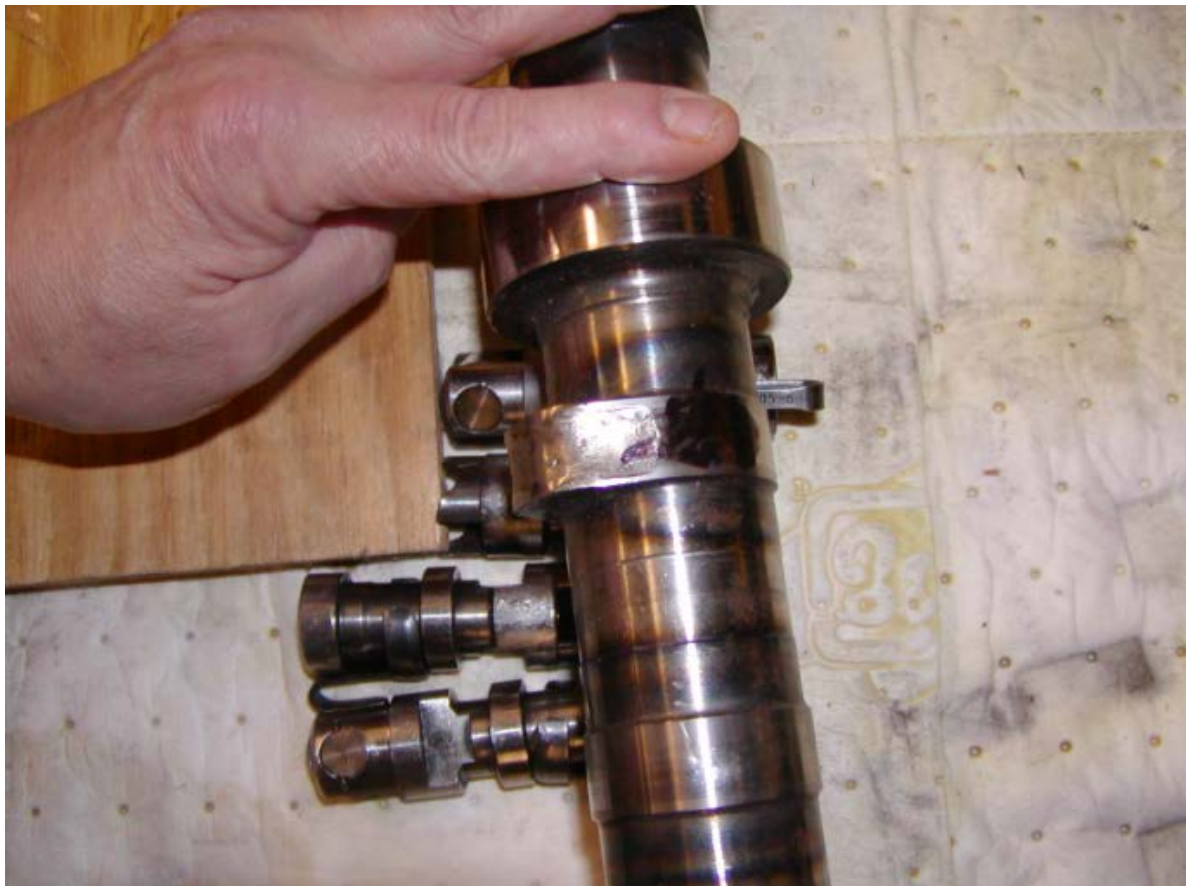
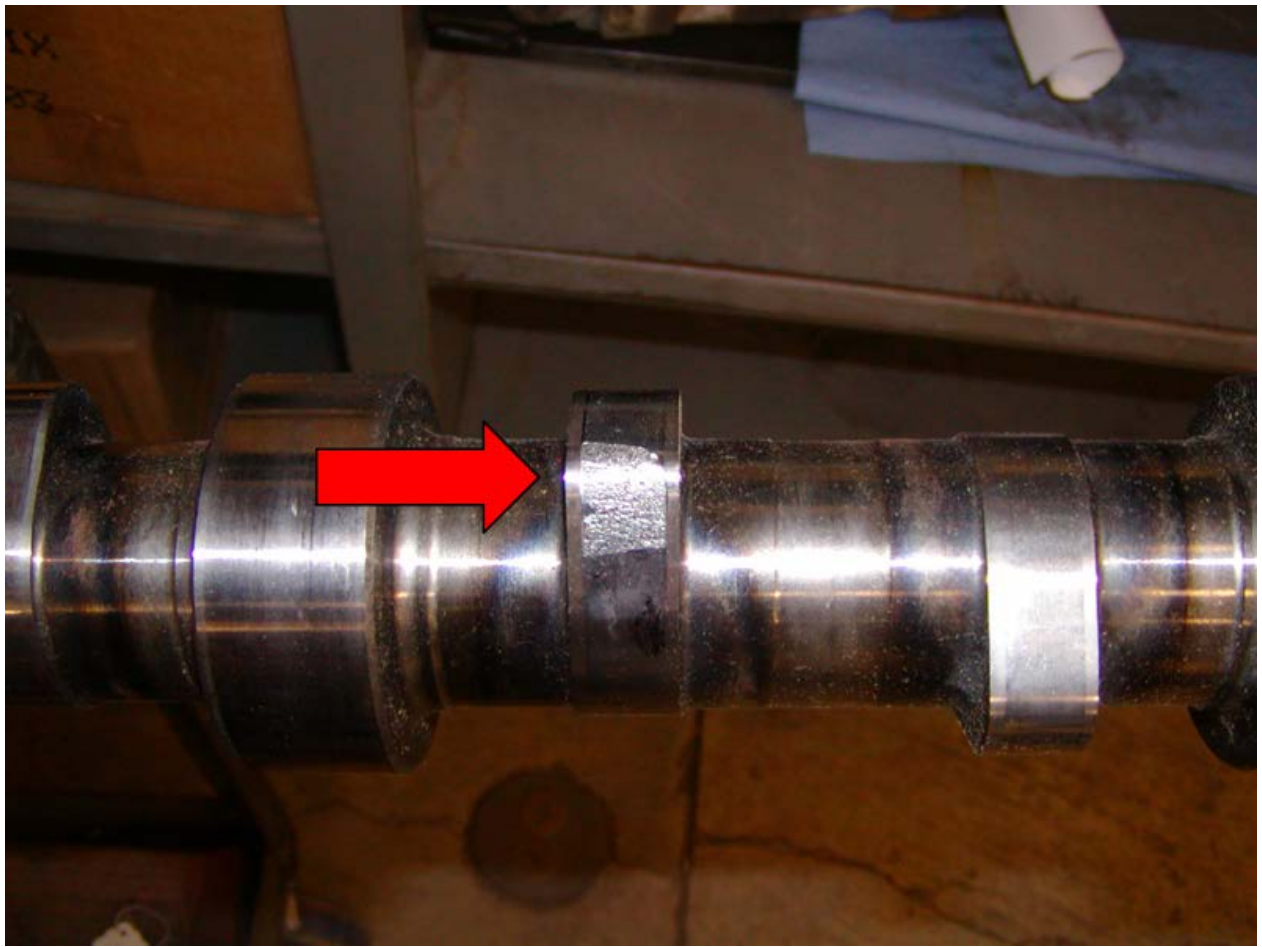
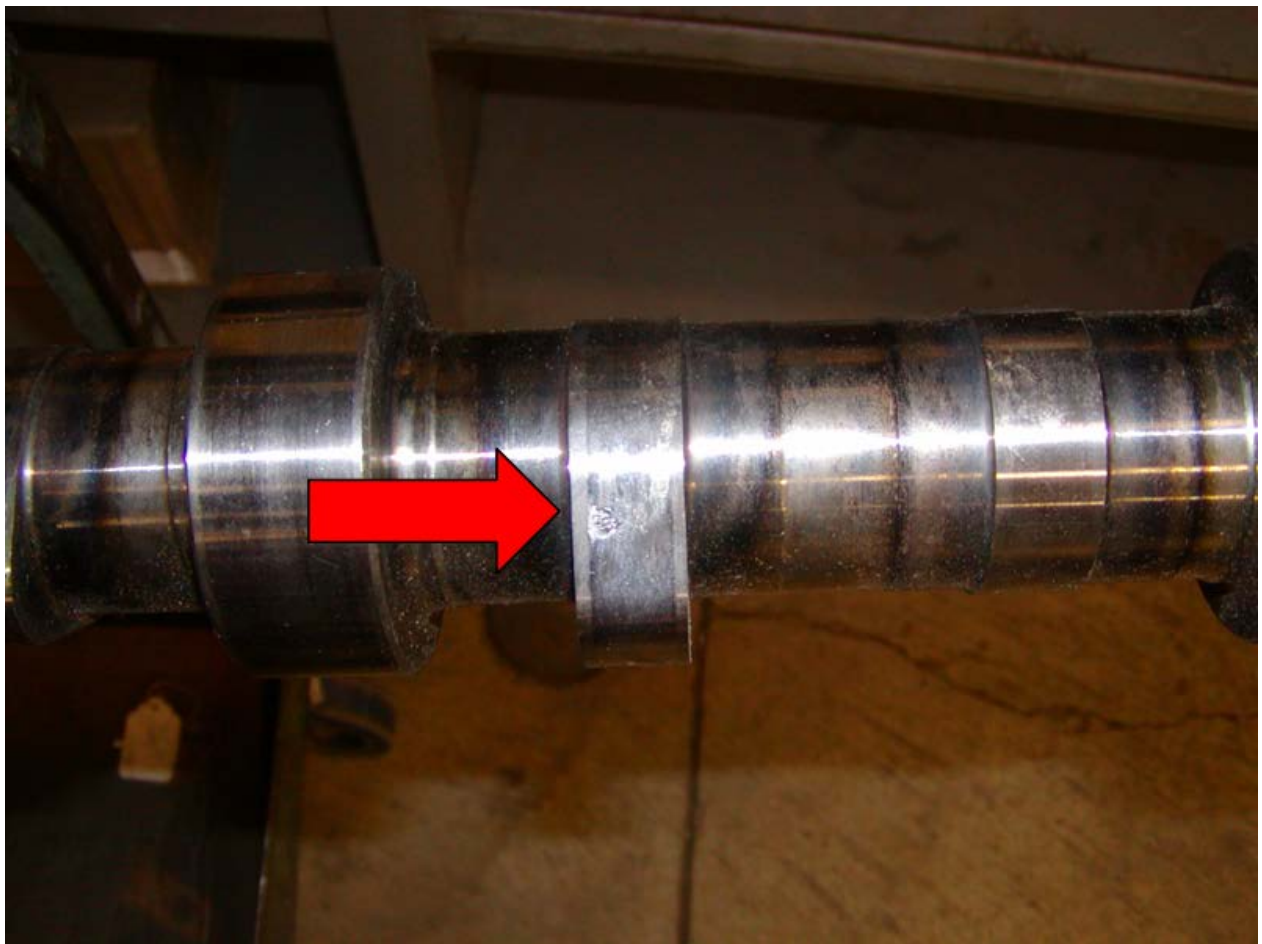
#### F. Engine over speed damage to camshaft and followers

The following pictures show different degrees of damage to the leading and descending sides of the camshaft lobes. This is caused by the downward impact of the lifter roller after it was instantly separated from the top of the cam lobe. This type of damage is caused by engine over speed.

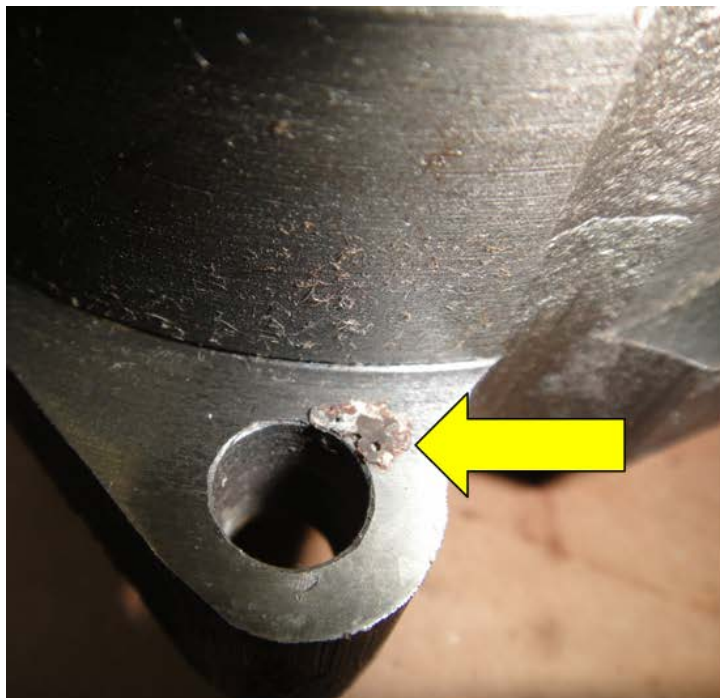
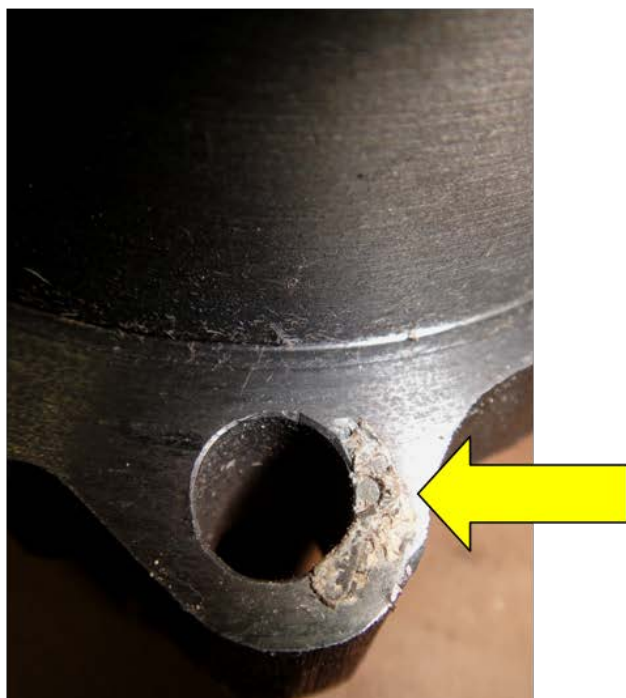
### A. Oil pump failure caused by improper installation

The pictures show the surface area where the pump interfaces with the block. Note the buildup of lock tight in these locations indicating presents of a gap.

The break area of the housing showed no inclusions or flaws. Backlash was not an issue as there is no indication of overheating. The most likely cause of failure is a bending break of the pump housing occurring when the retaining bolts side loaded the housing causing it to crack. This in turn allowed the driven gear shaft to come loose and bind and break the crankshaft gear.

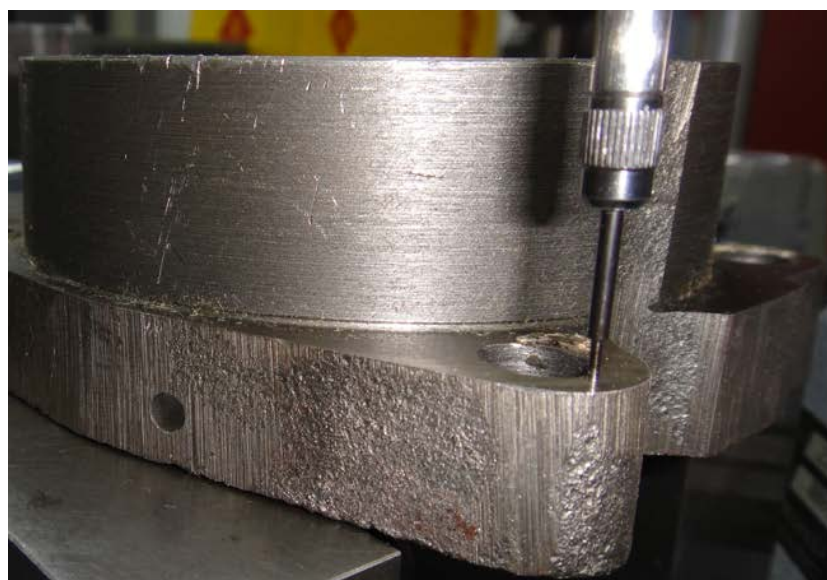
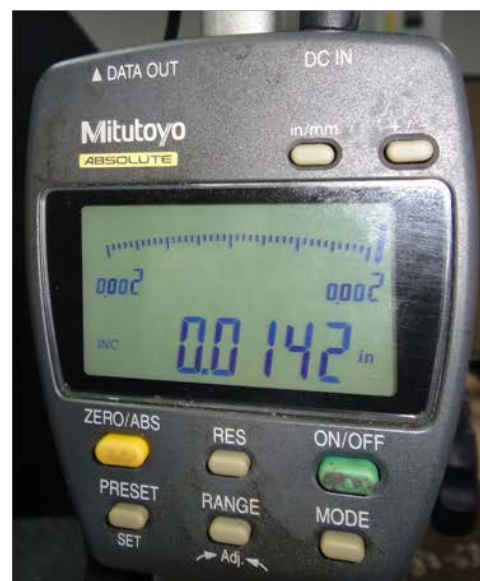
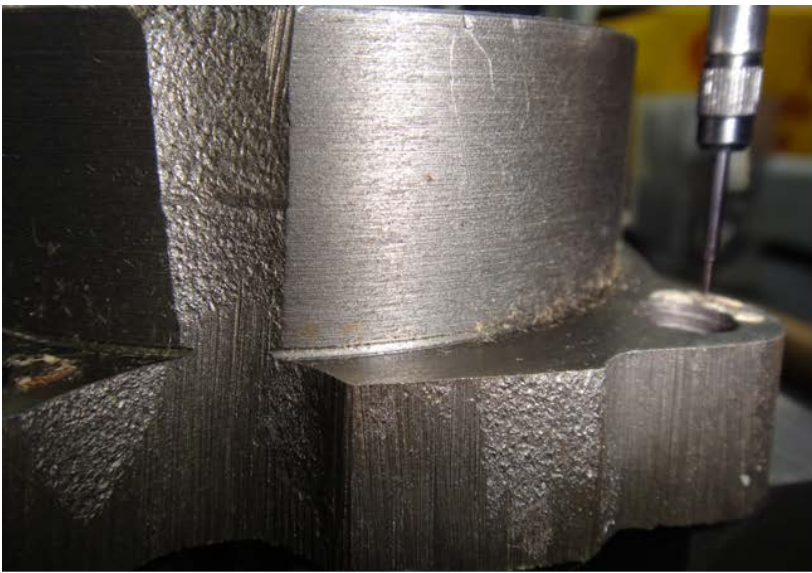
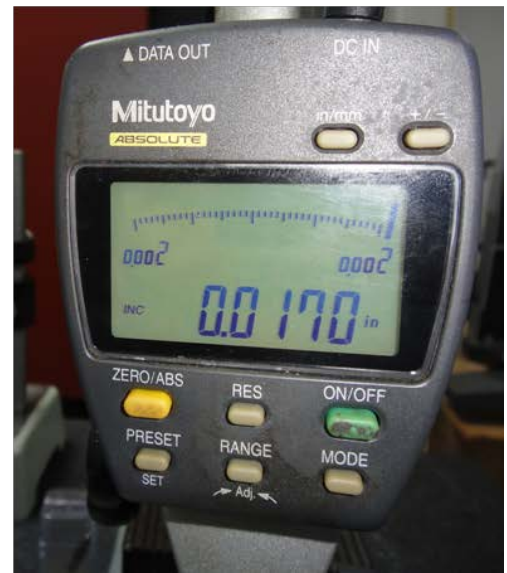
The following four pictures show the height of the hardened material from the mating area of the pump in the two locations show above. Note: the thickness differences.

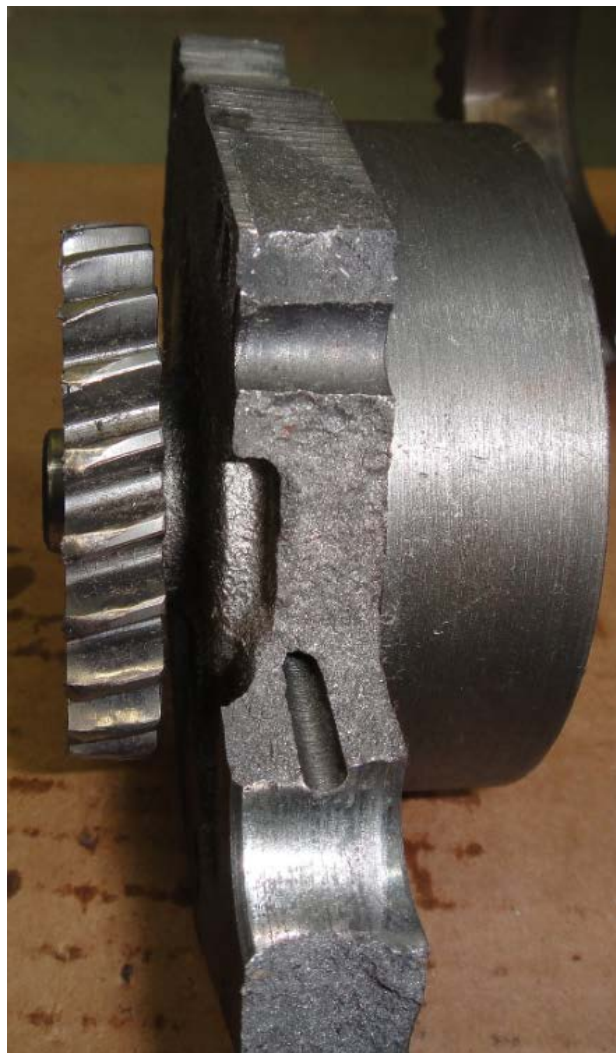
The final picture shows the broken area of the pump. No inclusions were found and no indication of overheating.

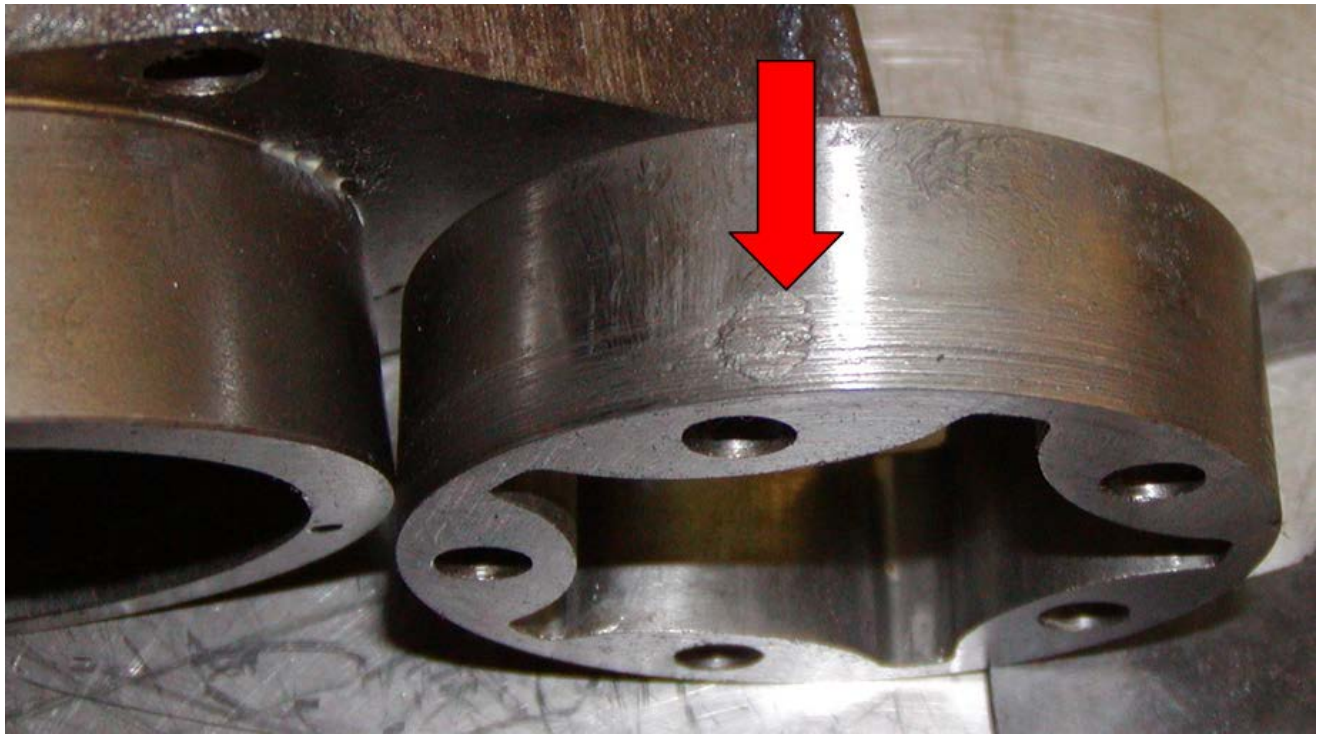
## B. Oil pump failure due to contamination

The red arrow points to where foreign material came to rest on the driven rotor.

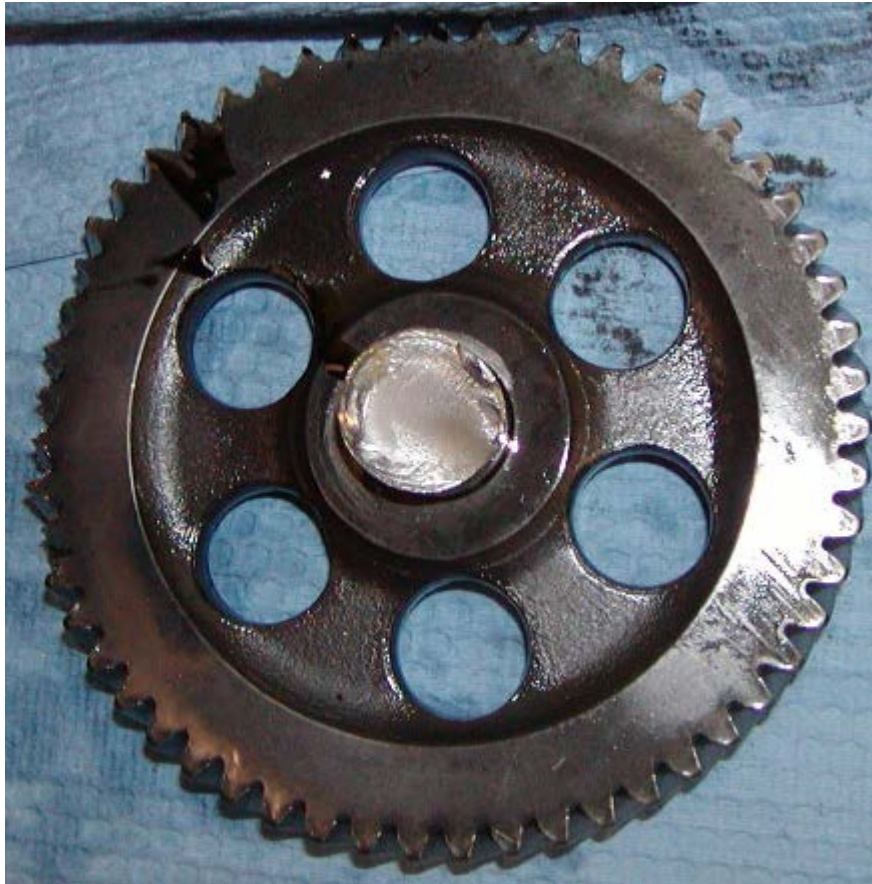
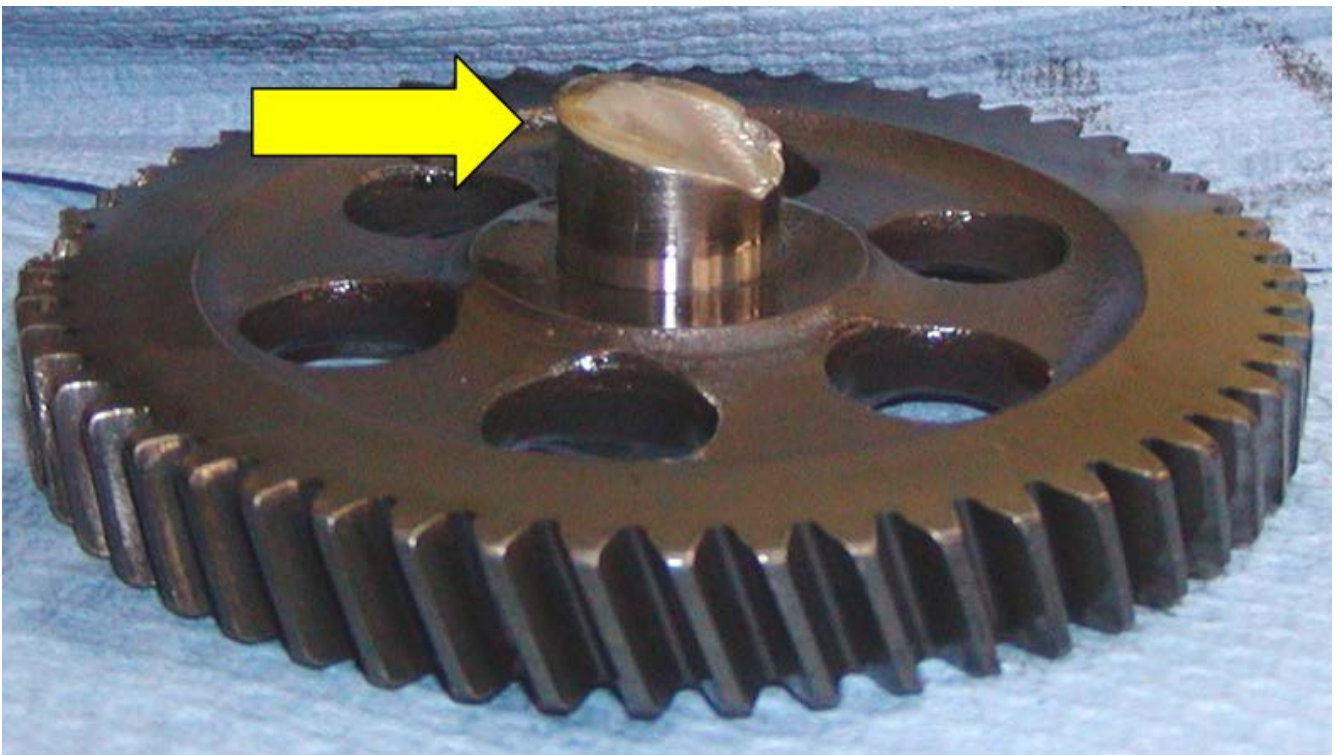
C. Pump failure due to improper installation procedures.

The pictures show an end view of the broken shaft and a side view of the shaft. Note angle of break.

The bushing failed from insufficient lubrication caused by excessive side loading. A shaft that breaks at or near a 45 degree angle indicates it has been under excessive torsional stress, a twisting break. The fact the bushing failed from side loading, one would expect a clean shaft break. However, when the shaft seized in the bushing the force of the engine twisted the shaft and caused the break to be torsional. The root cause of the pump failure was determined to be the pump was not shimmed properly and the gears did not have sufficient backlash.

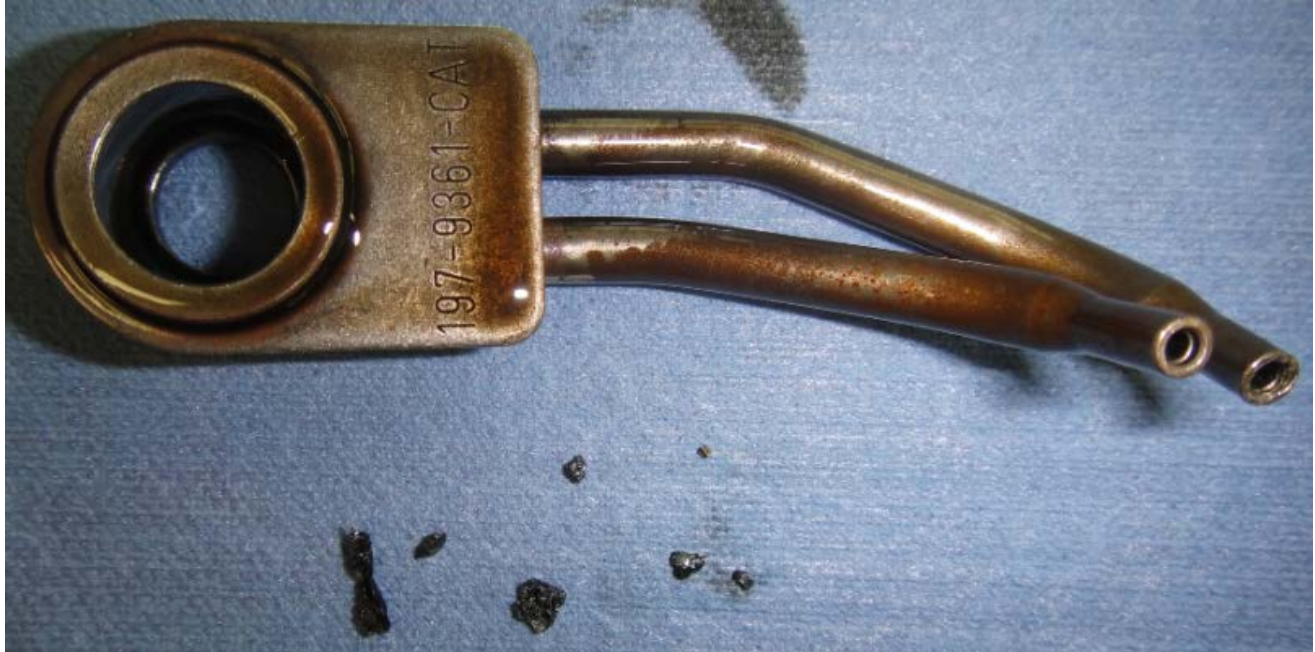
### A. Piston cooler failure caused by contamination in the oil system

Contamination left in the oil system from an engine overhaul plugged the piston cooler and caused the cylinder kit to seize from over heat. The material in the picture below the cooler was determined to be gasket material.

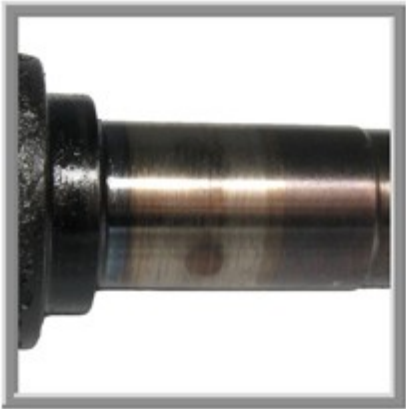
- Low engine oil pressure/level
- Obstructed oil supply or drain lines
- Improper weight of oil
- Contaminated oil
- Fast starts in cold weather
- Hot shutdown (**Figure 7**) - Engine is shutoff at high rpm/temp; instant oil flow loss causing overheating
- Engine Blow-by

**Figure 7: "Hot Shutdown"**  
Turbine Wheel Shows Visible Bearing Pattern and Heat Discoloration

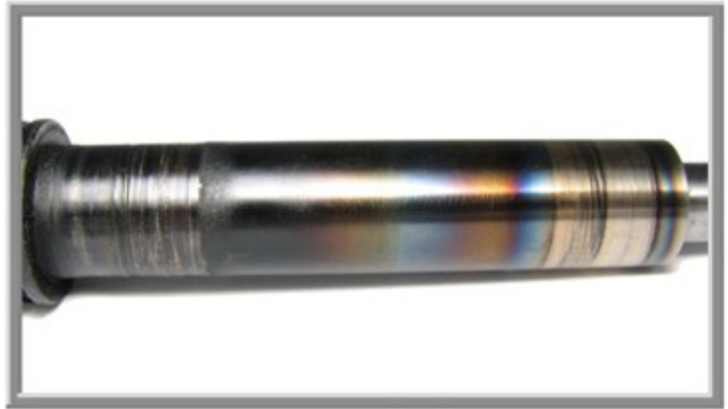
- Occurs when anything exterior to the turbocharger is affecting the oil flow (supply or drain lines, engine blow-by, etc.).
- All thrust & journal bearings as well as the turbine shaft will show signs heat discoloration (**Figure 8**) as well as wear from the resulting shaft motion. The wear will appear smooth or “wiped” (**Figures 9 & 10**) and should not have any significant scaring (**Figures 11 & 12**).
- **Unwarrantable:** The cause of this failure is external to the turbocharger.

**Figure 8: Turbine Shaft Lack of Lubrication** Turbine Wheel Shows Visible Heat Discoloration and Smeared Wear

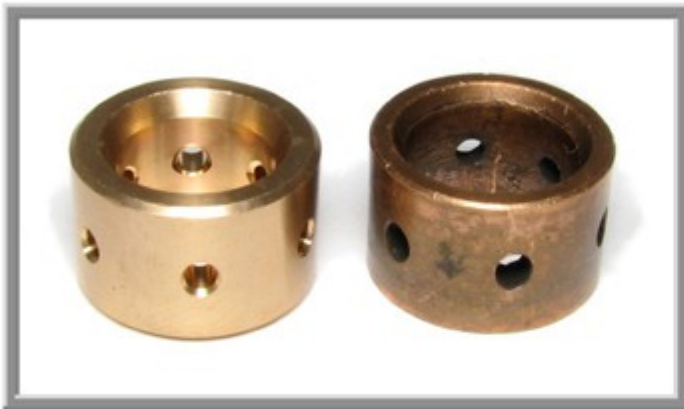
**Figure 9: Journal Bearing Lack of Lubrication**  
Left=New Bearing; Right=Smooth Wear & Heat Discoloration

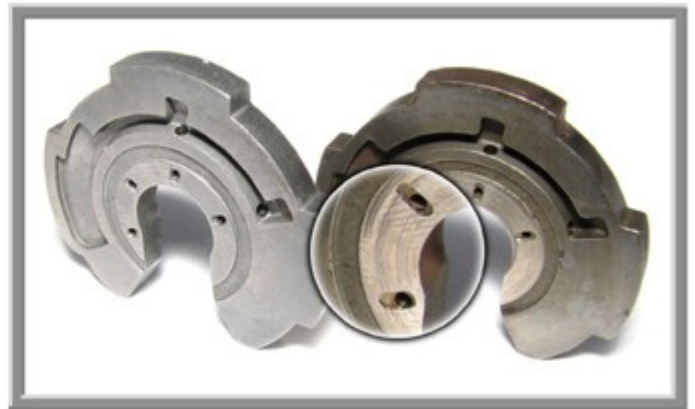
**Figure 10: Thrust Bearing Lack of Lubrication**  
Left=New Bearing; Right=Smooth Wear & Heat Discoloration

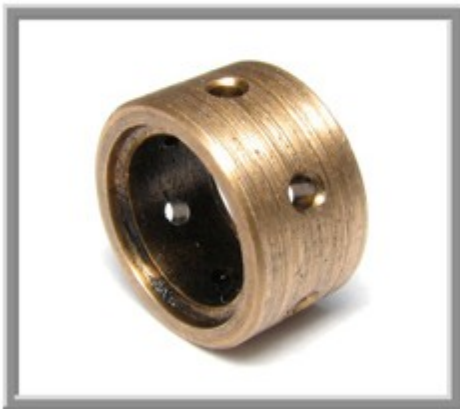
- Occurs when abrasive material such as dirt, sand, or metal shavings enters the oil passages. This is generally easy to notice as the bearings and connecting components will show abnormal grooves and scratches (**Figures 11 & 12**). This may also cause a lack of lubrication failure as noted above.
- **Unwarrantable:** The cause of this failure is related to the installation or oil quality within the vehicle.

**Figure 11: Journal Bearing Contaminated Oil**  
Visible Scarring on Inner and Outer Diameters
