# INTERSTATE-McBEE

## FAILURE ANALYSIS GUIDE

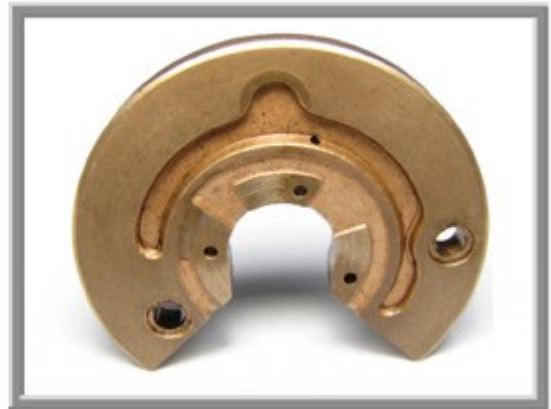
**Figure 12: Thrust Bearing Contaminated Oil**  
Visible Scarring on Pads

- Occurs when abrasive material such as dirt, sand, or metal shavings enters the oil passages. This is generally easy to notice as the bearings and connecting components will show abnormal grooves and scratches (**Figures 11 & 12**). This may also cause a lack of lubrication failure as noted above.
- **Unwarrantable:** The cause of this failure is related to the installation or oil quality within the vehicle.

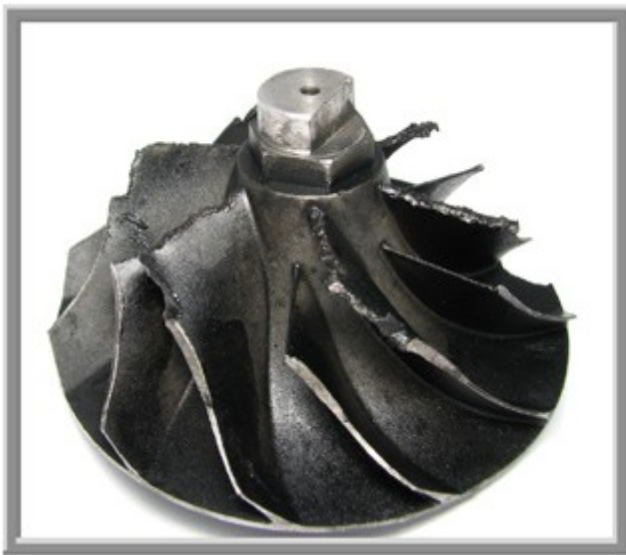
**Figure 13: Compressor Wheel Foreign Material**

In many cases, this is the most obvious damage to recognize as the compressor or turbine wheel will often show severe damage without removing the housing (**Figure 13 & 14**). However, in some scenarios, this is a gradual erosion of the wheel from fine particles such as sand or dirt. In this case, the wheel will display small pits across the vanes or minor wear on the inducer tips.

Severe Damage to the Vanes on the Wheel

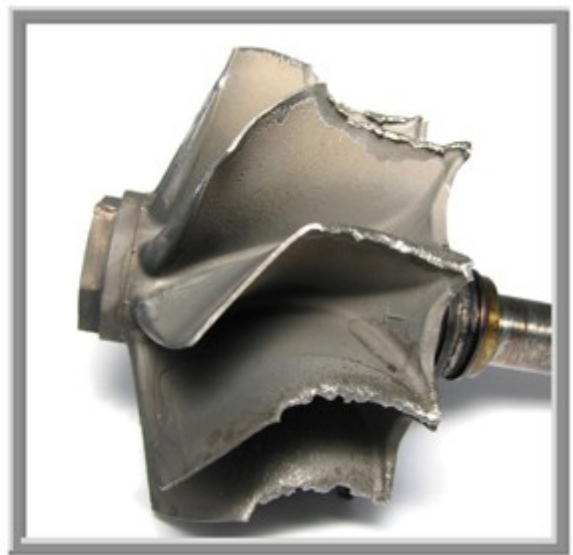
**Figure 14: Turbine Wheel Foreign Material**

Severe Damage to the Vanes on the Wheel

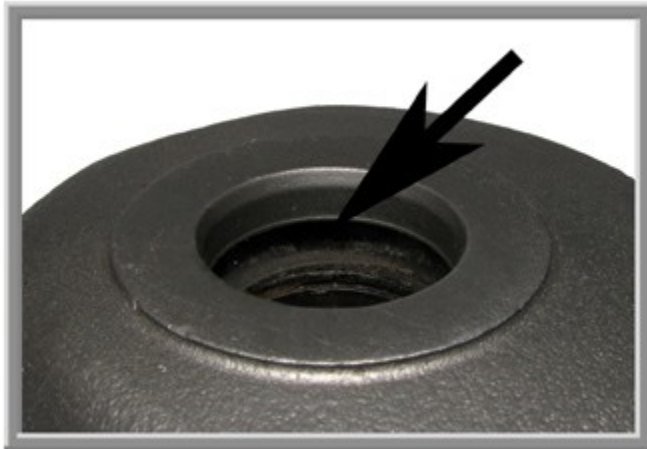
**Figure 15: Bearing Housing High Exhaust Temp**

Excessive temperature in the exhaust system will cause the lubricating oil to “coke” in the bearing housing drain annulus at the turbine end (**Figure 15**). This causes oil leakage into the turbine housing. Coke and carbon deposits will be visible and eventually damage the back of the turbine wheel and cause abnormal wear on the thrust bearing. High exhaust temperatures can also erode (**Figure 16**) and crack (**Figure 17**) the turbine housing and/or bearing housing. Excessive heat discoloration of the turbine shaft is usually visible. The piston ring in the turbine side of the bearing housing will often appear relaxed if it has been submitted to these high temperatures.

Blocked Drain Annulus from Oil Coking

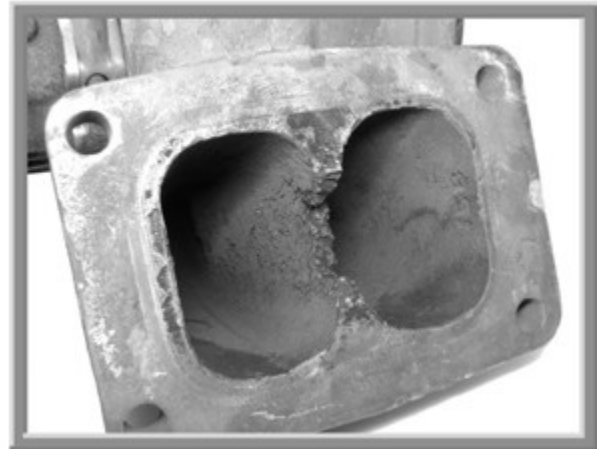
**Figure 16: Turbine Housing High Exhaust Temp**

Erosion of Web Caused by High Temperatures

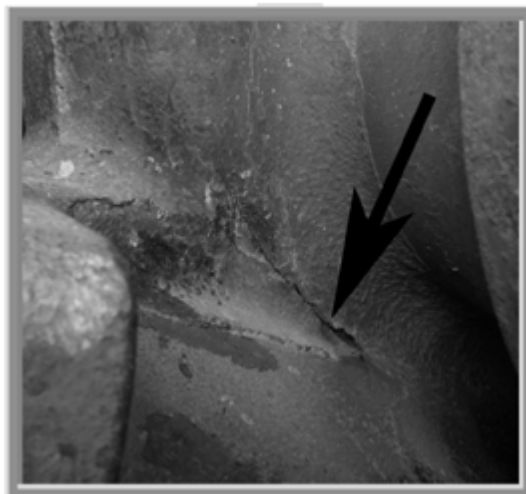
**Figure 17: Turbine Housing High Exhaust Temp**

Cracked Housing Caused by High Temperatures

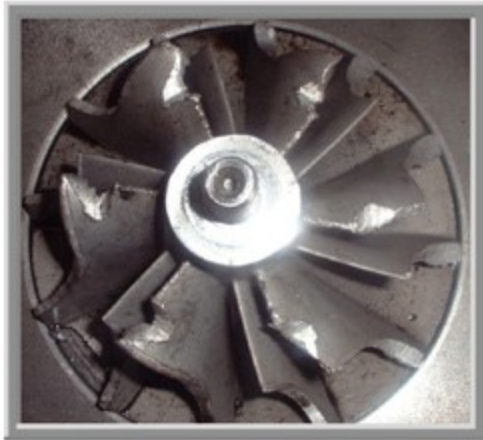
**Figure 18: Compressor Wheel Lock Nut Failure**

Although rare, this failure may also be caused by the compressor wheel lock nut loosening off and entering the compressor vanes (**Figure 18**). This failure originates from assembly if the lock nut was not tightened to the specified torque setting or the Loctite® compound was not applied.

Nut is missing, foreign object damage to vanes

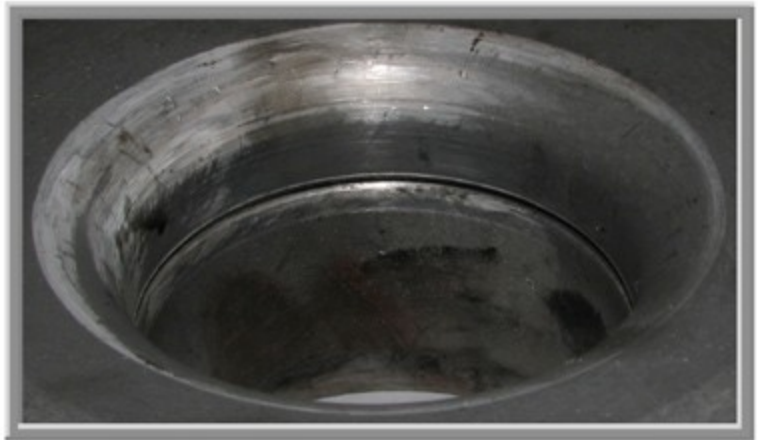
**Figure 19: One Sided Wear on Compressor Housing**

Can be caused by improper manufacturing or assembly

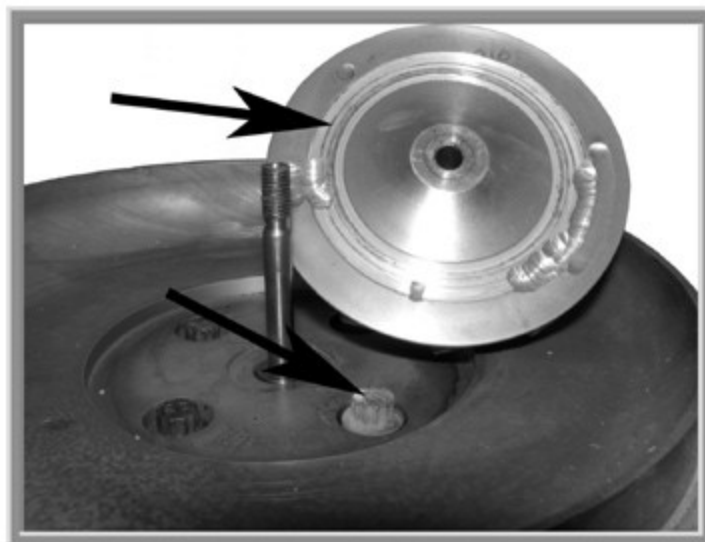
**Figure 20: Back Plate Bolt Loosened and Contacted Back of Compressor Wheel**

Can be caused by improper assembly (No Loctite®)

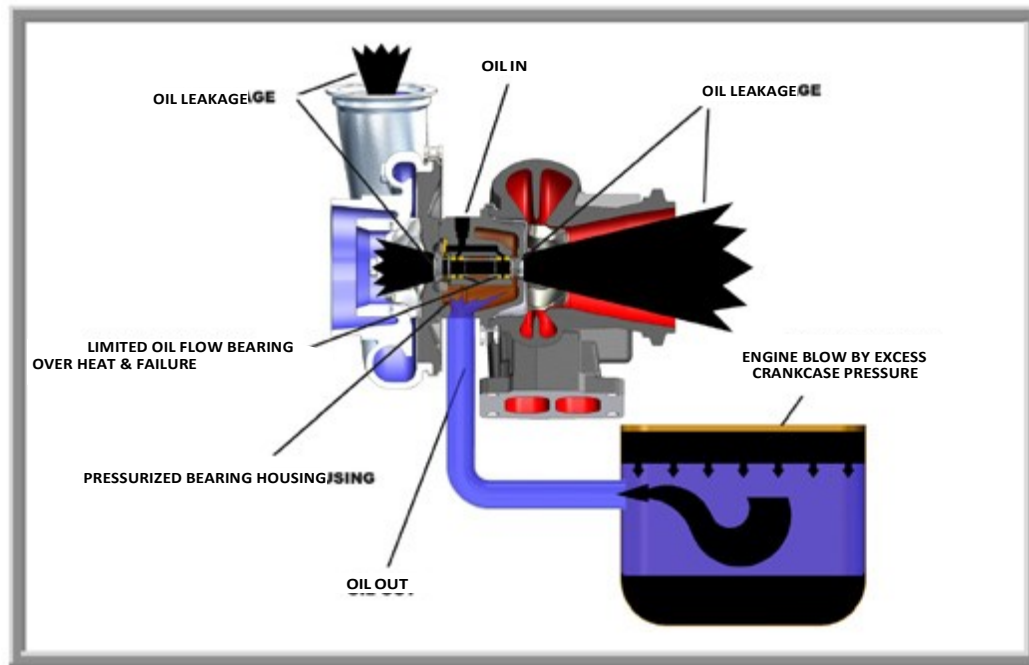
**Figure 21: Engine Blowby**

Increased crank case pressure causes flowing oil to squeeze out of the piston ring gaps and also reduces the amount of oil to the bearings causing failure

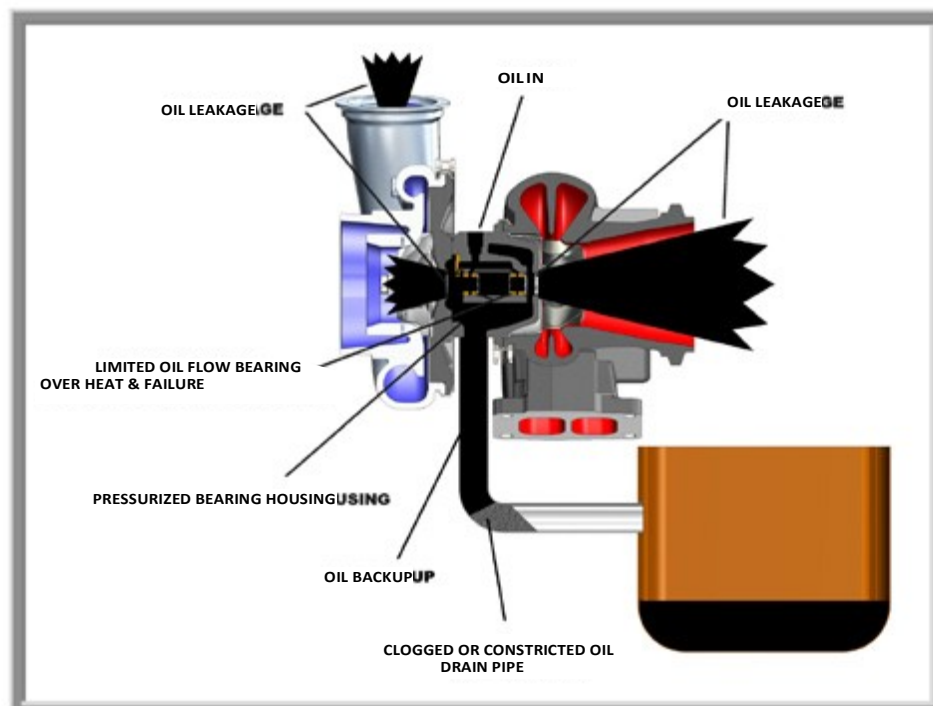
**Figure 22: Clogged Oil Drain Pipe**

Oil cannot flow and pressurizes the drain area causing oil leakage and bearing failure

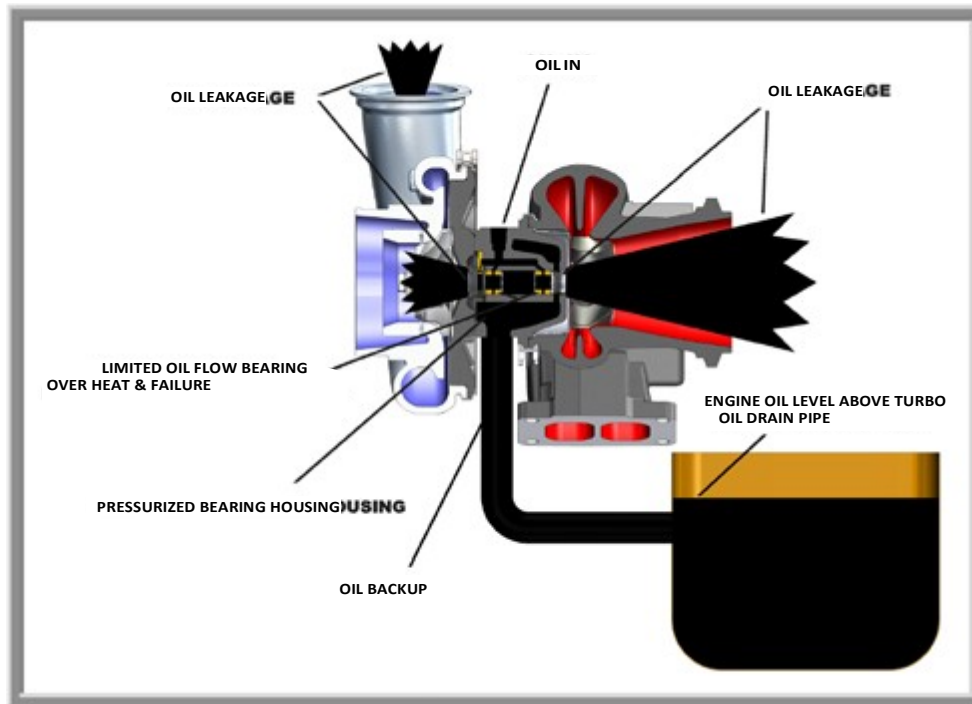
**Figure 23: Oil Level Too High**

Minor pressure in the crank case will prevent oil from flowing which pressurizes the drain area causing oil leakage and bearing failure

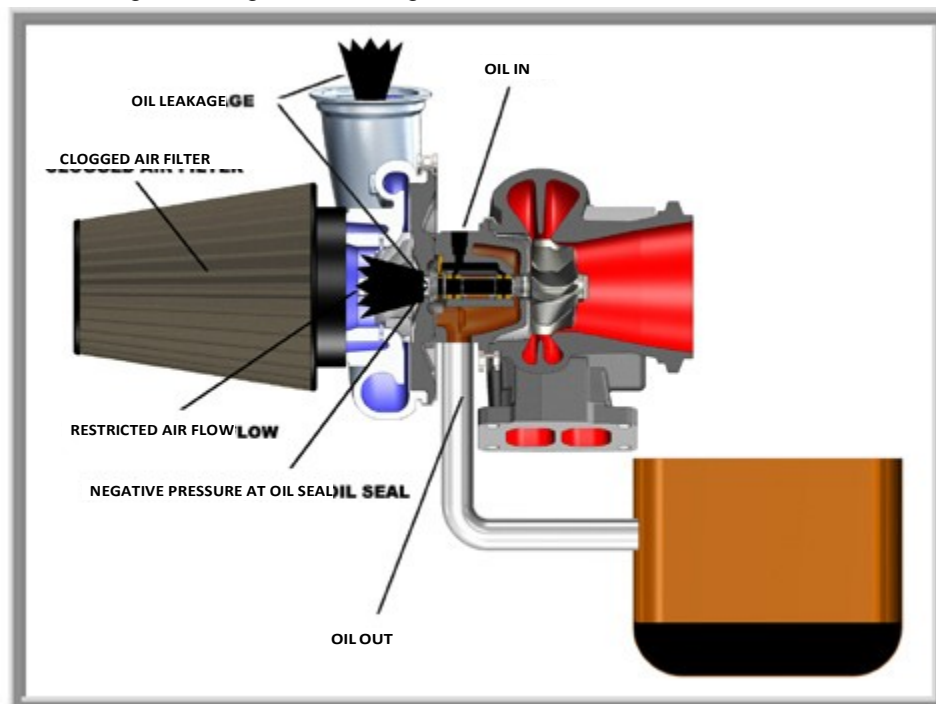
**Figure 24: Clogged Air Filter**

Reduced airflow in the compressor inducer will create high vacuum pressure which will suck oil into the compressor side of the turbocharger
